NOTICE OF DATA INACCURACY

INSPECTION REPORT

Electrical Corporation:	Southern California Edison Company
Report Number:	PAD_SCE_KSF_20260128_1118
Date of Inspection:	January 28, 2026
City and/or County of Inspection:	Pine Mountain Club, Kern County
Inspector:	Keyshawn Ford
WMP Year Inspected:	2025
Quarterly Data Report (QDR) Referenced:	Quarter 3 (Q3)
Inspection Selection:	Energy Safety viewed the contents of the Q3 QDR and performed an analysis that resulted in the selection of the WMP initiatives and locations referenced in this report.
Relevant WMP Initiative(s):	8.1.3.1 – Distribution Detailed Inspections and Remediation
Inspection Purpose:	Assess the accuracy of Southern California Edison Company’s QDR data, completeness of its work, and performance of WMP requirements.

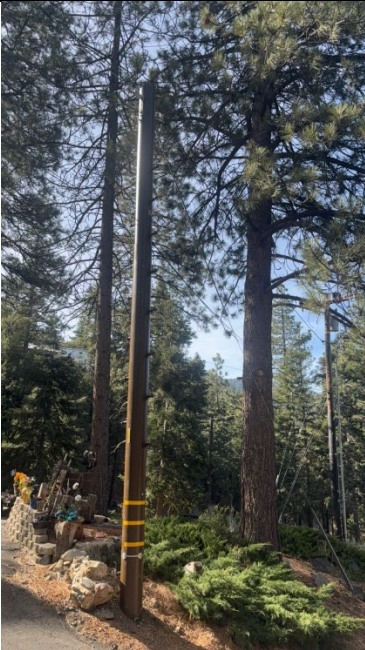
G1mg1: Overall Structure

On Pole ID 2059169E, Grid Hardening ID 414570632-2059169E at 1301 Linden Dr, Pine Mountain Club, CA, 93222, USA, 34.8387162903553, -119.141734838165, the inspector observed that two separate grid hardening points were reported for the completed pole replacement work. The inspector's observation is documented in Data Inaccuracy 1 photographs GImg1 and GImg2, which are attached to this report as Exhibit A.

1. The description of work details pole replacement at this location; however, that pole replacement was counted twice under two separate Grid Hardening IDs.
2. The "Long Text" for Grid Hardening ID 414570632-2059169E, provided via "ES-SCE-2025 Q3 Problem Statement Remediations" states "Per the multiple notification process, this is a duplicate notification. Setting REJC status. Pole will be or is already replaced on notification 414077621."
3. The "Long Text" for Grid Hardening ID 414077621-2059169E, provided via "ES-SCE-2025 Q3 Problem Statement Remediations" states "Per multiple notification process, pole is in process to be changed out on this notification, notification required start and end dates have been adjusted to match earlier due notification 414570632."

Within 30 days from the issuance date of this NODI, SCE should provide a response advising Energy Safety of corrective actions taken or planned to remedy the identified data inaccuracy or inaccuracies.
