NOTICE OF DATA INACCURACY

INSPECTION REPORT

Electrical Corporation:	Southern California Edison Company
Report Number:	PAD_SCE_KSF_20260128_1206
Date of Inspection:	January 28, 2026
City and/or County of Inspection:	Pine Mountain Club, Kern County
Inspector:	Keyshawn Ford
WMP Year Inspected:	2025
Quarterly Data Report (QDR) Referenced:	Quarter 3 (Q3)
Inspection Selection:	Energy Safety viewed the contents of the Q3 QDR and performed an analysis that resulted in the selection of the WMP initiatives and locations referenced in this report.
Relevant WMP Initiative(s):	8.1.3.1 – Distribution Detailed Inspections and Remediation
Inspection Purpose:	Assess the accuracy of Southern California Edison Company’s QDR data, completeness of its work, and performance of WMP requirements.

WMP Inspection Data Inaccuracies

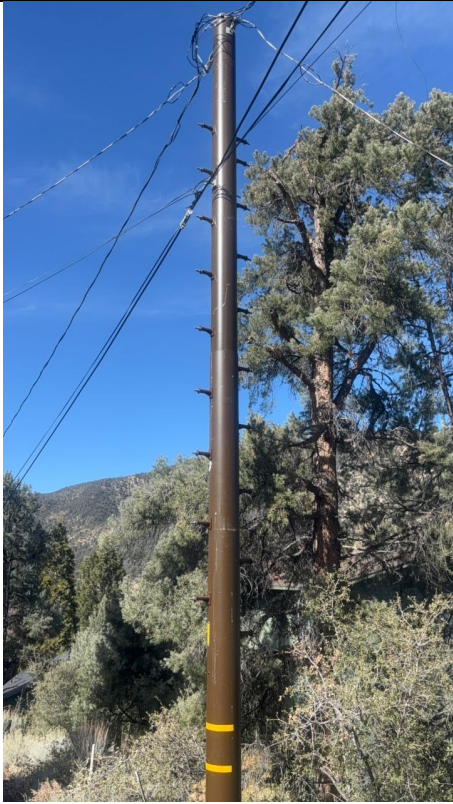
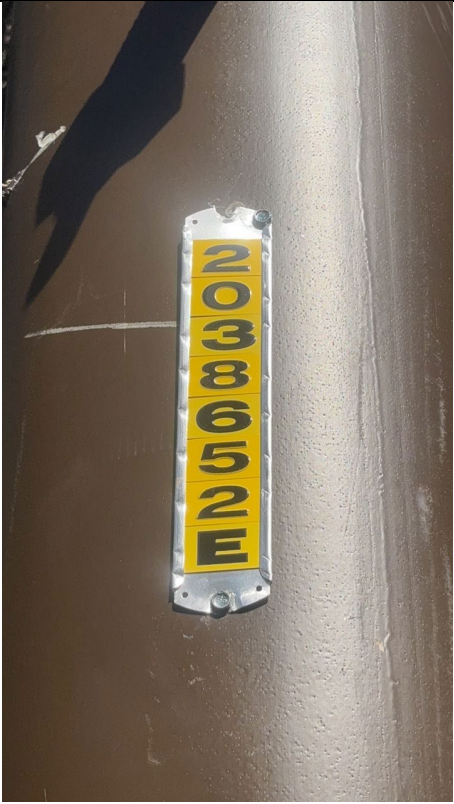
On Pole ID 2038652E, Grid Hardening ID 414580192-2038652E at 2445 Innsbruck Ct, Pine Mountain Club, CA, 93222, USA, 34.8508489998326, -119.159022000629, the inspector observed that two separate grid hardening points were reported for the completed pole replacement work. The inspector's observation is documented in Data Inaccuracy 1 photographs GImg1 and GImg2, which are attached to this report as Exhibit A.

1. The description of work details pole replacement at this location; however, that pole replacement was counted twice under two separate Grid Hardening IDs.
2. The "Long Text" for Grid Hardening ID 414580192-2038652E, provided via "ES-SCE-2025 Q3 Problem Statement Remediations" states "Per the multiple notification process, this is a duplicate notification. Setting REJC status. Pole will be or is already replaced on notification 414077620."
3. The "Long Text" for Grid Hardening ID 414077620-2038652E, provided via "ES-SCE-2025 Q3 Problem Statement Remediations" states "Per multiple notification process, pole is in process to be changed out on this notification, notification required start and end dates have been adjusted to match earlier due notification 414580192."

Within 30 days from the issuance date of this NODI, SCE should provide a response advising Energy Safety of corrective actions taken or planned to remedy the identified data inaccuracy or inaccuracies.
