## NOTICE OF DATA INACCURACY

Pursuant to Government Code section 15472, et seq, the Office of Energy Infrastructure Safety (Energy Safety) has conducted an inspection of work completed by Liberty Utilities (LU) in accordance with its 2025 Wildfire Mitigation Plan (WMP) and determined the existence of inaccurate data. Energy Safety therefore issues LU a Notice of Data Inaccuracy (NODI).

From June 1, 2026, to June 4, 2026, Energy Safety inspected 2025 Q3 and Q4 WMP initiatives in the vicinity of South Lake Tahoe, California. Energy Safety found the following data inaccuracies: Data Inaccuracies 1-12: The inspectors observed inaccurate data provided on expulsion fuse replacement; based on review of available online resources, the inspector observed new fuses were installed where no previous expulsion fuses existed to be replaced.<sup>1</sup> See Table 1: WMP Inspection Data Inaccuracies.

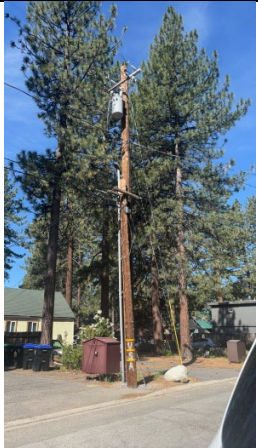
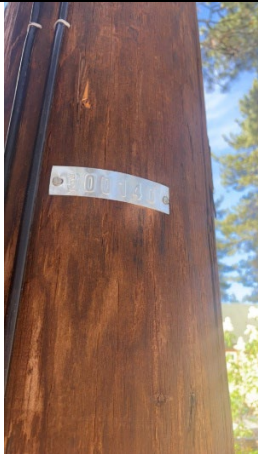
Data Inaccuracy 1

| Data Inaccuracy # | Record ID | Actual Structure ID | IOU Provided Structure ID | Grid Hardening ID | QDR Referenced | Lat/Long | Initiative Number | Data Inaccuracy Description |
|---|---|---|---|---|---|---|---|---|
| 1 | PAD_LU_CYA_20260602_0945 | 300140 | 300140 | 7b7c14d3-9c4f-4cab-ac1a-279f5699d51a | 2025 Q4 | 38.95177160015, -119.94635255053 | 8.1.2.12 - Expulsion fuse replacement | Inaccurate data provided on expulsion fuse replacement |

| Data Inaccuracy Img1-1: Overall Structure | Data Inaccuracy Img1-2: Structure ID |

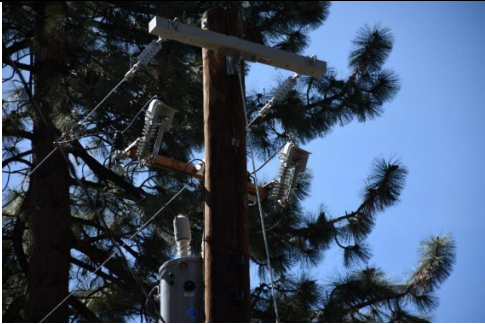
| Data Inaccuracy Img1-3: View of CALFIRE exempt fuses. | |

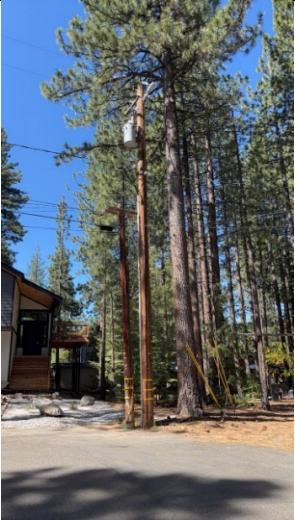
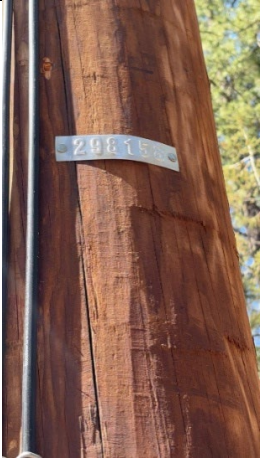
Data Inaccuracy 2

| Data Inaccuracy # | Record ID | Actual Structure ID | IOU Provided Structure ID | Grid Hardening ID | QDR Referenced | Lat/Long | Initiative Number | Data Inaccuracy Description |
|---|---|---|---|---|---|---|---|---|
| 2 | PAD_LU_CYA_20260602_1011 | 298158 | 298158 | de052c72-33d6-4c8b-a1cc-1660c658a52a | 2025 Q3 | 38.9494161697747, -119.946321799633 | 8.1.2.12 - Expulsion fuse replacement | Inaccurate data provided on expulsion fuse replacement |

| Data Inaccuracy Img2-1: Overall Structure | Data Inaccuracy Img2-2: Structure ID |

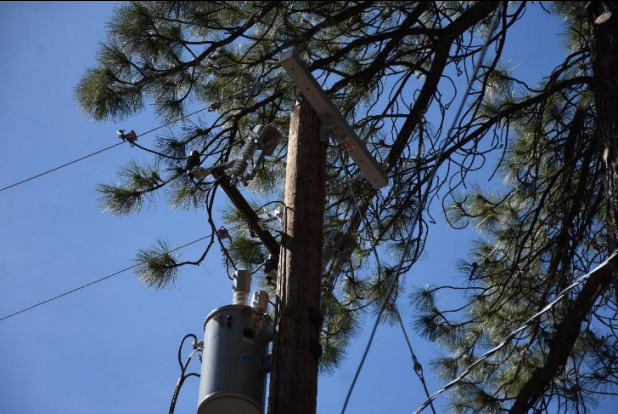
| Data Inaccuracy Img2-3: View of CALFIRE exempt fuses. | |

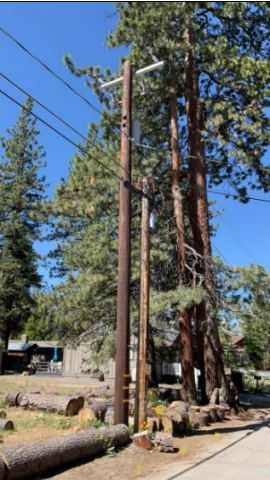
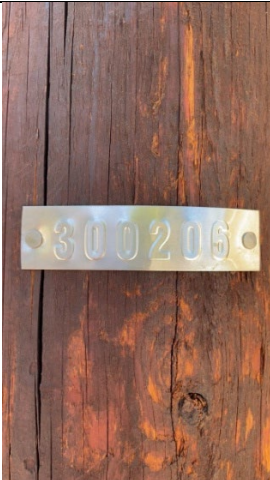
Data Inaccuracy 3

| Data Inaccuracy # | Record ID | Actual Structure ID | IOU Provided Structure ID | Grid Hardening ID | QDR Referenced | Lat/Long | Initiative Number | Data Inaccuracy Description |
|---|---|---|---|---|---|---|---|---|
| 3 | PAD_LU_AXS_20260602_1008 | 300206 | 300206 | 0ae6fcd8-336d-456d-9e5a-4ab5bd0878de | 2025 Q4 | 38.9418215399349, -119.988562899908 | 8.1.2.12 - Expulsion fuse replacement | Inaccurate data provided on expulsion fuse replacement |

| <b>Data Inaccuracy Img3-1:</b> Overall Structure | | <b>Data Inaccuracy Img3-2:</b> Structure ID | |

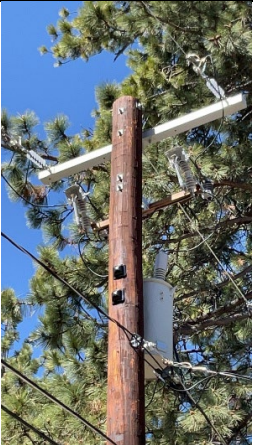
| <b>Data Inaccuracy Img3-3:</b> View of CALFIRE exempt fuses. | | | |

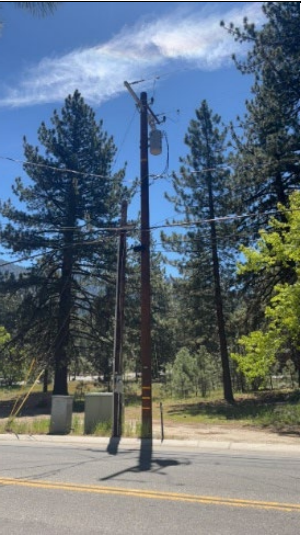
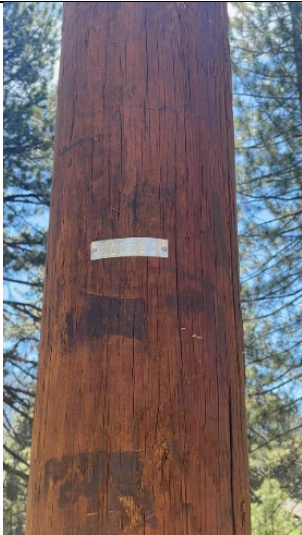
Data Inaccuracy 4

| Data Inaccuracy # | Record ID | Actual Structure ID | IOU Provided Structure ID | Grid Hardening ID | QDR Referenced | Lat/Long | Initiative Number | Data Inaccuracy Description |
|---|---|---|---|---|---|---|---|---|
| 4 | PAD_LU_CYA_20260602_1133 | 300136 | 300136 | 78f1cb2b-1d78-4901-9445-1db038427daf | 2025 Q3 | 38.9433478099751, -119.954508900442 | 8.1.2.12 - Expulsion fuse replacement | Inaccurate data provided on expulsion fuse replacement |

| Data Inaccuracy Img4-1: Overall Structure | Data Inaccuracy Img4-2: Structure ID |

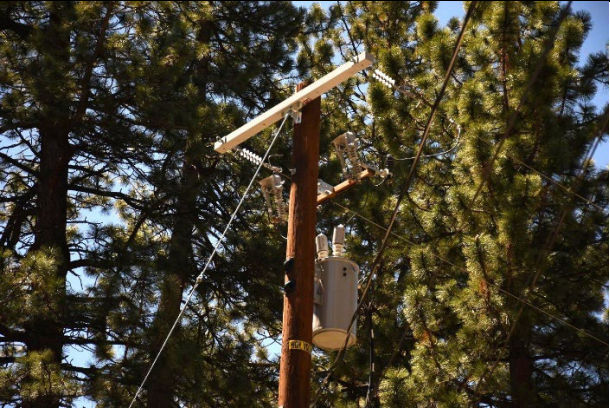
| Data Inaccuracy Img4-3: View of CALFIRE exempt fuses. | |

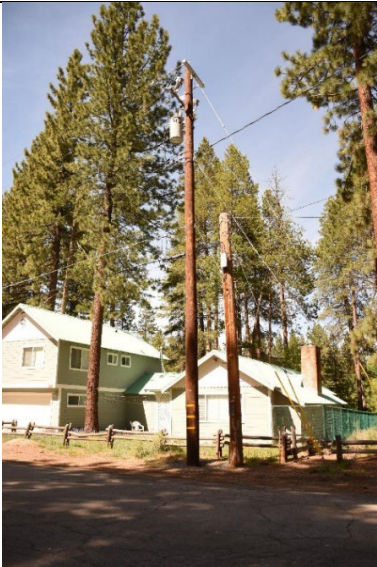
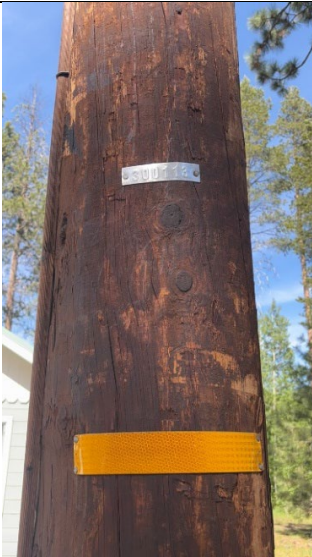
Data Inaccuracy 5

| 5 | PAD_LU_CYA_20260<br>602_1524 | 300113 | 300113 | 92740522-<br>9cce-43e0-<br>aa9a-<br>8300270dad<br>9d | 2025 Q3 | 38.9393273496841,<br>-119.955749799512 | 8.1.2.12 -<br>Expulsion<br>fuse<br>replacement | Inaccurate data<br>provided on expulsion<br>fuse replacement |

| Data Inaccuracy Img5-1: Overall Structure | Data Inaccuracy Img5-2: Structure ID |

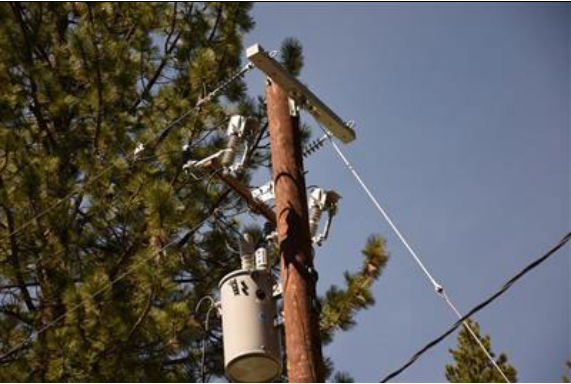
| Data Inaccuracy Img5-3: View of CALFIRE exempt fuses. | |

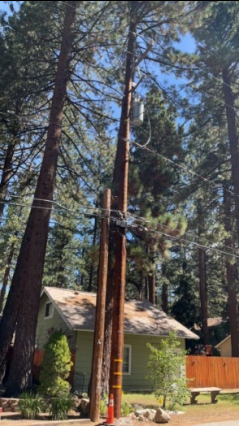
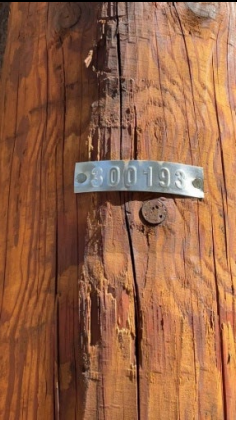
Data Inaccuracy 6

| 6 | PAD_LU_BKA_20260<br>603_1034 | 300193 | 300193 | a7f45fe2-<br>3140-4622-<br>a045-<br>0738792b31<br>54 | 2025 Q4 | 38.9298083200493,<br>-119.959674730428 | 8.1.2.12 -<br>Expulsion<br>fuse<br>replacement | Inaccurate data<br>provided on expulsion<br>fuse replacement |

| Data Inaccuracy Img6-1: Overall Structure | Data Inaccuracy Img6-2: Structure ID |

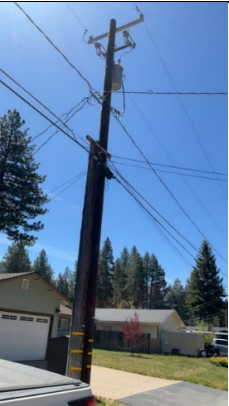
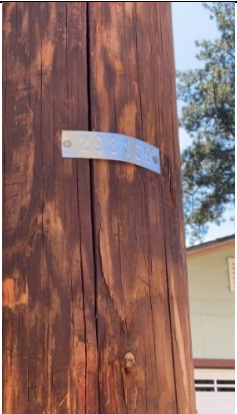
Data Inaccuracy 7

| 7 | PAD_LU_BKA_20260<br>603_1101 | 298169 | 298169 | cb82fce4-<br>4e91-48d2-<br>b8dc-<br>8a98c49d8c<br>bb | 2025 Q3 | 38.9319780096993,<br>-119.963056200197 | 8.1.2.12 -<br>Expulsion<br>fuse<br>replacement | Inaccurate data<br>provided on expulsion<br>fuse replacement |

| Data Inaccuracy Img7-1: Overall Structure | Data Inaccuracy Img7-2: Structure ID |

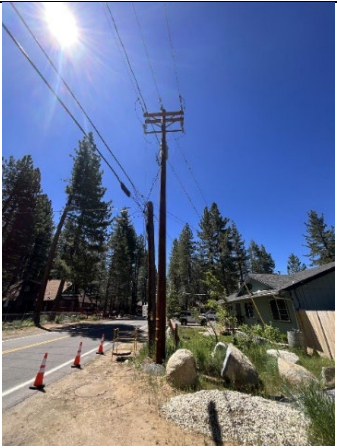
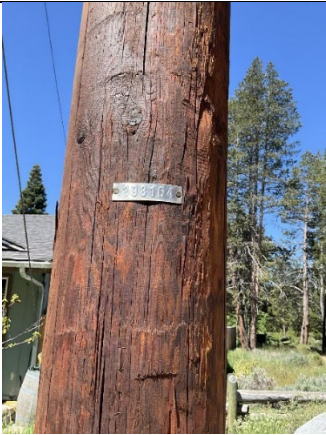
Data Inaccuracy 8

| 8 | PAD_LU_BKA_20260<br>603_1124 | 298164 | 298164 | 3864bb64-<br>8e57-4a8c-<br>94c2-<br>08be40756e<br>cf | 2025 Q3 | 38.9343087501424,<br>-119.962466600374 | 8.1.2.12 -<br>Expulsion<br>fuse<br>replacement | Inaccurate data<br>provided on expulsion<br>fuse replacement |

| <p>Data Inaccuracy Img8-1: Overall Structure</p> | <p>Data Inaccuracy Img8-2: Structure ID</p> |

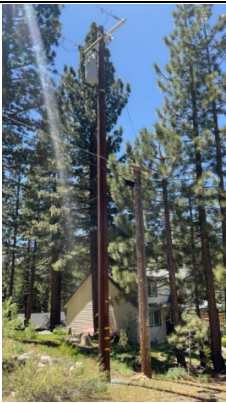
Data Inaccuracy 9

| 9 | PAD_LU_AXS_20260<br>603_1316 | 300151 | 300151 | 219aa647-<br>25f3-4667-<br>a457-<br>85c427a1d3<br>8f | 2025 Q4 | 38.8514997704, -<br>120.012697219466 | 8.1.2.12 -<br>Expulsion<br>fuse<br>replacement | Inaccurate data<br>provided on expulsion<br>fuse replacement |

| <p>Data Inaccuracy Img9-1: Overall Structure</p> | <p>Data Inaccuracy Img9-2: Structure ID</p> |

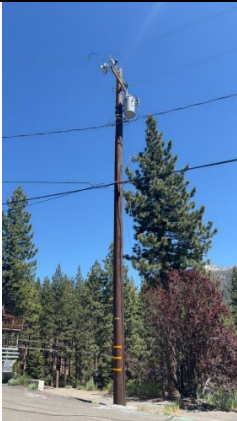
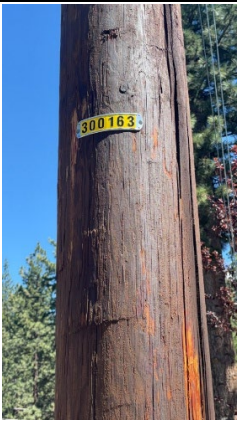
Data Inaccuracy 10

| 10 | PAD_LU_CYA_20260<br>603_1443 | 300163 | 300163 | 7afbac3f-<br>1c56-47d7-<br>b386-<br>4aa445cbd0<br>6b | 2025 Q3 | 38.9026379900316,<br>-119.953285500101 | 8.1.2.12 -<br>Expulsion<br>fuse<br>replacement | Inaccurate data<br>provided on expulsion<br>fuse replacement |

| Data Inaccuracy Img10-1: Overall Structure | Data Inaccuracy Img10-2: Structure ID |

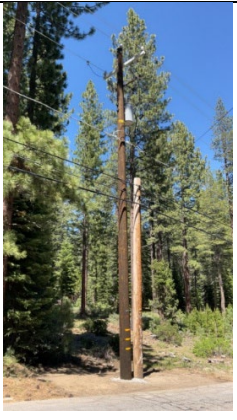
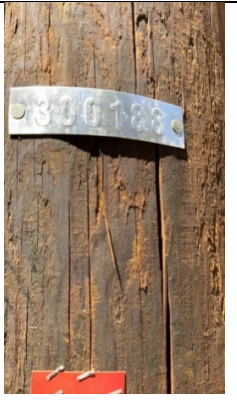
Data Inaccuracy 11

| 11 | PAD_LU_AXS_20260<br>603_1428 | 300188 | 300188 | da804e05-<br>7b9a-46be-<br>bd9f-<br>a4f66c8a9e<br>5e | 2025 Q4 | 38.8542817799093,<br>-120.001672679836 | 8.1.2.12 -<br>Expulsion<br>fuse<br>replacement | Inaccurate data<br>provided on expulsion<br>fuse replacement |

| Data Inaccuracy Img11-1: Overall Structure | Data Inaccuracy Img11-2: Structure ID |

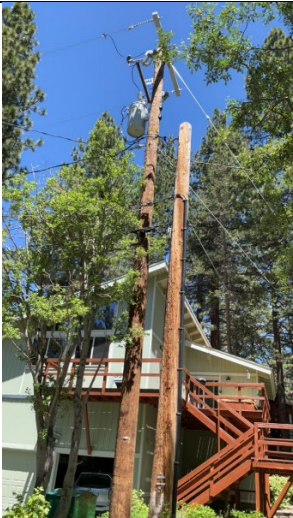
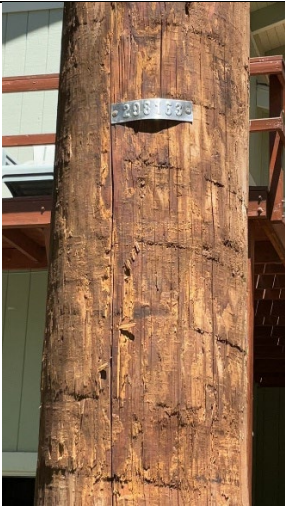
Data Inaccuracy 12

| 12 | PAD_LU_BKA_20260<br>603_1333 | 298163 | 298163 | 27725915-<br>7a4d-4e85-<br>b008-<br>50f535b6eb<br>bb | 2025 Q3 | 38.9378304396999,<br>-119.9399299001 | 8.1.2.12 -<br>Expulsion<br>fuse<br>replacement | Inaccurate data<br>provided on expulsion<br>fuse replacement |

| <p>Data Inaccuracy Img12-1: Overall Structure</p> | <p>Data Inaccuracy Img12-2: Structure ID</p> |
