## **NOTICE OF DATA INACCURACY**

Pursuant to Government Code section 15472, et seq, the Office of Energy Infrastructure Safety (Energy Safety) has conducted an inspection of work completed by PacifiCorp (PC) in accordance with its 2025 Wildfire Mitigation Plan (WMP) and determined the existence of inaccurate data. Energy Safety therefore issues PC a Notice of Data Inaccuracy (NODI).

From May 19, 2026, to May 21, 2026, Energy Safety inspected 2025 Q4 WMP initiatives in the vicinity of Etna, Fort Jones, and Yreka. Energy Safety found the following data inaccuracies: Data Inaccuracies 1-3: 8.1.2.1 Covered Conductor installation, the inspector observed that PC failed to adhere to data accuracy. No covered conductor was observed by the inspector at the submitted segments. Data Inaccuracies 4-11: 8.1.2.3 Distribution pole replacement and reinforcements, the inspector observed that PC failed to adhere to data accuracy. Two distribution pole replacement initiatives have been submitted at these locations. Data inaccuracy 12: 8.1.2.12 Expulsion Fuse Replacements, the inspector observed that PC failed to adhere to data accuracy. Two expulsion fuse replacement initiatives have been submitted

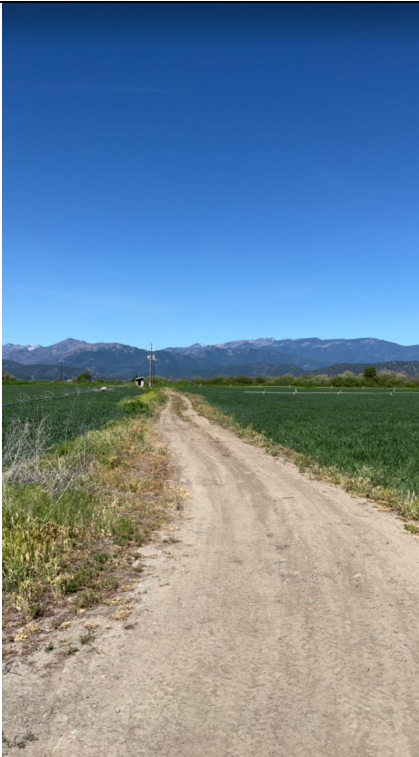
Data Inaccuracy 1

| Data Inaccuracy # | Record ID | Actual Structure ID | IOU Provided Structure ID | Grid Hardening ID | QDR Referenced | Lat/Long | Initiative Number | Data Inaccuracy Description |
|---|---|---|---|---|---|---|---|---|
| 1 | PAD_PC_BKA_20260519_1038 | No structure ID | No structure ID | 7368953 | 2025 Q4 | 41.54185025630667, -122.83711867481033 | 8.1.2.1 Covered Conductor Installation | Inaccurate data provided on covered conductor installation |

| <p><b>Data Inaccuracy Img1-1:</b> No Covered Conductor installed at this location</p> | <p><b>Data Inaccuracy Img1-2:</b> Structure ID – No existing structure at this location</p> |

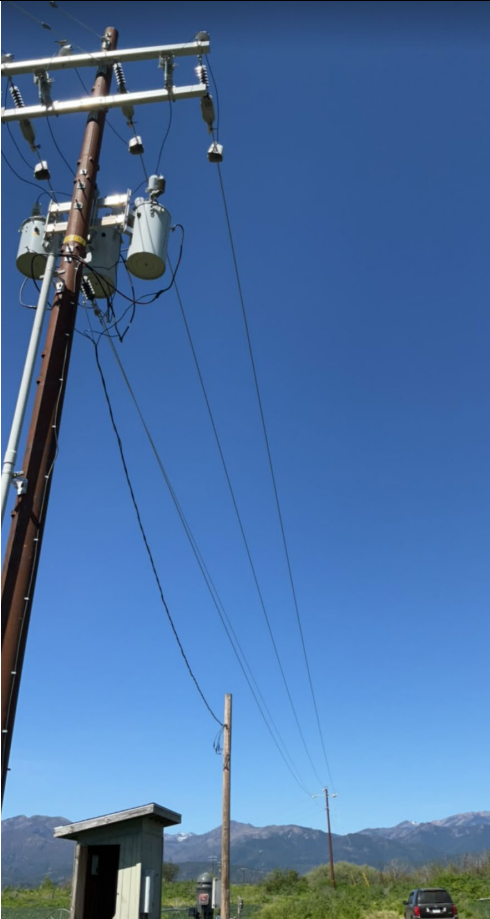
Data Inaccuracy 2

| Data Inaccuracy # | Record ID | Actual Structure ID | IOU Provided Structure ID | Grid Hardening ID | QDR Referenced | Lat/Long | Initiative Number | Data Inaccuracy Description |
|---|---|---|---|---|---|---|---|---|
| 2 | PAD_PC_BKA_20260519_1055 | 0624300926000 | 0624300926000 | 7368953 | 2025 Q4 | 41.54185047371937, -122.8390398153311 | 8.1.2.1 Covered Conductor Installation | Inaccurate data provided on covered conductor installation |

| <p><b>Data Inaccuracy Img2-1:</b> West view of the pole showing no covered conductor on east side of the pole.</p> | <p><b>Data Inaccuracy Img2-2:</b> Structure ID - 0624300926000</p> |

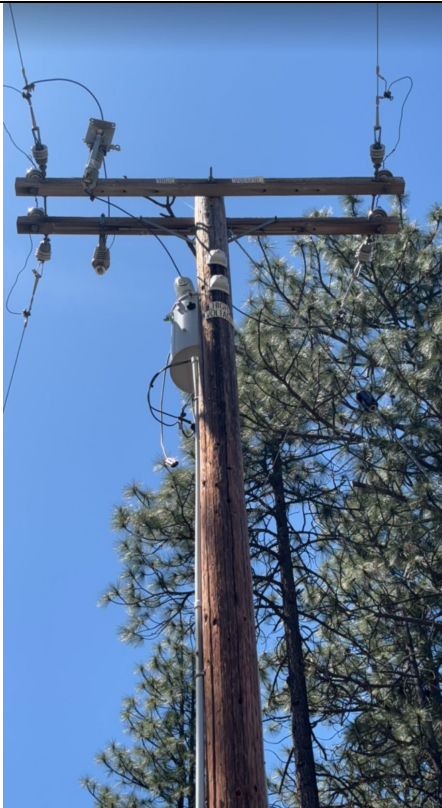
Data Inaccuracy 3

| Data Inaccuracy # | Record ID | Actual Structure ID | IOU Provided Structure ID | Grid Hardening ID | QDR Referenced | Lat/Long | Initiative Number | Data Inaccuracy Description |
|---|---|---|---|---|---|---|---|---|
| 3 | PAD_PC_IAG_20260519_1342 | 062420090054101 | 062420090054101 | 7428970 | 2025 Q4 | 41.51471545123778, -122.90687915361072 | 8.1.2.1 Covered Conductor Installation | Inaccurate data provided on covered conductor installation |

**Data Inaccuracy Img3-1:** East view of the pole showing no covered conductor on the east portion of the pole.

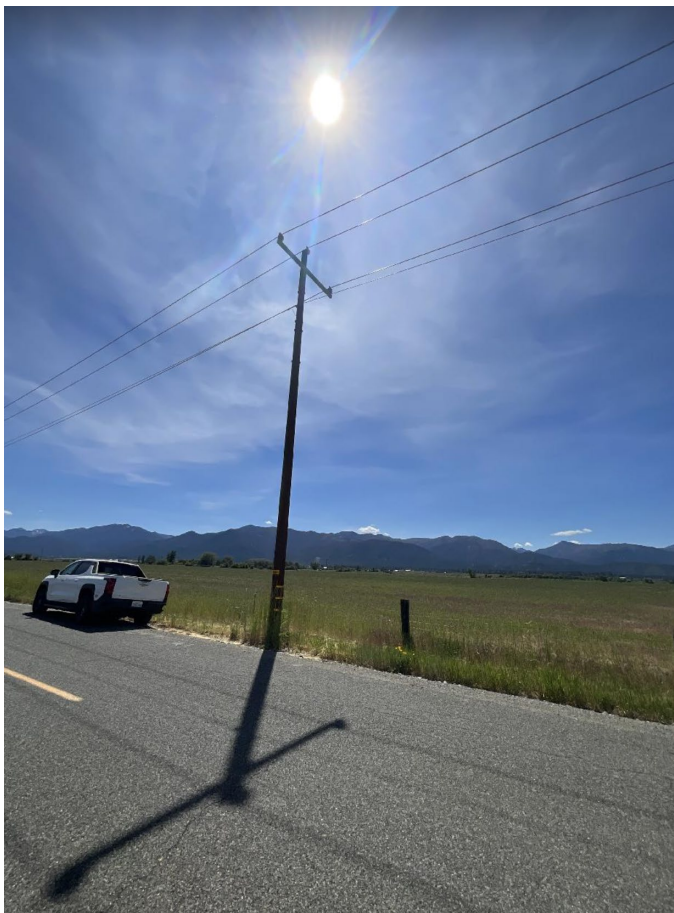
Data Inaccuracy 4

| Data Inaccuracy # | Record ID | Actual Structure ID | IOU Provided Structure ID | Grid Hardening ID | QDR Referenced | Lat/Long | Initiative Number | Data Inaccuracy Description |
|---|---|---|---|---|---|---|---|---|
| 4 | PAD_PC_BKA_20260519_1446 | 06243009039700 | 06243009039700 | 7368953 | 2025 Q4 | 41.52261868521354, -122.85825564841996 | 8.1.2.3 Distribution pole replacements and reinforcements | Inaccurate data provided on distribution pole replacements and reinforcements |

**Data Inaccuracy Img4-1:** Overall structure showing one pole, despite two distribution replacement initiatives that have been submitted at this location for the same quarter (Q4).

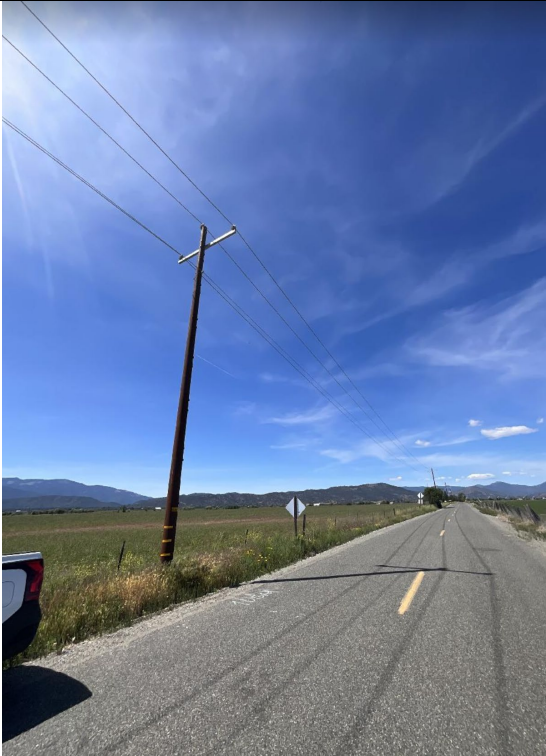
Data Inaccuracy 5

| Data Inaccuracy # | Record ID | Actual Structure ID | IOU Provided Structure ID | Grid Hardening ID | QDR Referenced | Lat/Long | Initiative Number | Data Inaccuracy Description |
|---|---|---|---|---|---|---|---|---|
| 5 | PAD_PC_BKA_20260519_1454 | 06243009039505 | 06243009039505 | 7368953 | 2025 Q4 | 41.520612257419224, -122.85829059225932 | 8.1.2.3 Distribution pole replacements and reinforcements | Inaccurate data provided on distribution pole replacements and reinforcements |

| <p><b>Data Inaccuracy Img5-1:</b> Two distribution replacement initiatives have been submitted at this location for the same quarter Q4.</p> | <p><b>Data Inaccuracy Img5-2:</b> Structure ID - 06243009039505</p> |

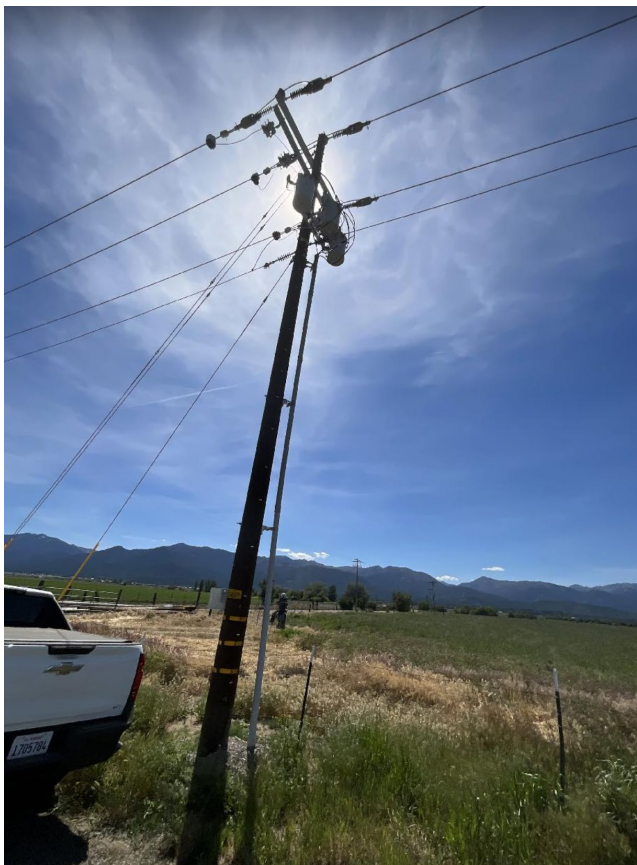
Data Inaccuracy 6

| Data Inaccuracy # | Record ID | Actual Structure ID | IOU Provided Structure ID | Grid Hardening ID | QDR Referenced | Lat/Long | Initiative Number | Data Inaccuracy Description |
|---|---|---|---|---|---|---|---|---|
| 6 | PAD_PC_BKA_20260519_1501 | 06243009039504 | 06243009039504 | 7368953 | 2025 Q4 | 41.51964668623864, -122.858313307307 | 8.1.2.3 Distribution pole replacements and reinforcements | Inaccurate data provided on distribution pole replacements and reinforcements |

**Data Inaccuracy Img6-1:** Two distribution replacement initiatives have been submitted at this location for the same quarter Q4.

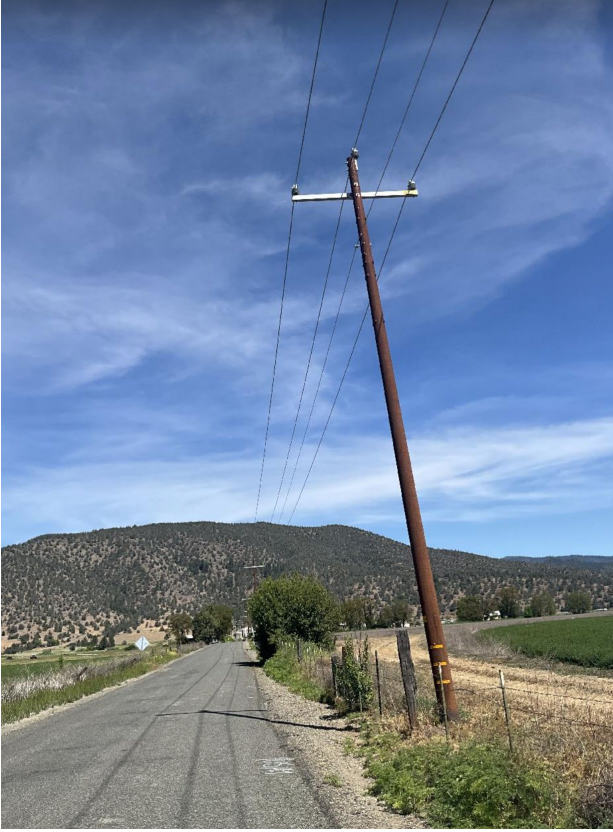
Data Inaccuracy 7

| Data Inaccuracy # | Record ID | Actual Structure ID | IOU Provided Structure ID | Grid Hardening ID | QDR Referenced | Lat/Long | Initiative Number | Data Inaccuracy Description |
|---|---|---|---|---|---|---|---|---|
| 7 | PAD_PC_BKA_20260519_1508 | 06243009020500 | 06243009020500 | 7368953 | 2025 Q4 | 41.51939062689927, -122.85714250983996 | 8.1.2.3 Distribution pole replacements and reinforcements | Inaccurate data provided on distribution pole replacements and reinforcements |

| <p><b>Data Inaccuracy Img7-1:</b> Two distribution replacement initiatives have been submitted at this location for the same quarter Q4.</p> | <p><b>Data Inaccuracy Img7-2:</b> Structure ID - 06243009020500</p> |

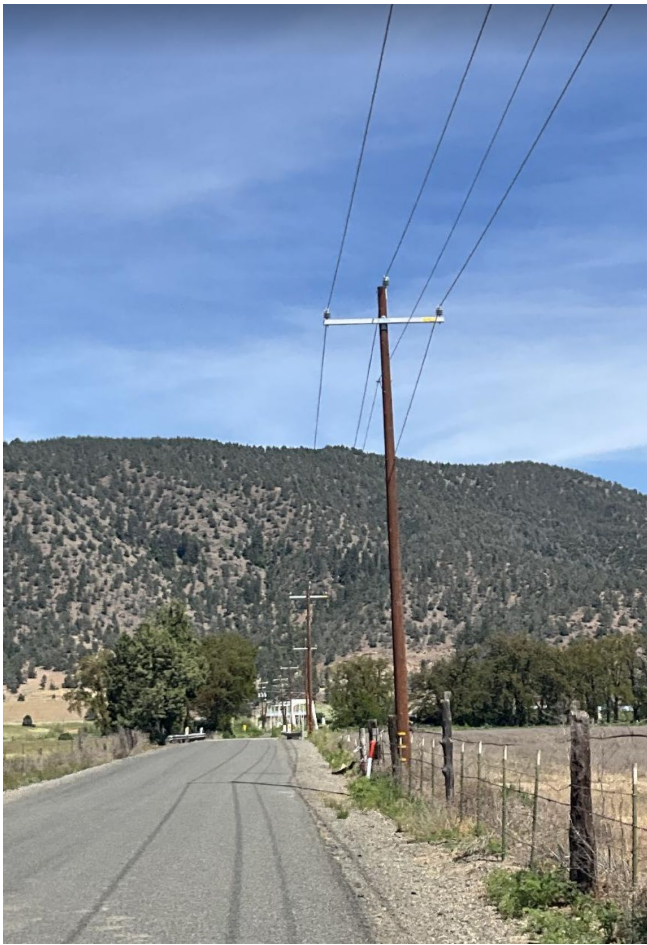
Data Inaccuracy 8

| Data Inaccuracy # | Record ID | Actual Structure ID | IOU Provided Structure ID | Grid Hardening ID | QDR Referenced | Lat/Long | Initiative Number | Data Inaccuracy Description |
|---|---|---|---|---|---|---|---|---|
| 8 | PAD_PC_BKA_20260519_1518 | 06243009021501 | 06243009021501 | 7368953 | 2025 Q4 | 41.519392576403945, -122.85598182653315 | 8.1.2.3 Distribution pole replacements and reinforcements | Inaccurate data provided on distribution pole replacements and reinforcements |

| <p><b>Data Inaccuracy Img8-1:</b> Two distribution replacement initiatives have been submitted at this location for the same quarter Q4.</p> | <p><b>Data Inaccuracy Img8-2:</b> Structure ID - 06243009021501</p> |

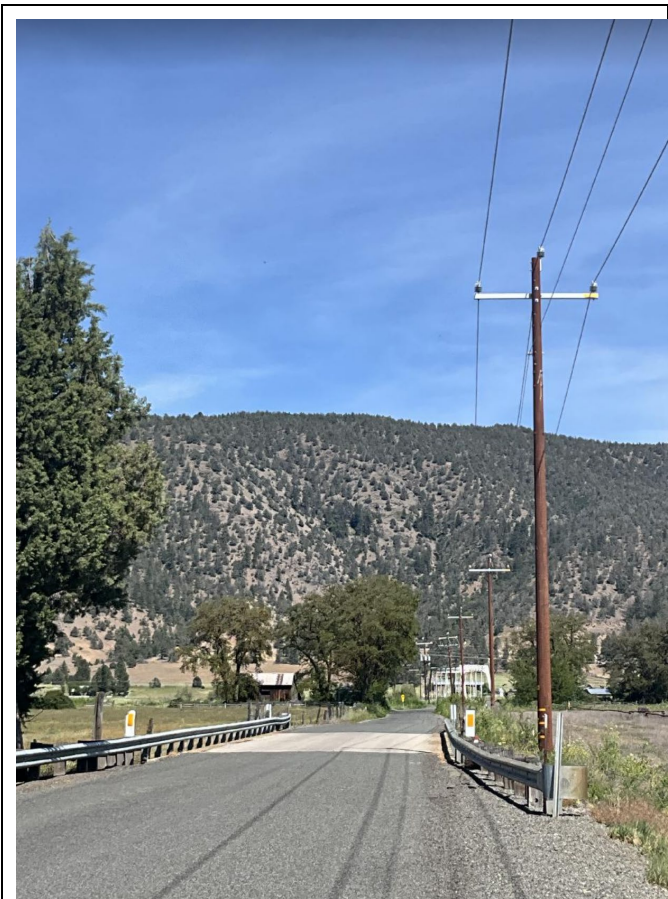
Data Inaccuracy 9

| Data Inaccuracy # | Record ID | Actual Structure ID | IOU Provided Structure ID | Grid Hardening ID | QDR Referenced | Lat/Long | Initiative Number | Data Inaccuracy Description |
|---|---|---|---|---|---|---|---|---|
| 9 | PAD_PC_BKA_20260519_1522 | 06243009021500 | 06243009021500 | 7368953 | 2025 Q4 | 41.51941440206455, -122.85476054132924 | 8.1.2.3 Distribution pole replacements and reinforcements | Inaccurate data provided on distribution pole replacements and reinforcements |

**Data Inaccuracy Img9-1:** Two distribution replacement initiatives have been submitted at this location for the same quarter Q4.

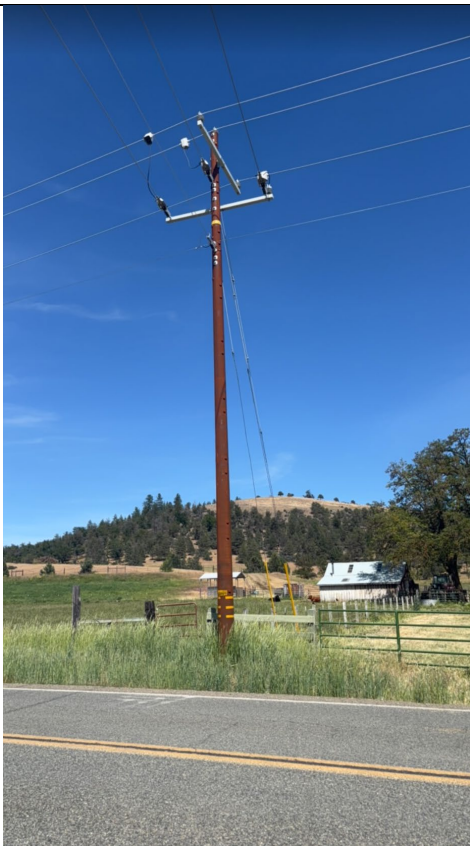
Data Inaccuracy 10

| Data Inaccuracy # | Record ID | Actual Structure ID | IOU Provided Structure ID | Grid Hardening ID | QDR Referenced | Lat/Long | Initiative Number | Data Inaccuracy Description |
|---|---|---|---|---|---|---|---|---|
| 10 | PAD_PC_CYA_20260519_1535 | 06243009.0255803 | 062430090255803 | 7339340 | 2025 Q4 | 41.55413949320639, -122.82817620398112 | 8.1.2.3 Distribution pole replacements and reinforcements | Inaccurate data provided on distribution pole replacements and reinforcements |

**Data Inaccuracy Img10-1:** Two distribution replacement initiatives have been submitted at this location for the same quarter Q4.

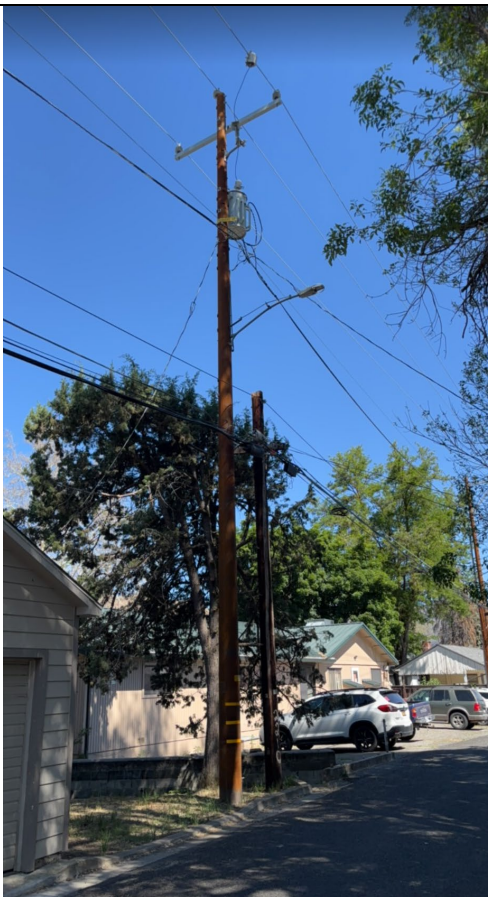
Data Inaccuracy 11

| Data Inaccuracy # | Record ID | Actual Structure ID | IOU Provided Structure ID | Grid Hardening ID | QDR Referenced | Lat/Long | Initiative Number | Data Inaccuracy Description |
|---|---|---|---|---|---|---|---|---|
| 11 | PAD_PC_IAG_20260521_1050 | 062450070229644 | 062450070229644 | 7221400 | 2025 Q4 | 41.737350819747704, -122.63340468248602 | 8.1.2.3 Distribution pole replacements and reinforcements | Inaccurate data provided on distribution pole replacements and reinforcements |

**Data Inaccuracy Img11-1:** Two distribution replacement initiatives have been submitted at this location for the same quarter Q4.

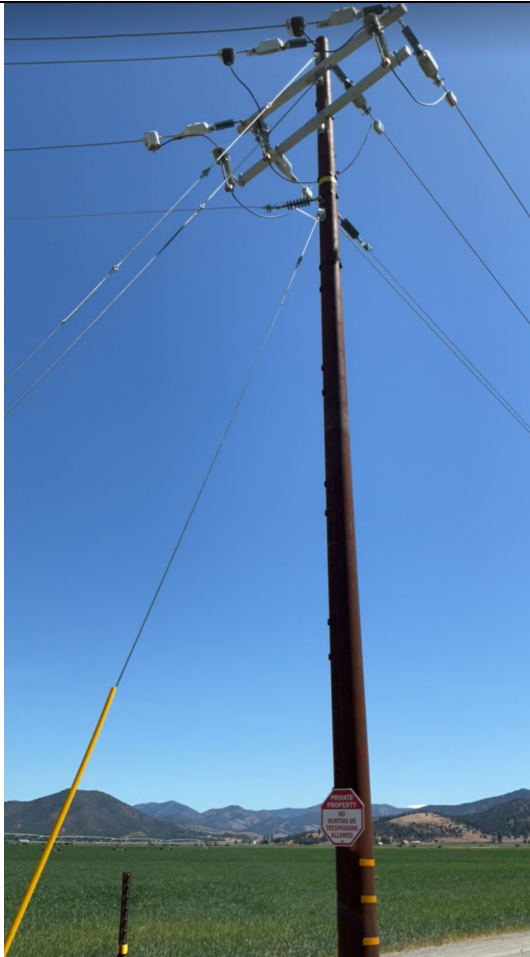
Data Inaccuracy 12

| Data Inaccuracy # | Record ID | Actual Structure ID | IOU Provided Structure ID | Grid Hardening ID | QDR Referenced | Lat/Long | Initiative Number | Data Inaccuracy Description |
|---|---|---|---|---|---|---|---|---|
| 12 | PAD_PC_BKA_20260519_1126 | 06243009352901 | 06243009352901 | 7368953 | 2025 Q4 | 41.54125016965504, -122.85324117064329 | 8.1.2.12 Expulsion Fuse Replacements | Inaccurate data provided on expulsion fuse replacements. |

**Data Inaccuracy Img12-1:** Two expulsion fuse replacement initiatives have been submitted at this location for the same quarter Q4.
