## **NOTICE OF DATA INACCURACY**

## INSPECTION REPORT

| Report Number: | PAD_LU_CYA_20260602_1500 |
| Relevant WMP Initiative(s): | 8.1.2.12 - Tree attachment removals |

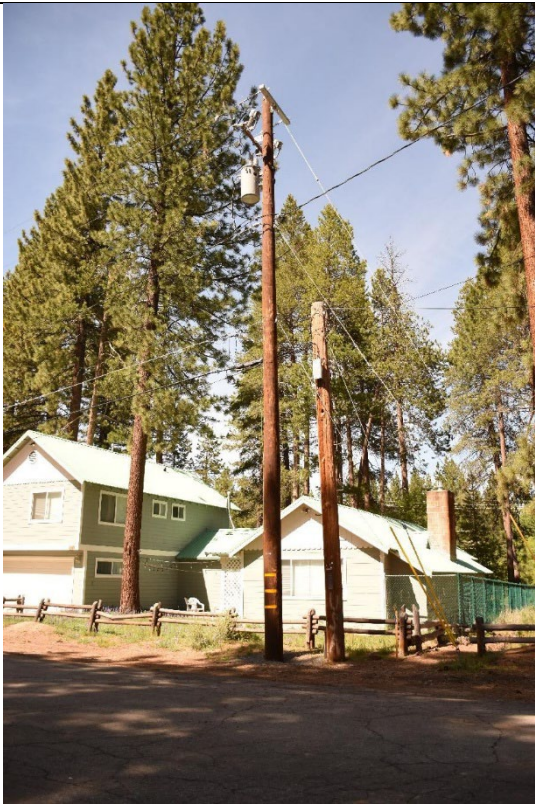
| <p><b>General Image 1:</b> Overall Structure</p> | <p><b>General Image 2:</b> Structure ID</p> |

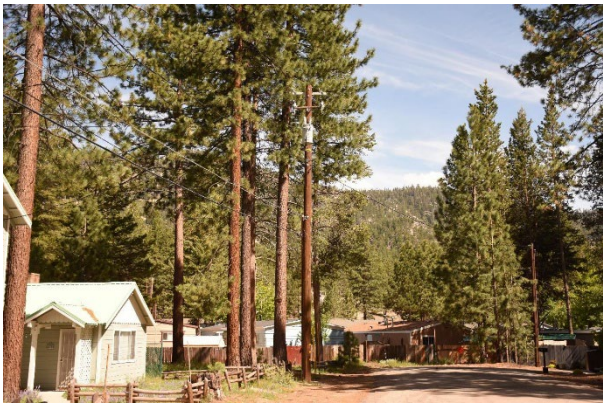
On Structure ID 300113, Grid Hardening ID ce741644-91bd-486d-bb46-0105de3d452e at 1311 Heather Lake Rd, South Lake Tahoe, CA, 96150, USA, 38.9393273496841, -119.955749799512, the inspector observed that no prior tree attachment existed at the reported location. The inspector's observation is documented in Data Inaccuracy 1 photographs, which are attached to this report as Exhibit A.

1. LU reported in the 2025 Q3 QDR that work on WMP initiative 8.1.2.12 – Tree attachment removals was completed at this location.
2. Based on review of Google Maps imagery from September 2024, the inspector observed that there was no existing tree attachment at this location to remove, given that the location in question provides service to homes that did not previously utilize a tree attachment.

| <p><b>Asset Image 1:</b> Overview of service conductor - view 1</p> | <p><b>Asset Image 2:</b> Overview of service conductor - view 2</p> |

Within 30 days from the issuance date of this NODI, LU should provide a response advising Energy Safety of corrective actions taken or planned to remedy the identified data inaccuracy or inaccuracies.

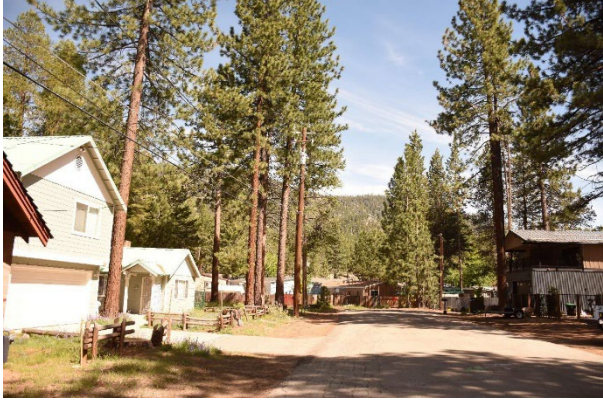
**Asset Image 3:** Overview of service conductor - view 3
