## NOTICE OF NON-PERFORMANCE

# INSPECTION REPORT

## Deficiency 1

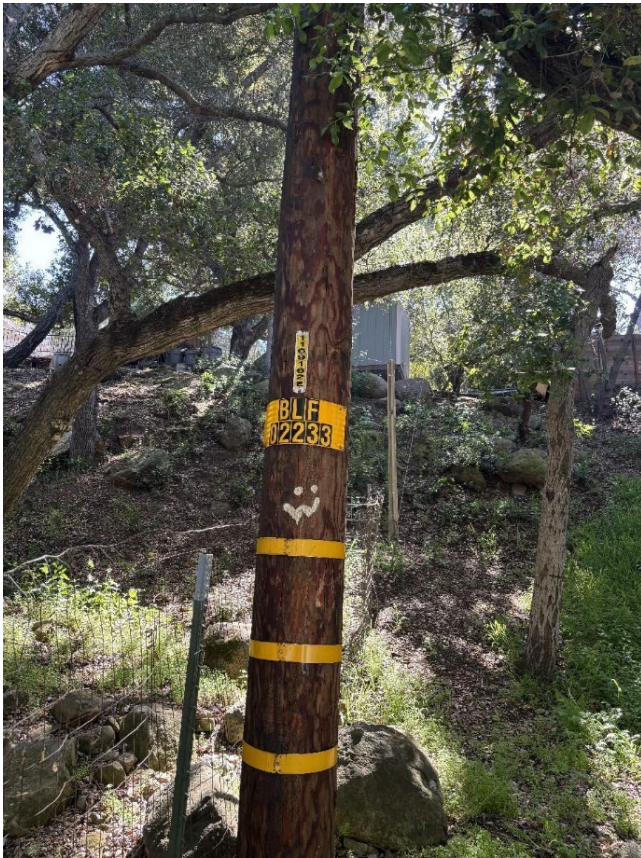
**Photo 1:** Photo of pole ID 1169162E located approximately 65 feet east of the subject tree.

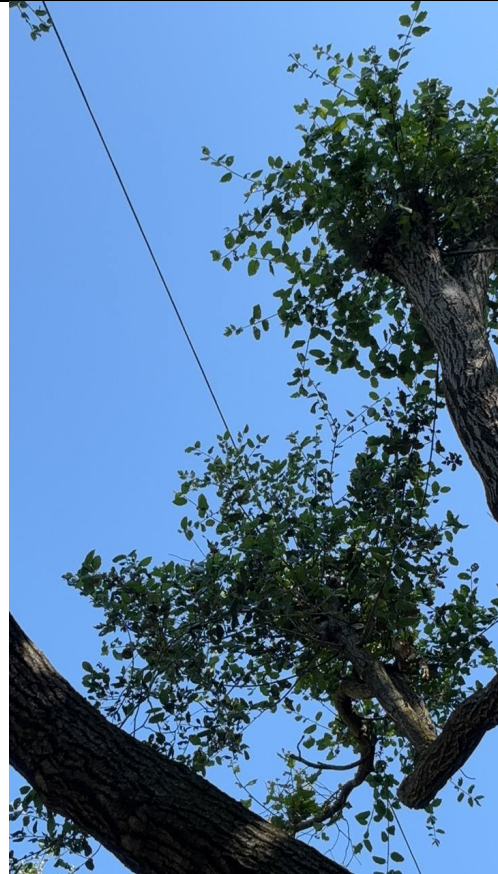
Energy Safety considers this deficiency as "Moderate" because SCE failed to maintain the required minimum clearance distance between vegetation and its conductors, consistent with the requirements of Public Resources Code section 4293. An oak tree was growing within the four-foot clearance distance, and the continued encroachment presents a wildfire risk.

On March 24, 2026, Energy Safety conducted an inspection of SCE's WMP initiatives in the vicinity of Calabasas, California. During the inspection, Energy Safety identified a three-stemmed oak tree growing within the four-foot minimum clearance distance near pole ID 1169162E and near coordinates 34.079224, -118.6878 along Wildwood Drive. The oak tree is located within SCE's defined HFRA and HFTD Tier 3, and SRA. The inspector measured the distance between the primary conductors and the closest branches of the oak tree using a Nikon Forestry Pro II laser range finder. The measured distance was two feet, which is less than the required four-foot clearance. The three-stemmed oak tree has a combined diameter at breast height of 38 inches, is approximately 40 feet tall, and is located 65 feet west of pole ID 1169162E. The inspector's observations are documented in Exhibit A photographs, which are attached to this report. Photo 1 depicts pole ID 1169162E. Photo 2 depicts the oak tree growing under the conductors and encroaching within the four-foot minimum clearance distance. Photo 3 depicts the three-stemmed trunk of the oak tree.

**Photo 2:** Photo of the oak tree encroaching within the four-foot minimum clearance distance from the primary conductor. The oak tree is growing under the conductors in the grow-in zone.

Deficiency 1. Energy Safety observed that SCE failed to implement its 2025 WMP initiative 8.2.3.3.1 Distribution Expanded Clearing by not maintaining a four-foot clearance distance around the primary conductors near coordinates 34.079224, -118.6878. Energy Safety considers this non-performance to be in the Moderate risk category. SCE must complete a corrective action for this non-performance by two months from the date of this notice.<sup>1</sup>

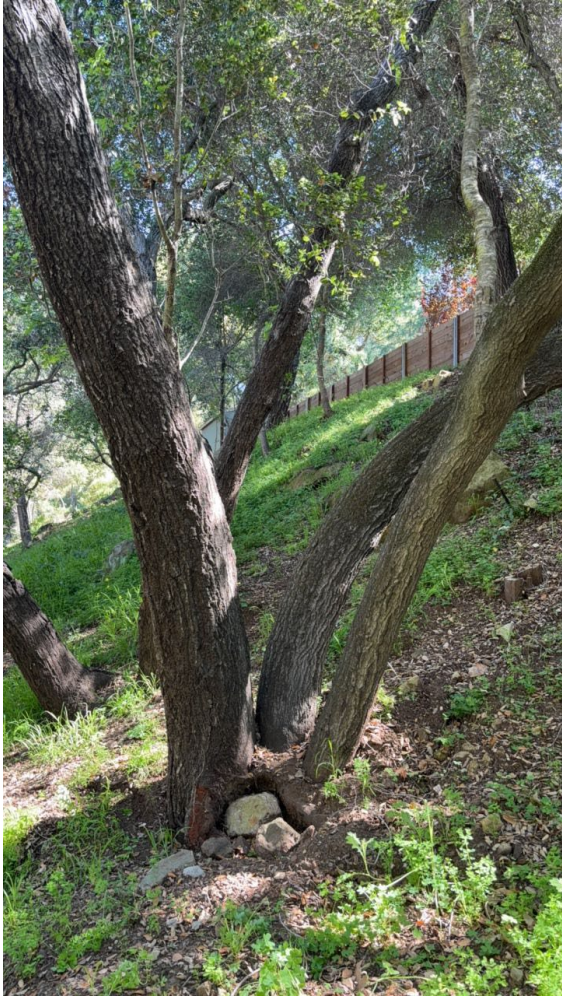
**Photo 3:** Photo of the three-stemmed trunk of oak tree. Photo taken west of the tree and pole, looking east.
