NOTICE OF NON-PERFORMANCE

INSPECTION REPORT

Deficiency 1

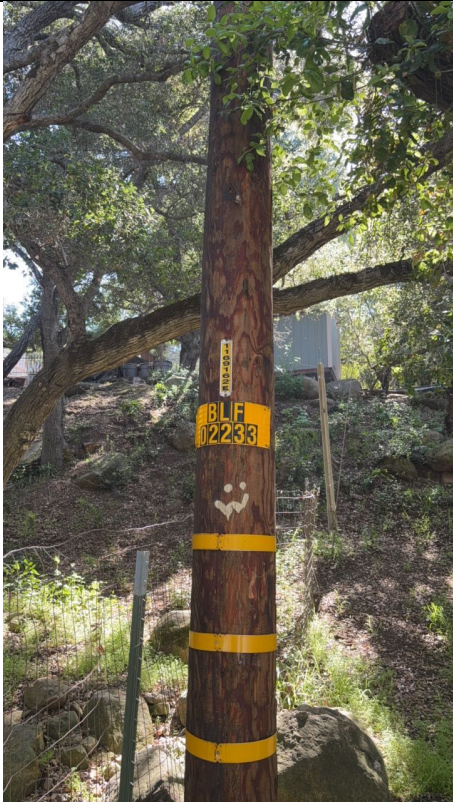
Photo 1: Photo of pole ID 1169162E located approximately 62 feet east of the subject tree.

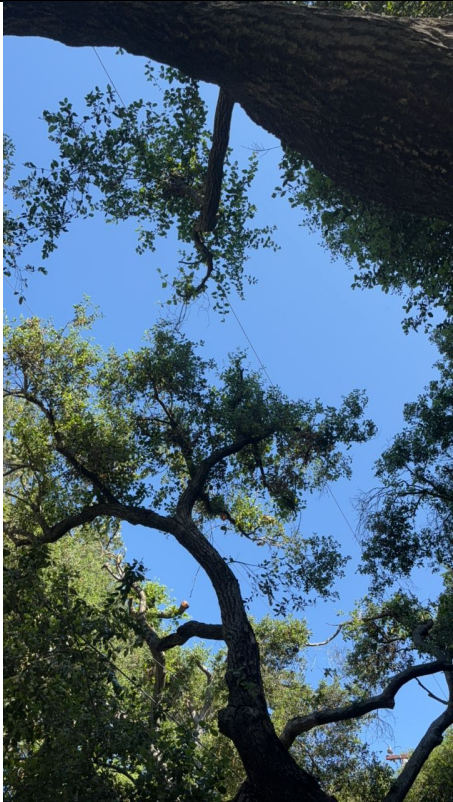
Energy Safety considers this deficiency as "Moderate" because SCE failed to maintain the required minimum clearance distance between vegetation and its conductors, consistent with the requirements of Public Resources Code section 4293. An oak tree was growing within the four-foot clearance distance, and the continued encroachment presents a wildfire risk.

On March 24, 2026, Energy Safety conducted an inspection of SCE's WMP initiatives in the vicinity of Calabasas, California. During the inspection, Energy Safety identified an oak tree growing within the four-foot minimum clearance distance near pole ID 1169162E and near coordinates 34.079208, -118.687734 along Wildwood Drive. The oak tree is located within SCE's defined HFRA and HFTD Tier 3, and SRA. The inspector measured the distance between the primary conductors and the closest branches of the oak tree using a Nikon Forestry Pro II laser range finder. The measured distance was two and a half feet, which is less than the required four-foot clearance. The oak tree has a diameter at breast height of 14 inches, is approximately 23 feet tall, and is located 62 feet west of pole ID 1169162E. The inspector's observations are documented in Exhibit A photographs, which are attached to this report. Photo 1 depicts pole ID 1169162E. Photos 2 and 3 depict the oak tree growing under the conductors and encroaching within the four-foot minimum clearance distance. Photo 4 depicts the trunk of the oak tree.

Photo 2: Photo of the oak tree encroaching within the four-foot minimum clearance distance from the primary conductor. The oak tree is growing under the conductors in the grow-in zone.

Deficiency 1. Energy Safety observed that SCE failed to implement its 2025 WMP initiative 8.2.3.3.1 Distribution Expanded Clearing by not maintaining a four-foot clearance distance around the primary conductors near coordinates 34.079208, -118.687734. Energy Safety considers this non-performance to be in the Moderate risk category. SCE must complete a corrective action for this non-performance by two months from the date of this notice.¹

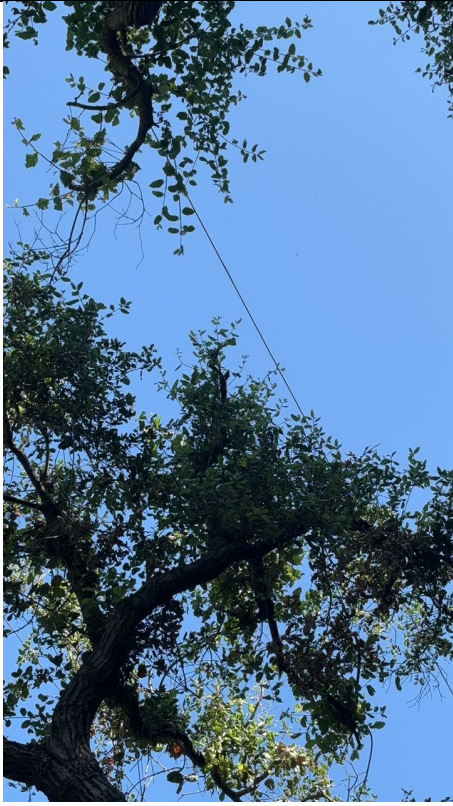
Photo 3: Close-up photo of the same oak tree encroaching within the four-foot minimum clearance distance from the primary conductor.

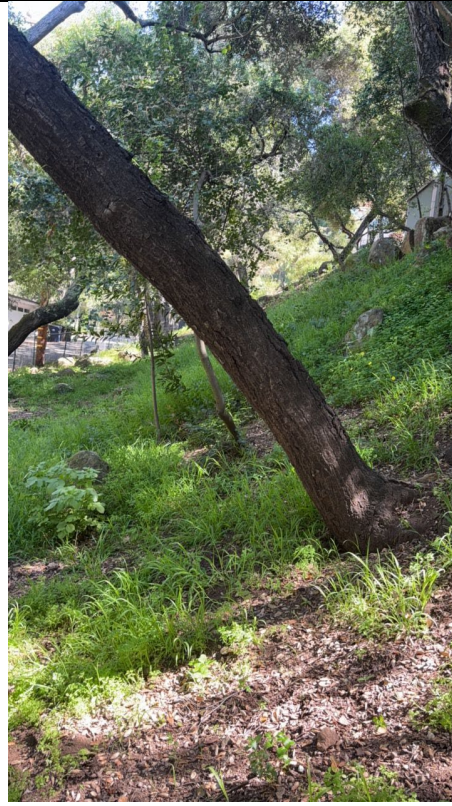
Photo 4: Photo of the oak tree trunk. Photo taken west of the tree and pole, looking east.
