NOTICE OF NON-PERFORMANCE

INSPECTION REPORT

Electrical Corporation:	SCE
Report Number:	NON_ESD_SCE_GCA_20260326_0845
Inspector:	Gary Candelas
WMP Year Inspected:	2025
Quarterly Data Report (QDR) Referenced:	Quarter 4 (Q4) 2025
Inspection Selection:	Energy Safety inspected the locations based on SCE’s Q4 QDR.
Relevant WMP Initiative(s):	8.2.3.3.1 Expanded Clearing
Date of inspection:	March 26, 2026
City and/or County of Inspection:	Agoura Hills, California

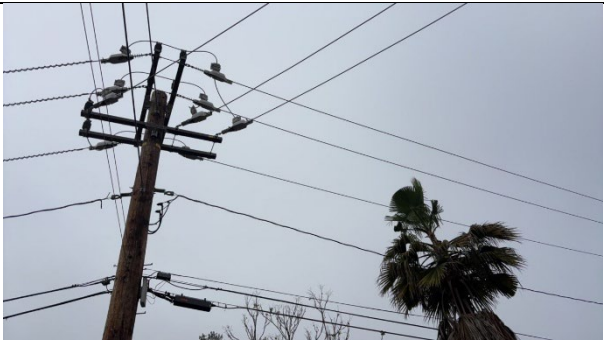
Energy Safety considers this deficiency as "Moderate" because SCE failed to maintain the required minimum clearance distance between vegetation and its conductors, consistent with the requirement of Public Resources Code section 4293. A palm tree was growing within four feet of the conductors, and the continued encroachment presents a wildfire risk.

<p>Photo 1: Photo of pole ID4848157E</p>	<p>Photo 2: Overview photo showing the pole and the Mexican palm tree. Palm is under the conductor in the grow-in zone.</p>

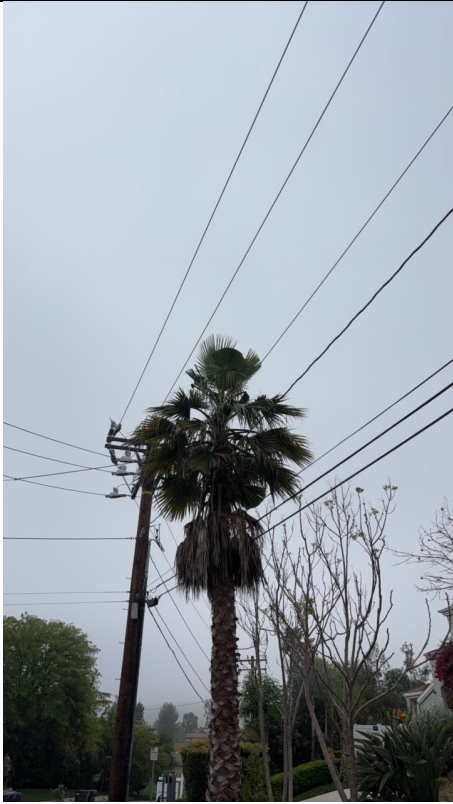
On March 26, 2026, Energy Safety conducted an inspection of SCE's WMP initiatives in the vicinity of Agoura Hills, California. During the inspection, Energy Safety identified a Mexican palm tree growing within the four-foot minimum clearance distance near pole ID 4848157E and near coordinates 34.150924, -118.746338 along Foothill Drive. The Mexican palm tree is located within SCE's defined HFRA, in HFTD Tier 3, and SRA. SCE's Q4 2025 data reports that SCE trimmed the palm, VMP ID 1WLRn0000019PD7OAM-2025_4, on November 11, 2025. The inspector measured the distance between the primary conductors and the closest fronds of the Mexican palm using a Nikon Forestry Pro II laser range finder. The measured distance was two feet, which is less than required four-foot clearance. The Mexican palm tree is approximately 26 feet tall, growing under the conductors, and is located at approximately 0.2 span north of the pole ID4848157E. The inspector's observations are documented in Exhibit A photographs, which are attached to this report. Photo 1 depicts pole ID 4848157E. Photo 2 shows the Mexican palm tree in relation to the pole. Photos 3 and 4 depict the Mexican palm tree encroaching within the four-foot minimum clearance distance.

Photo 3: Photo of the Mexican palm tree growing under the conductors and within the four-foot minimum clearance distance. Photo taken south of the tree looking north.

Deficiency 1. Energy Safety observed that SCE failed to implement its 2025 WMP initiative 8.2.3.3.1 Expanded Clearing (VM-7), which requires compliance with Public Resource Code section 4293, by not maintaining a four-foot clearance distance around the primary conductors near pole ID 4848157E, at coordinates 34.150924, -118.746338 and Vegetation Management ID 1WLRn0000019PD7OAM-2025_4. Energy Safety considers this non-performance to be in the Moderate risk category. SCE must complete a corrective action for this non-performance by two months from the date of this notice.¹

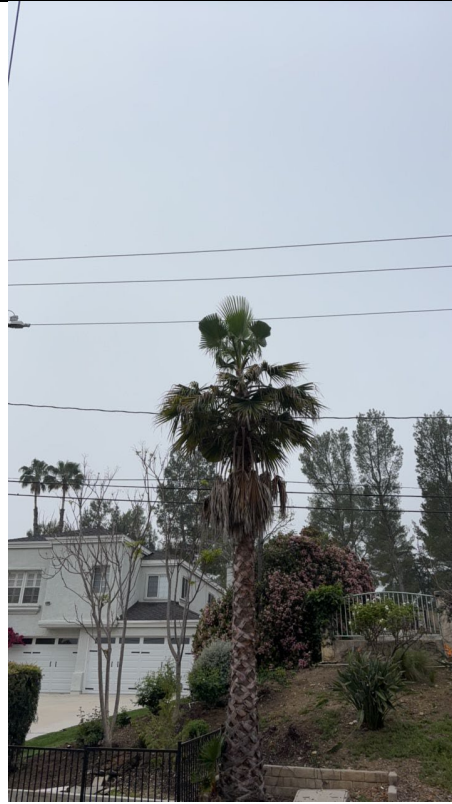
Photo 4: Additional photo of the Mexican palm tree encroaching within the four-foot minimum clearance distance from the primary conductor. Photo taken south of the tree looking west.
