NOTICE OF NON-PERFORMANCE

INSPECTION REPORT

Electrical Corporation:	SCE
Report Number:	NON_ESD_SCE_GCA_20260326_0756
Inspector:	Gary Candelas
WMP Year Inspected:	2025
Quarterly Data Report (QDR) Referenced:	Quarter 4 (Q4) 2025
Inspection Selection:	Energy Safety inspected the locations based on SCE’s Q4 QDR.
Relevant WMP Initiative(s):	8.2.3.3.1 Expanded Clearing
Date of inspection:	March 26, 2026
City and/or County of Inspection:	Agoura Hills, California

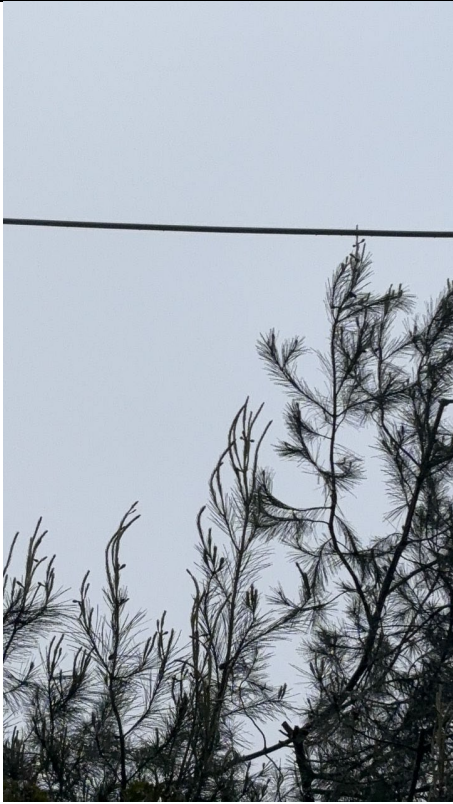
Energy Safety considers this deficiency as "Moderate" because SCE failed to maintain the required minimum clearance distance between vegetation and its conductors, consistent with the requirement of Public Resources Code section 4293. A pine tree was growing within four feet of the conductors, and the continued encroachment presents a wildfire risk.

<p>Photo 1: Photo of pole ID 4382726E.</p>	<p>Photo 2: Overview photo showing the orientation of the pole, conductors, and the pine tree.</p>

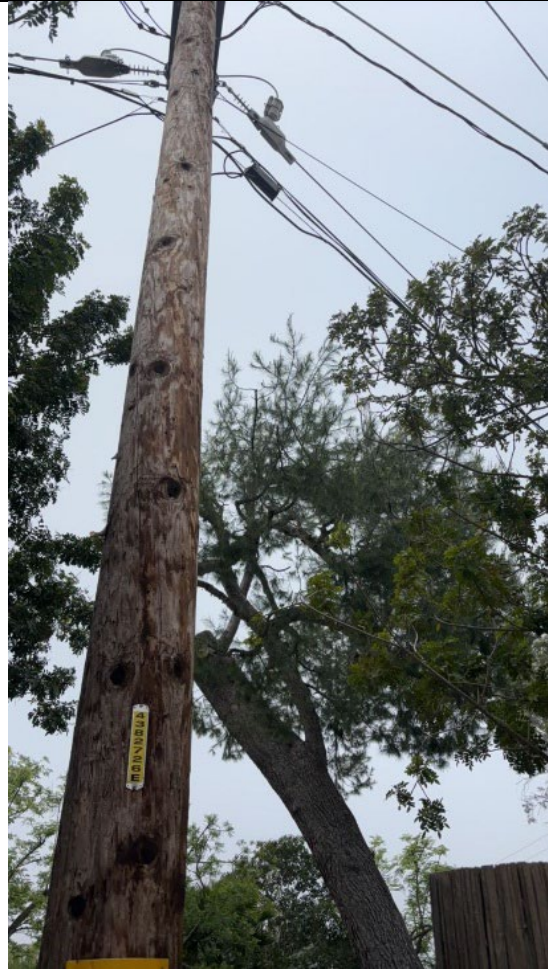
On March 26, 2026, Energy Safety conducted an inspection of SCE's WMP initiatives in the vicinity of Agoura Hills, California. During the inspection, Energy Safety identified a pine tree growing within the four-foot minimum clearance distance near pole ID 4382726E and near coordinates 34.15106162767872, -118.7405848910039 along Fairview Place. The pine tree is located within SCE's defined HFRA, in HFTD Tier 3, and in SRA. SCE's Q4 QDR data indicated it completed tree work in the area on November 10, 2025. The inspector measured the distance between the primary conductors and the closest branches of the pine tree using a Nikon Forestry Pro II Laser range finder. The measured distance was 3.2 feet, which is less than required four-foot clearance. The pine tree is located at approximately 0.1 span south of pole ID 4382726E. The inspector's observations are documented in Exhibit A photographs, which are attached to this report. Photo 1 depicts pole ID 4382726E. Photo 2 shows of the pine tree relative to the pole. Photo 3 depicts the pine tree in relation to the driveway. Photos 4, 5, and 6 depict the pine tree encroaching within the four-foot minimum clearance distance.

Photo 3: Close-up photo of the pine tree encroaching within the four-foot minimum clearance distance from the primary conductor. Photo taken approximately 27 feet south of the tree.

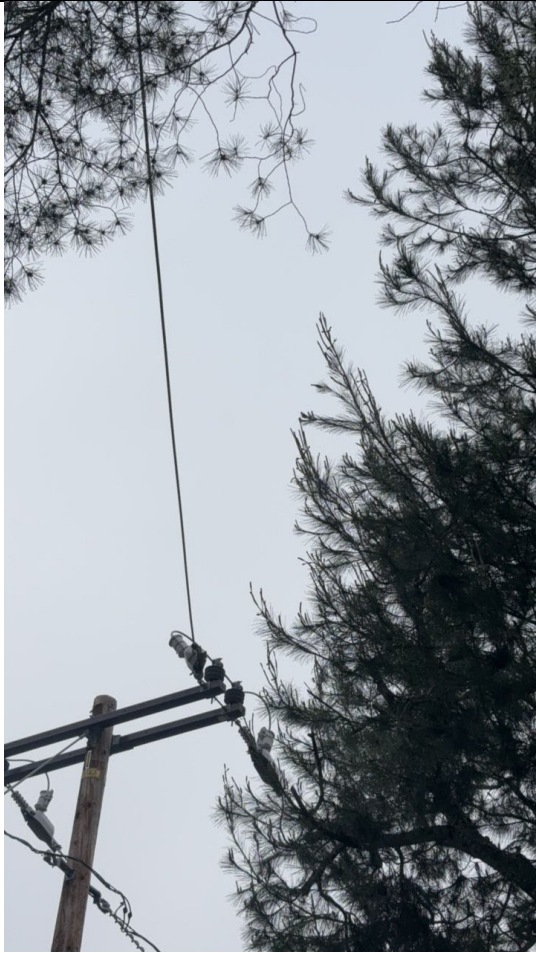
Photo 4: Additional photo of the pine tree in relation to the pole.
