NOTICE OF NON-PERFORMANCE

On April 8, 2026, Energy Safety conducted an inspection of PG&E's WMP initiatives in the vicinity of Sutter Creek, California within High Fire Threat District (HFTD) Tier 2 and the State Responsibility Area (SRA). The inspection report is enclosed herewith. Energy Safety found the following deficiency:

INSPECTION REPORT

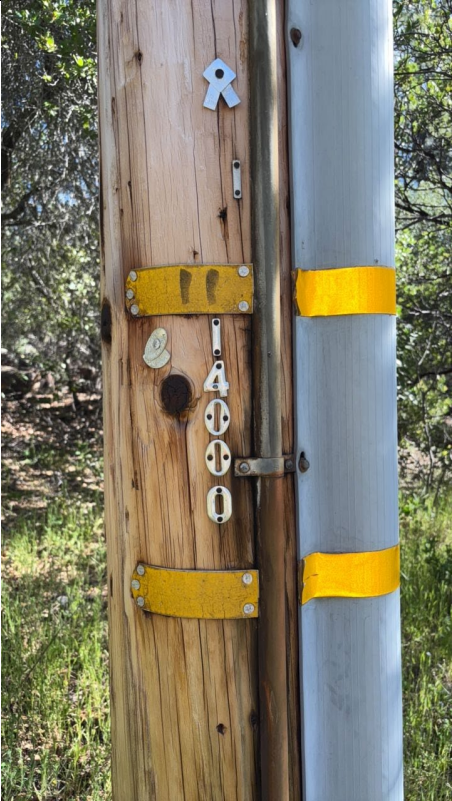
Photo 1: Photo of pole marked with an "14000" address marker.

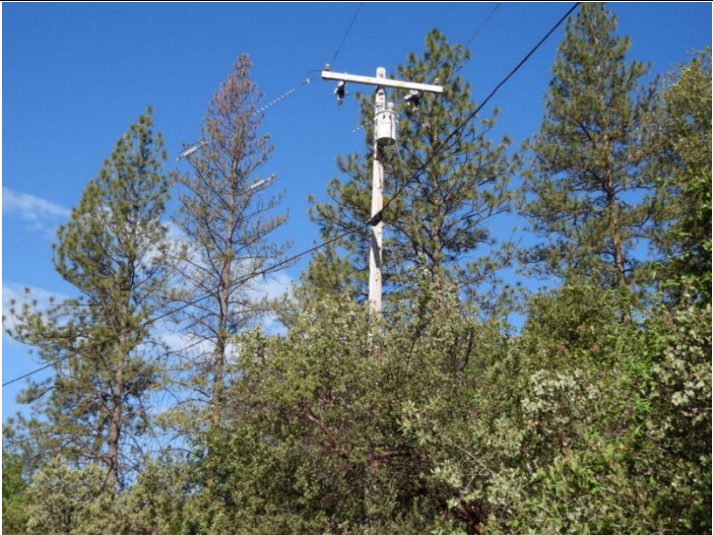
Energy Safety considers this deficiency as "Moderate" because PG&E has not removed the dying Jeffrey pine tree located within striking distance of conductors, consistent with the requirements of Public Resources Code section 4293. The continued presence of this tree presents an ongoing wildfire risk.

On April 8, 2026, Energy Safety conducted an inspection of PG&E's WMP's initiatives in the vicinity of Sutter Creek, California. During the inspection, Energy Safety identified a dying Jeffrey pine tree near a pole listed as "Support Structure ID 101262415" in PG&E's Q4 2025 spatial QDR asset layer. The pole was marked with an address marker reading "14000" and is near coordinates 38.44392947856192, -120.76739774096828 along Echo Drive. The Jeffrey pine tree is located within the SRA. The Jeffrey pine tree is approximately 62 feet tall and is located approximately 28 feet from the conductors and south of the pole. The inspector's observations are documented in Exhibit A photographs, which are attached to this report. Photo 1 depicts pole with the "14000" address marker. Photos 2, 3, 4 and 5 depict the dying Jeffrey pine tree.

Photo 2: Photo of dying Jeffrey pine located south of the pole.

Deficiency 1. Energy Safety observed that PG&E failed to implement its 2025 WMP initiative 8.2.3.4, which requires compliance with Public Resources Code section 4293, by not removing a dead, declining or dying tree near coordinates 38.44392947856192, -120.76739774096828. Energy Safety considers this non-performance to be in the Moderate risk category. PG&E must complete a corrective action for this non-performance by six months from the date of this notice.¹

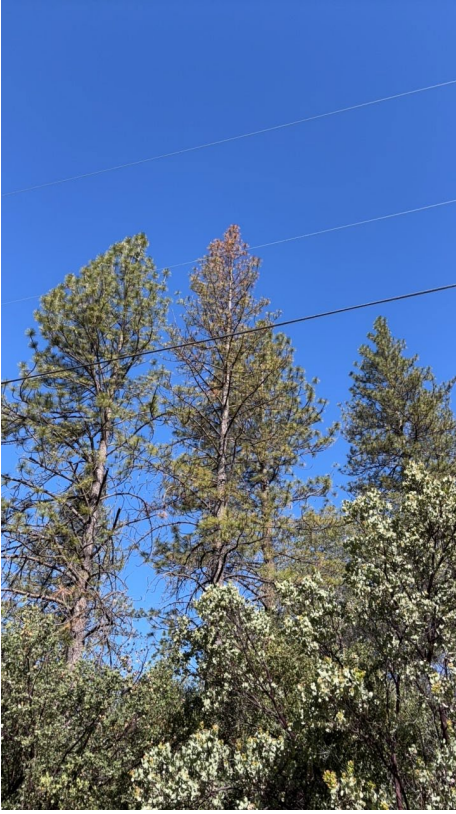
Photo 3: Photo of the dying Jeffrey pine tree near the conductor.

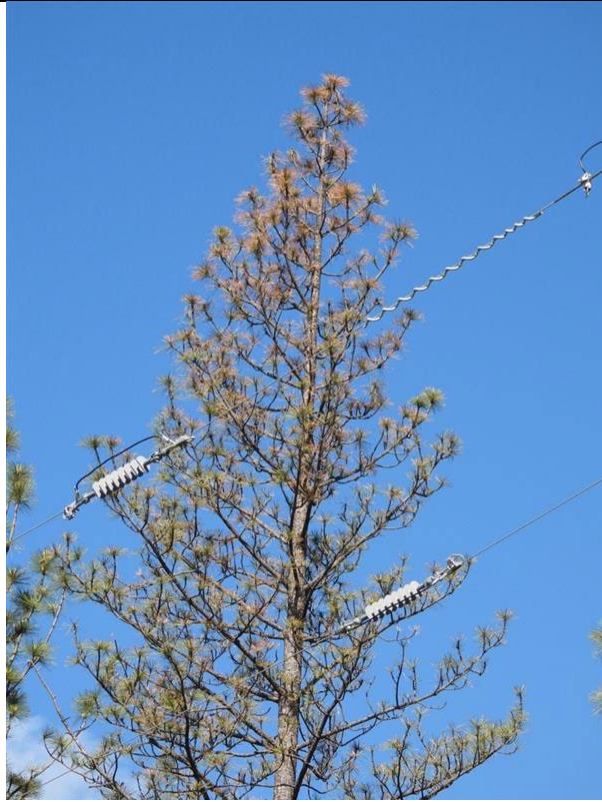
Photo 4: Photo of the dying Jeffrey pine tree showing discoloration and thinning needles at its canopy.

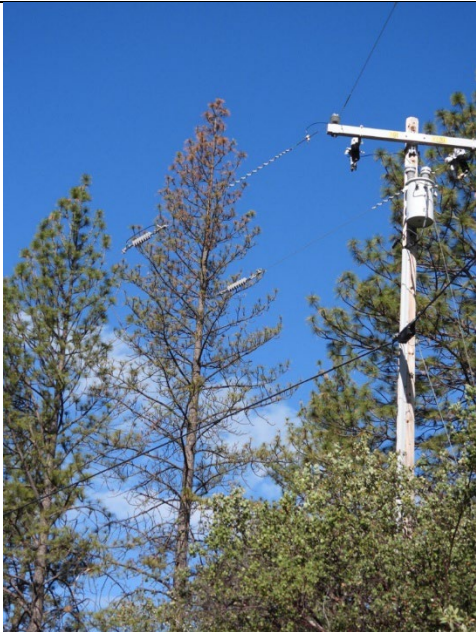
Photo 5: Additional photo of the dying Jeffrey pine tree near the conductors and the pole.
