NOTICE OF NON-PERFORMANCE

INSPECTION REPORT

Electrical Corporation:	PG&E
Report Number:	NON_ESD_PGE_AKM_20260311_1138
Inspector:	Akiko Masuda
WMP Year Inspected:	2025
Quarterly Data Report (QDR) Referenced:	Quarter 4 (Q4) 2025
Inspection Selection:	Energy Safety inspected the locations based on PG&E’s Q4 QDR.
Relevant WMP Initiative(s):	8.2.3.2 Wood and Slash Management
Date of inspection:	March 11, 2026
City and/or County of Inspection:	North San Juan, Yuba County

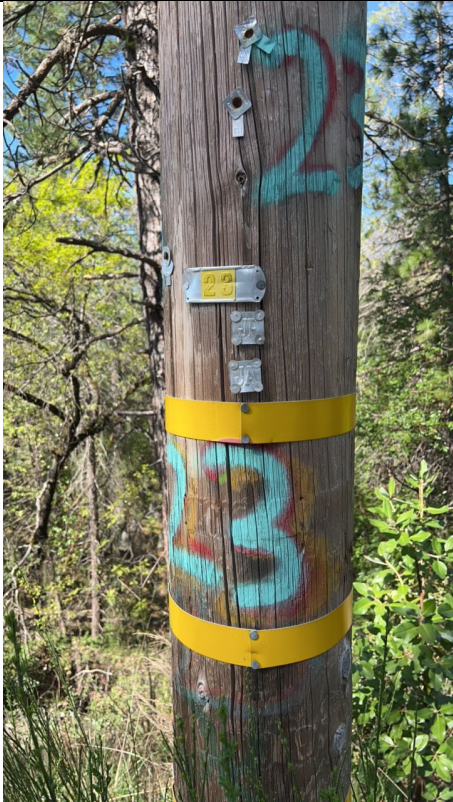
Photo 1: Photo of the metal tags “23,” “JP” and “JA” on the pole.

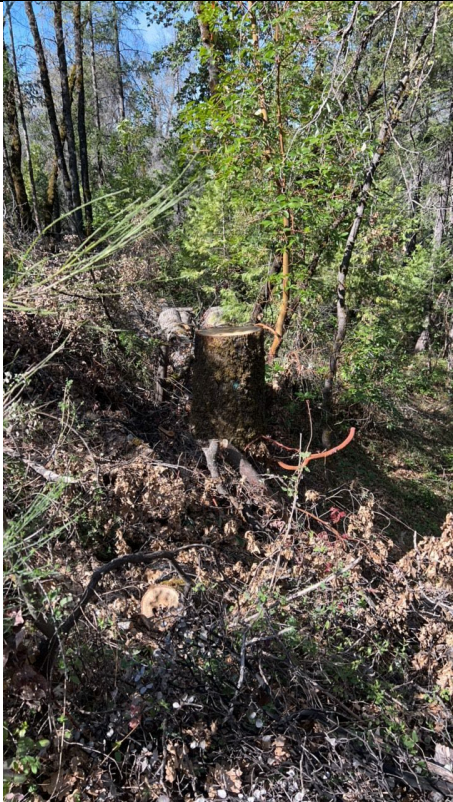
Photo 2: Photo of the black oak tree trunk surrounded by its wood and slash debris.

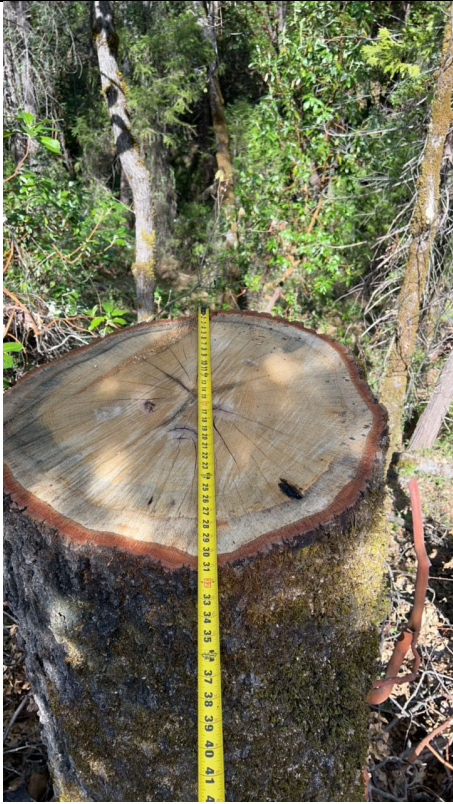
In response to a data request (no. OIES-E-INP_2026-PG&E-009) PG&E confirmed that the slash and woody debris at this site was created by PG&E’s work associated with VMP ID VP_AV114-K19_550169.

Photo 3: Photo of the black oak tree trunk measuring approximately 32 inches in diameter, consistent with the description for VMP ID VP_AV114-K19_550169.

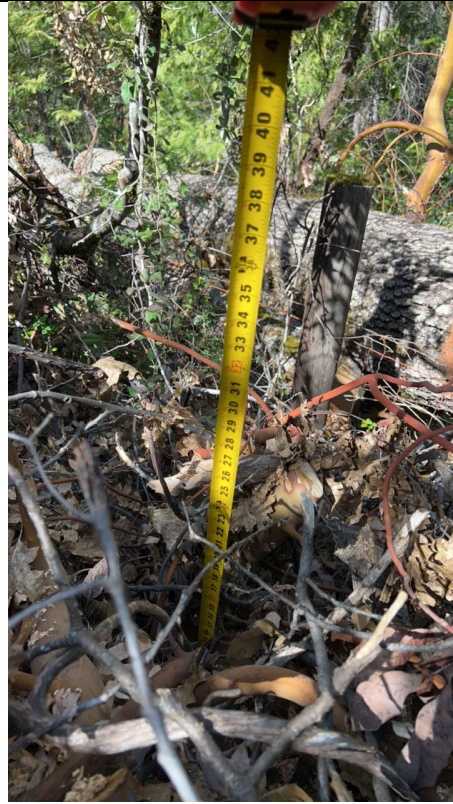
Energy Safety considers this deficiency "Moderate" because the slash pile is over 18-inches in height, creating a potential fuel source for wildfire.

On March 11, 2026, Energy Safety conducted an inspection of PG&E's WMP initiatives in the vicinity of the city of North San Juan, California. During the inspection, Energy Safety observed slash and woody debris left onsite near a pole listed as "Support Structure ID 100101092" in PG&E's Q4 2025 spatial QDR asset layer. The pole had metal tags "23," "JP," and "JA" and is near coordinates 39.409452, -121.059311 along Ridge Road. PG&E's 2025 Q4 data reported completed work on December 8, 2025 under its Tree Removal Inventory program under VMP ID VP_AV114-K19_550169, where a 32-inch diameter at breast height, 71-foot-tall black oak tree was removed. Energy Safety's inspector observed that slash and woody debris from the tree removal activities remained onsite in a pile approximately 40 inches high. The inspector's observations are documented in

Photo 4: Photo of a pile of wood and slash debris measuring approximately 40 inches in height.

Deficiency 1. Energy Safety observed that in implementing 2025 WMP initiative 8.2.2.2.4, PG&E failed to adhere to its protocol of wood and slash management at Vegetation Management ID VP_AV114-K19_550169 and coordinates 39.409452, -121.059311. Energy Safety considers this non-performance to be in the Moderate risk category. PG&E must complete a corrective action for this non-performance by two months from the date of this notice.¹

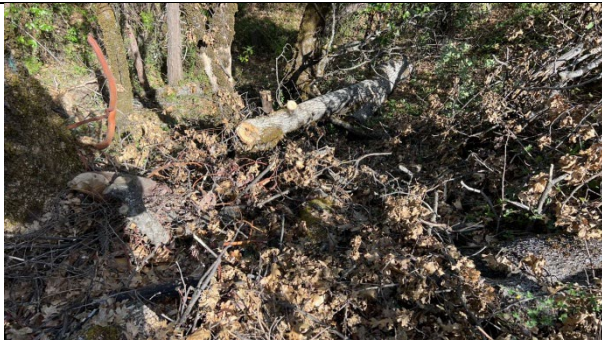
Photo 5: Additional photo of the pile of wood and slash debris left onsite.

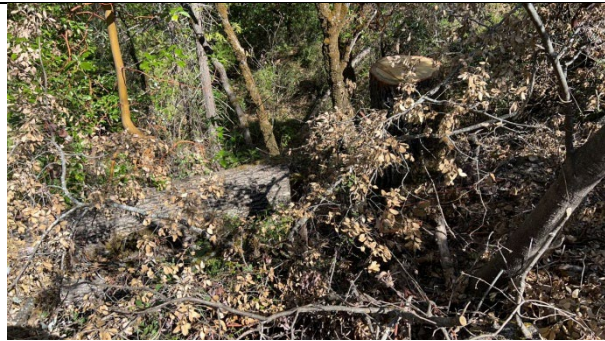
Photo 6: Additional photo of the pile of wood and slash debris left onsite.
