## NOTICE OF NON-PERFORMANCE

# INSPECTION REPORT

Electrical Corporation:	Pacific Gas and Electric Company
Report Number:	PAD_PGE_RMA_20251216_1256
Inspector:	Romeo Marroquin Ajcac
WMP Year Inspected:	2025
Quarterly Data Report (QDR) Referenced:	Quarter 2 (Q2)
Inspection Selection:	Energy Safety viewed the contents of the Q2 QDR and performed an analysis that resulted in the selection of the WMP initiatives and locations referenced in this report.
Relevant WMP Initiative(s):	8.1.2.10.5 - Non-Exempt Expulsion Fuses
Date of Inspection:	December 16, 2025
City and/or County of Inspection:	Angwin, Napa County
Inspection Purpose:	Assess the accuracy of Pacific Gas and Electric Company’s QDR data, completeness of its work, and performance of requirements.

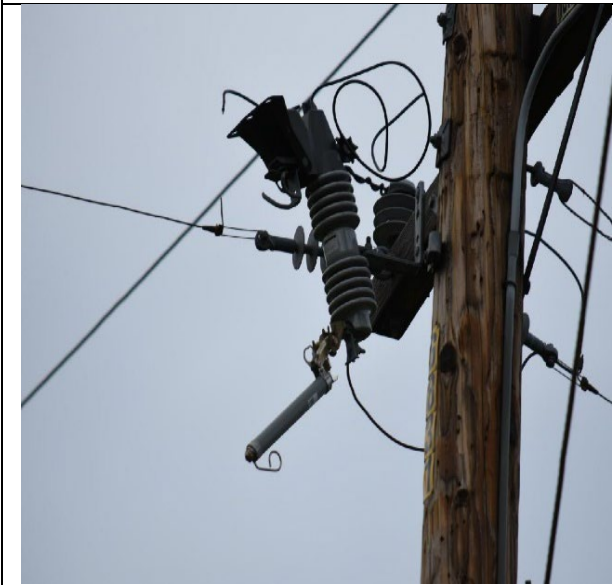
In the 2025 Q2 Quarterly Data Report submission, PG&E reported that work on WMP initiative 8.1.2.10.5 – Non-Exempt Expulsion Fuses was completed at Pole ID 110460390, Grid Hardening ID 31699669 at 29-165 Diogenes Dr, Angwin, CA, 94508, USA, 38.5714506595772, -122.447841100213. At this location the inspector observed that an exempt fuse was left in the open position in its cutout and was also disconnected from its primary line. The inspector's observation is documented in Deficiency 1 photographs, which are attachments to this report. Photo numbers IA1Img1, and IA1Img2, depict the exempt fuse in the open position and disconnected from its primary line.

1. The inspector observed an exempt fuse in the open position in its cutout.
2. The inspector observed that the exempt fuse's cutout was disconnected from the primary line.
3. The disconnection of the cutout from the primary line indicates that the work was not completed, even if leaving the fuse in an open position would be considered normal practice.

**IA1mg1:** Exempt fuse is disconnected and unplugged.

Deficiency 1. Energy Safety observed that in implementing 2025 WMP initiative 8.1.2.10.5 - Non-Exempt Expulsion Fuses, PG&E failed to complete the installation of non-exempt expulsion fuses on Pole ID 110460390, Grid Hardening ID 31699669 at coordinates 38.5714506595772, -122.447841100213. Energy Safety considers this non-performance to be in the Minor risk category. PG&E must complete a corrective action for this deficiency by 12 months of this notice.

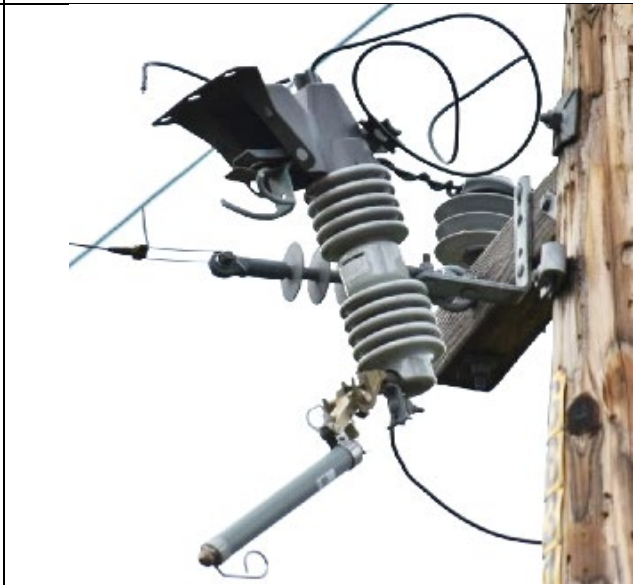
**IA1mg2:** Exempt fuse is disconnected and unplugged (close view).
