NOTICE OF NON-PERFORMANCE

INSPECTION REPORT

Electrical Corporation:	SDG&E
Report Number:	NON_ESD_SDGE_KJO_20260210_1351
Inspector:	Kelsea Jones
WMP Year Inspected:	2025
Quarterly Data Report (QDR) Referenced:	Quarter 3 (Q3) 2025
Inspection Selection:	Energy Safety inspected the locations based on SDG&E’s Q3 QDR.
Relevant WMP Initiative(s):	8.2.3.1 Pole Clearing (WMP.512)
Date of inspection:	February 10, 2026 and April 13, 2026
City and/or County of Inspection:	Ramona, California

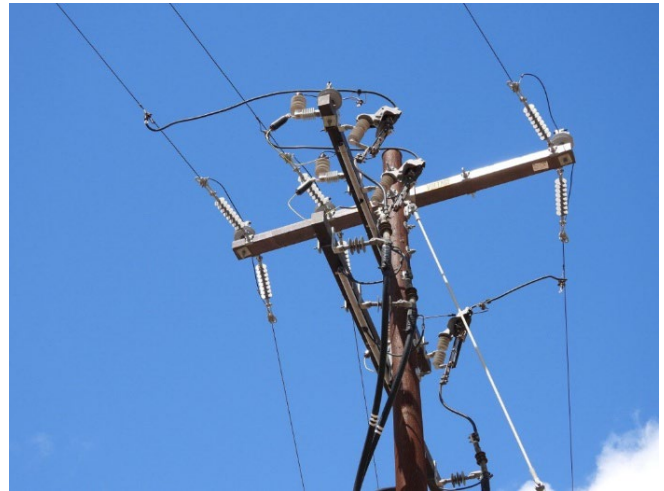
Photo 2: Overview of the equipment on pole ID P610587.

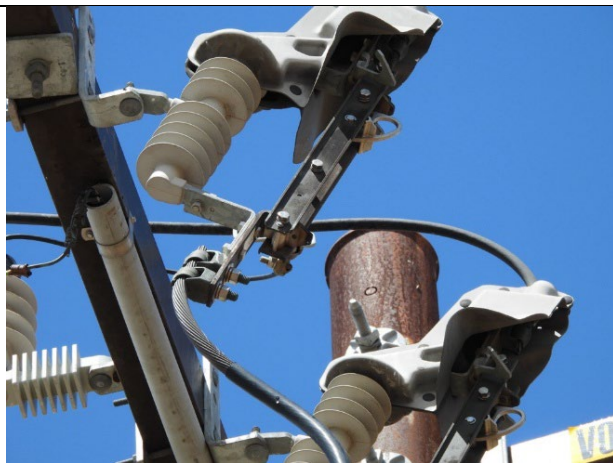
exempt solid blade disconnect fuses.⁹ Therefore, the pole is subject to the WMP vegetation management requirements under initiative 8.2.3.1 Pole Clearing (WMP .512), which mandates the removal of all vegetation to bare mineral soil within a 10-foot radius around the base of the pole. Therefore, SDG&E has committed to perform pole clearing activities at such poles.

Photo 3: Closer view of the non-exempt solid blade disconnect on pole ID P610587.

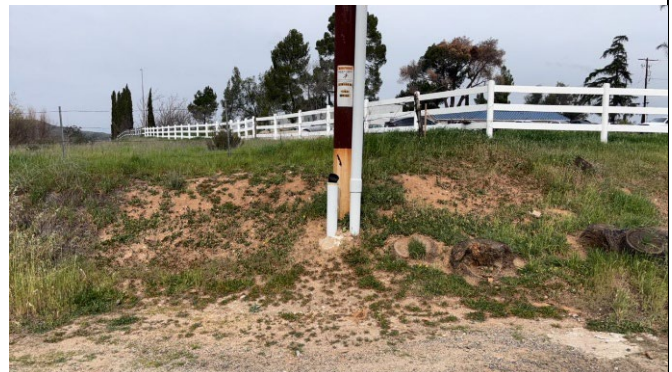
SDG&E's Q3 2025 QDR data reported that vegetation around pole ID P610587 was cleared on August 6, 2025, under its 8.2.3.1 Pole Clearing (WMP .512) program, near coordinates 33.0409399658502, -116.910492194103. However, during a February 10, 2026 inspection, Energy Safety observed regrowth of annual vegetation within the 10-foot radius of the pole. On April 13, 2026, Energy Safety conducted a follow-up inspection and confirmed that the vegetation was still present and had begun to dry out.

Photo 4: Overview of the pole and regrowth of vegetation within the 10-foot radius of the pole, taken during the inspection on February 10, 2026

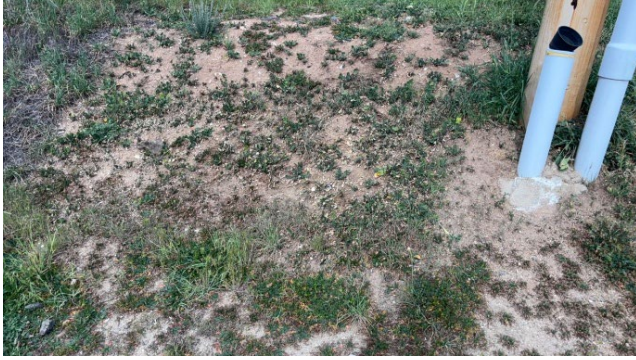
Photo 5: View of annual vegetation within the 10-foot radius of the pole, taken during the inspection on February 10, 2026.

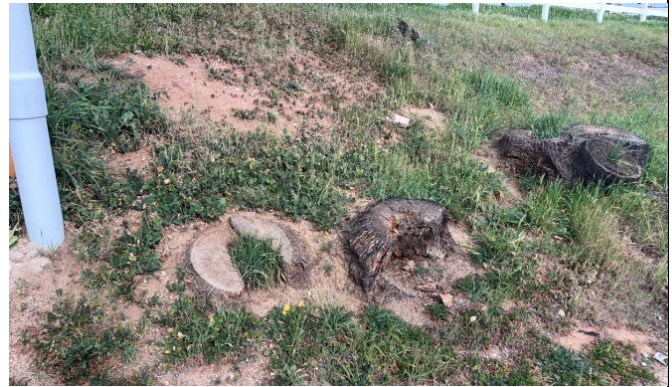
The presence of vegetation and desiccated stumps approximately six and eight months after the reported clearing indicates that SDG&E did not re-visit and clear the pole as indicated in its WMP. The inspector's observation is documented in Exhibit A photographs, which are attached to this report. Photo 1 depicts pole ID P61058. Photos 2 and 3 depict the equipment present on the pole at the time of inspection. Photos 4, 5 and 6 depict vegetation growing at the base of the pole within the 10-foot radius during the February 10, 2026 inspection. Photos 7, 8, and 9 show the dry fuel source present at the base of the pole within the 10-foot radius during the April 13, 2026 inspection. Photo 10 depicts the desiccated stump during the April 13, 2026 inspection.

Photo 6: View of annual vegetation and desiccated stumps within the 10-foot radius of the pole, taken during the inspection on February 10, 2026.

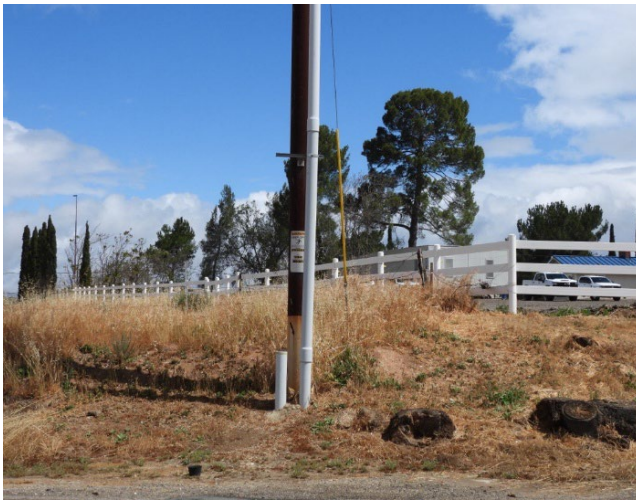
Photo 7: Overview of dry fuel source around pole ID P610587, taken during the inspection on April 13, 2026.

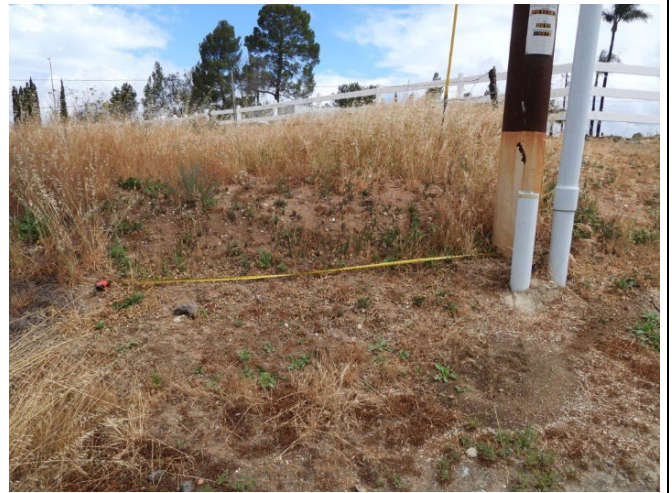
Photo 8: Photo depicting the 10-foot radius around pole ID P610587, taken during the inspection on April 13, 2026.

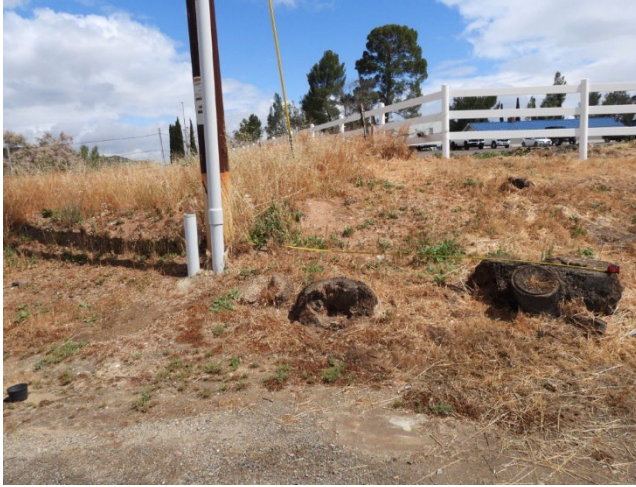
Photo 9: Additional photo depicting the 10-foot radius from pole ID P610587, taken during the inspection on April 13, 2026.

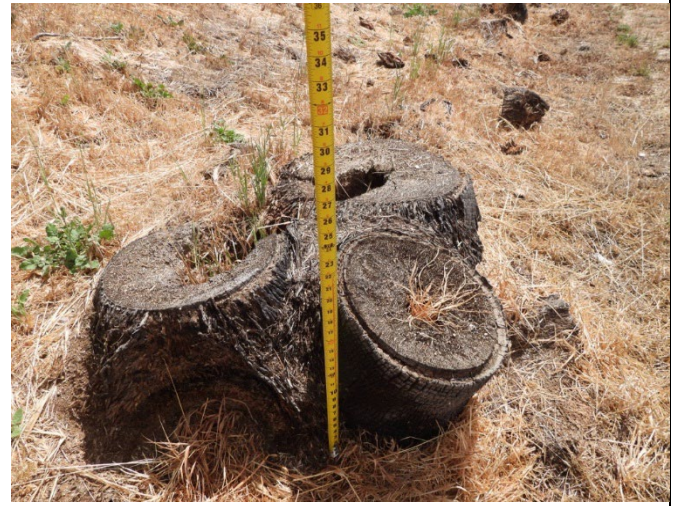
Photo 10: Photo depicting the desiccated palm stump, approximately 22 inches tall, taken during the inspection on April 13, 2026.
