NOTICE OF NON-PERFORMANCE

INSPECTION REPORT

Electrical Corporation:	PG&E
Report Number:	NON_ESD_PGE_GCA_20260408_1333
Inspector:	Gary Candelas
WMP Year Inspected:	2025
Quarterly Data Report (QDR) Referenced:	Quarter 4 (Q4) 2025
Inspection Selection:	Energy Safety inspected the locations based on PG&E’s Q4 QDR.
Relevant WMP Initiative(s):	8.2.3.4 Fall-In Mitigation
Date of inspection:	April 8, 2026
City and/or County of Inspection:	Brownsville, California

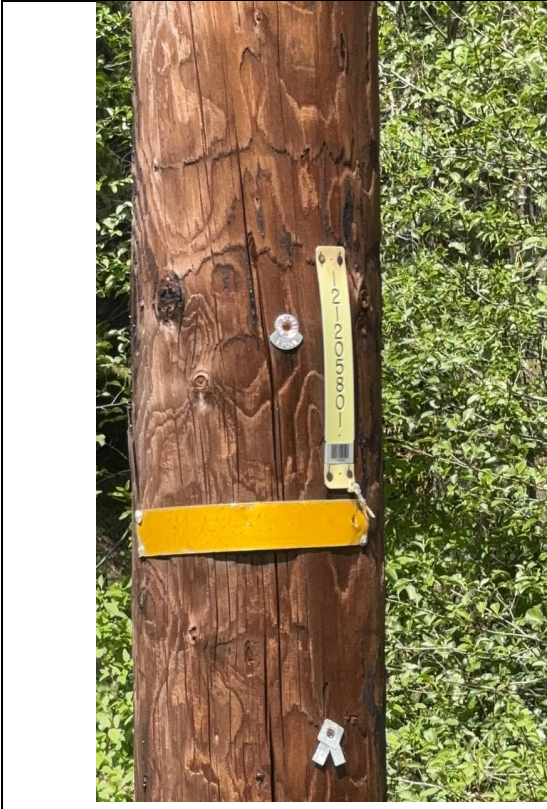
Photo 1: Photo of pole ID 121205801.

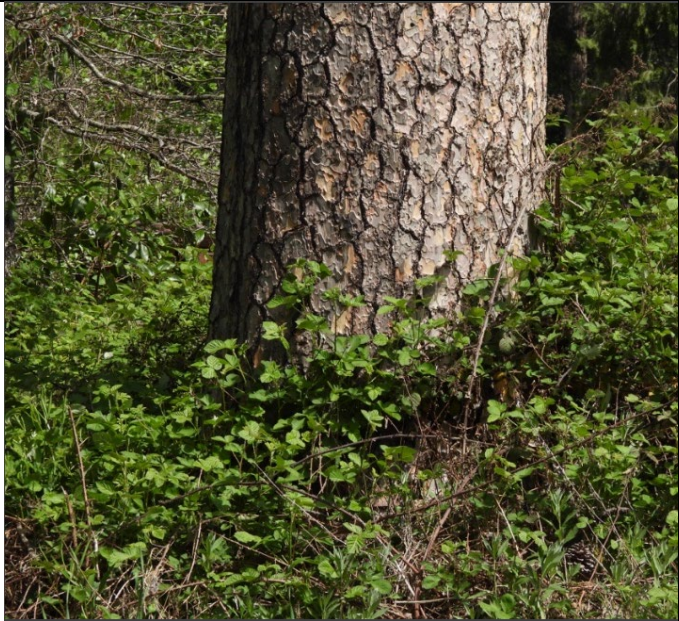
On April 8, 2026, Energy Safety conducted an inspection of PG&E's WMP's initiatives in the vicinity of Brownville, California. During the inspection, Energy Safety identified a declining ponderosa pine tree found at coordinates 39.47929647526301, -121.25189022605244, at 9478 La Porte Road. The ponderosa pine tree is located within HFTD Tier 3 and the SRA. The tree is approximately 140 feet tall, located northeast of conductors and 37.6 feet east of pole ID 121205801. It exhibits yellowing needles throughout the canopy, though there are still green needles present. The inspector also observed insect burrows along the trunk and discolored bark, which are signs of a potential insect infestation. The inspector's observations are documented in Exhibit A photographs, which are attached to this report. Photo 1 depicts pole ID 121205801. Photo 2 shows the base of the ponderosa pine tree trunk. Photos 3 through 8 depict the declining ponderosa pine tree.

Photo 2: Photo of the base of the declining ponderosa pine tree with vines present around the trunk.

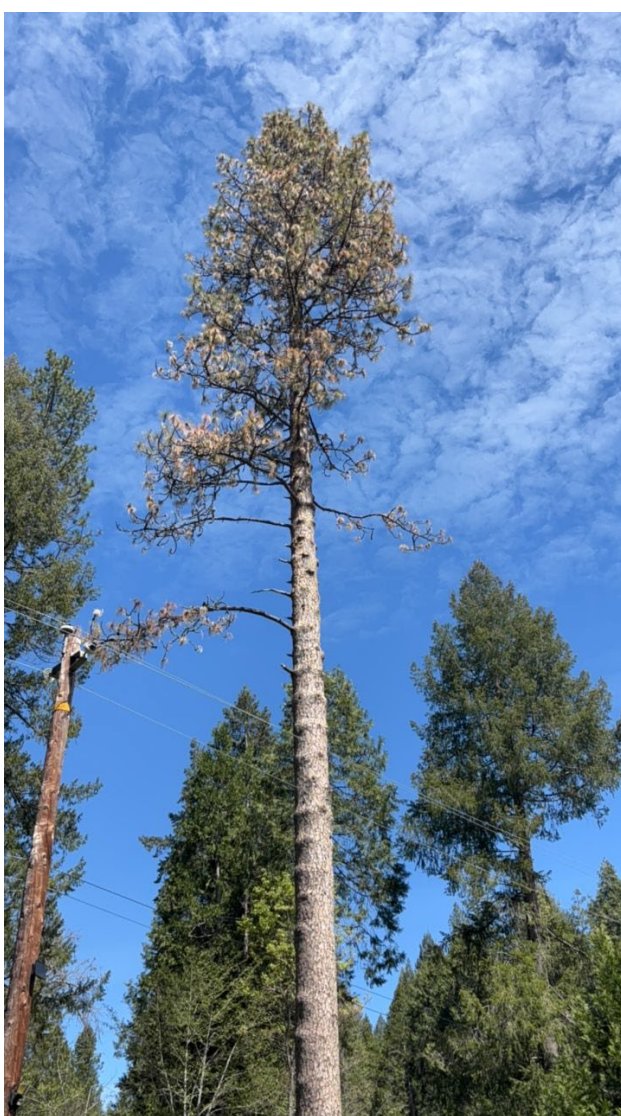
Energy Safety considers this deficiency as "Minor" because PG&E has not removed the declining ponderosa pine tree located within striking distance of conductors, consistent with the requirements of Public Resources Code section 4293. The continued presence of this tree presents an ongoing wildfire risk.

Photo 3: Photo of the declining ponderosa pine tree near pole ID 121205801.

Deficiency 1. Energy Safety observed that PG&E failed to implement its 2025 WMP initiative 8.2.3.4, which requires compliance with Public Resources Code section 4293, by not removing a declining or dying pine tree near coordinates 39.47929647526301, -121.25189022605244 and near pole ID 121205801. Energy Safety considers this non-performance to be in the Minor risk category. PG&E must complete corrective action for this non-performance by twelve months from the date of this notice.¹

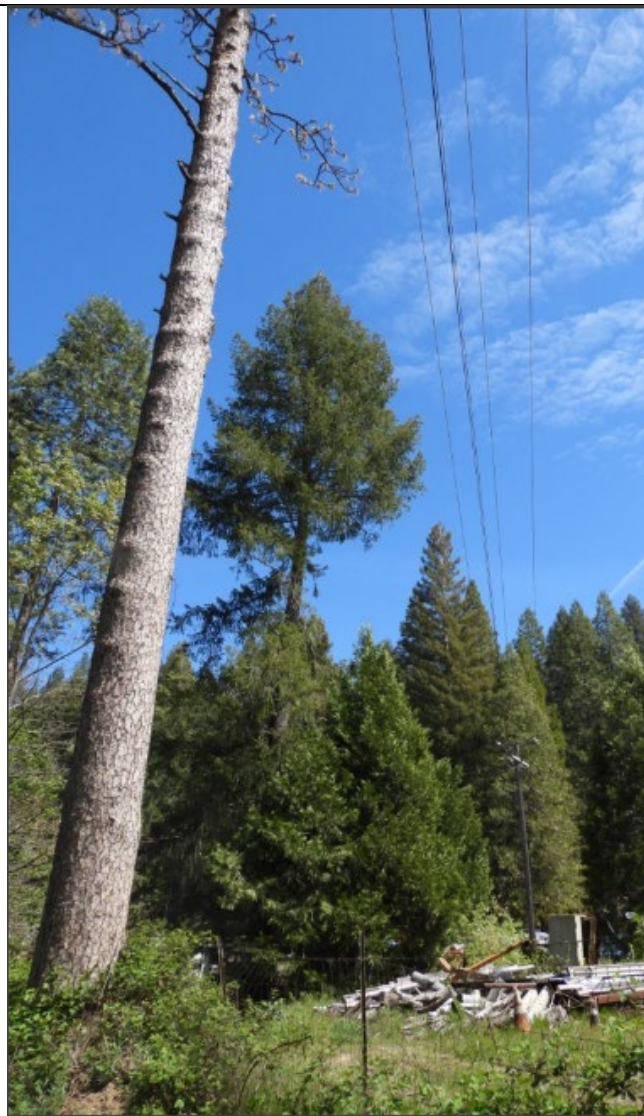
Photo 4: Photo of the ponderosa pine tree located approximately 15-feet northeast of the conductors.

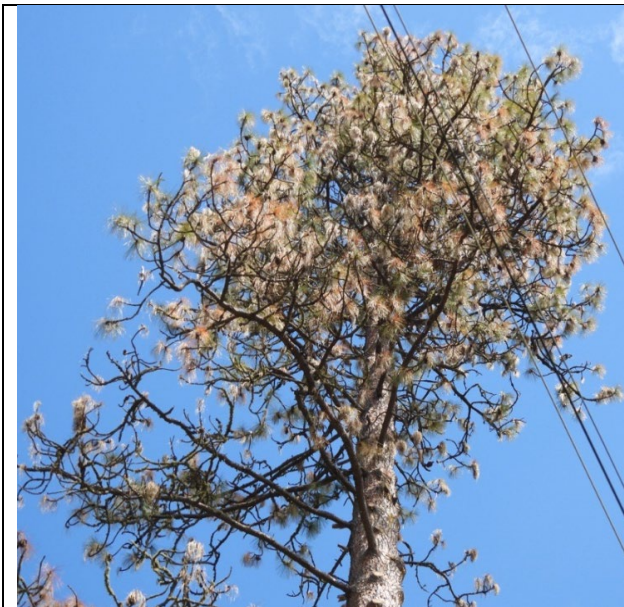
Photo 5: Photo of the ponderosa pine tree with yellowing needles in its canopy in relation to the conductors.

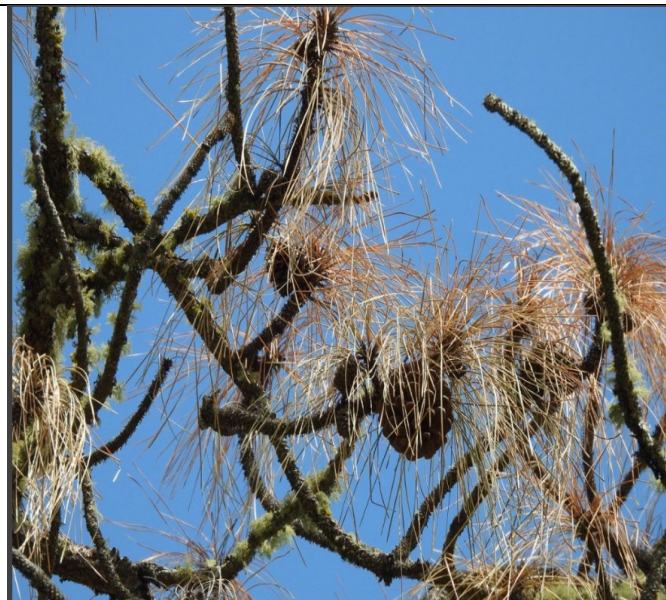
Photo 6: Photo showing yellowing needles and moss on the branches.

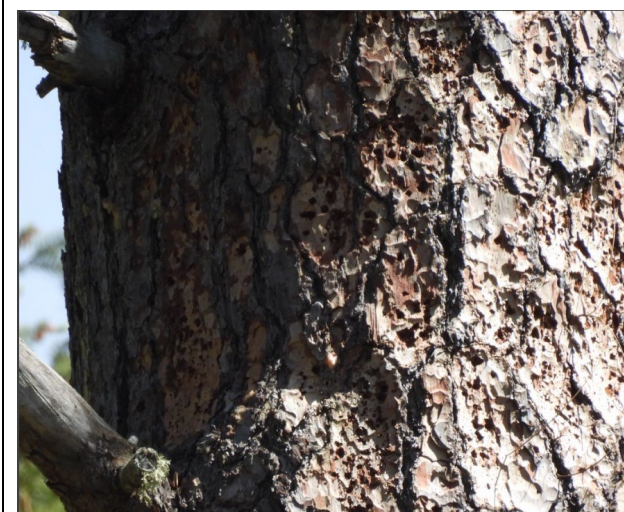
Photo 7: Photo of the ponderosa pine tree trunk showing insect burrows.

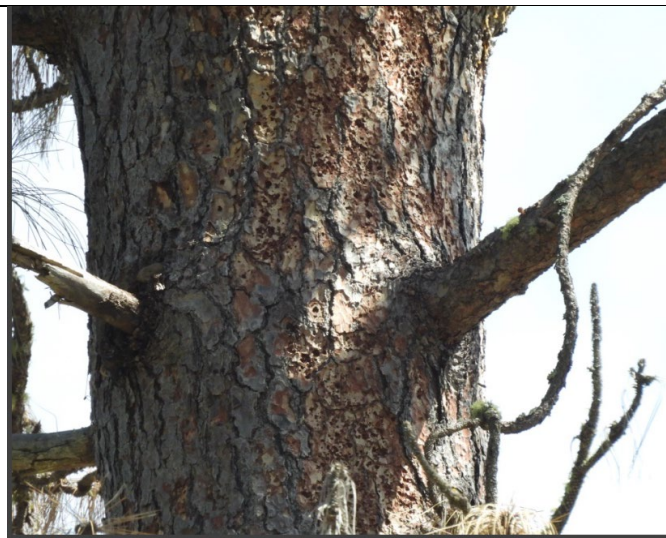
Photo 8: Photo of the ponderosa pine tree trunk with insect burrows and discolored bark.
