NOTICE OF NON-PERFORMANCE

INSPECTION REPORT

Electrical Corporation:	PG&E
Report Number:	NON_ESD_PGE_AKM_20260311_1348
Inspector:	Akiko Masuda
WMP Year Inspected:	2025
Quarterly Data Report (QDR) Referenced:	Quarter 4 (Q4) 2025
Inspection Selection:	Energy Safety inspected the locations based on PG&E’s Q4 QDR.
Relevant WMP Initiative(s):	8.2.3.2 Wood and Slash Management
Date of inspection:	March 11, 2026
City and/or County of Inspection:	North San Juan, Yuba County

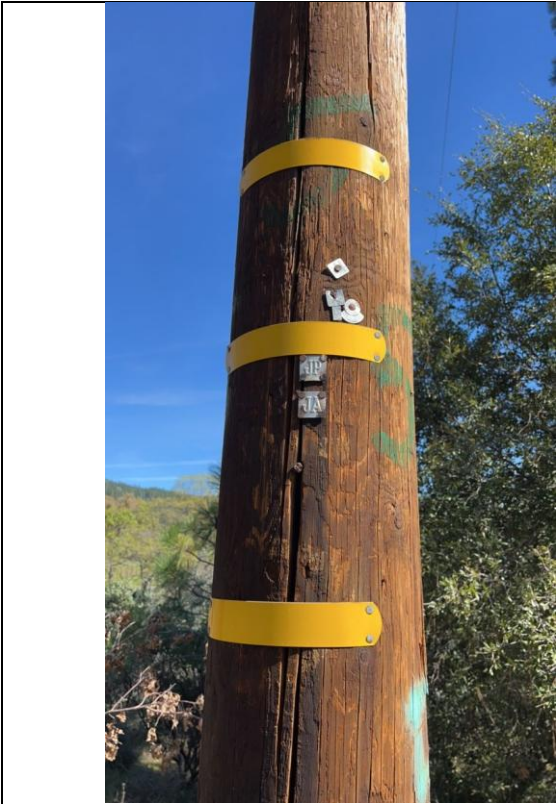
Photo 1: Photo of the metal tags “55y,” “JP,” and “JA” on the pole.

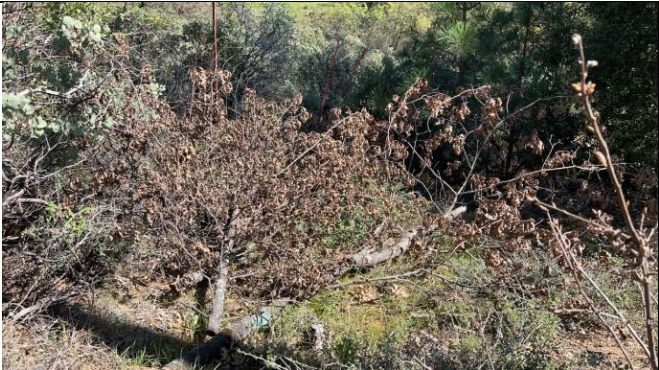
On March 11, Energy Safety conducted an inspection of PG&E's WMP initiatives in the vicinity of the city of North San Juan, California. During the inspection, Energy Safety observed woody debris left onsite near a pole listed as "Support Structure ID 100112200" in PG&E's Q4 2025 Spatial QDR asset layer. The pole had metal tags "55," "JP," and "JA" and is near coordinates 39.407835, -121.057122 along Alleghany Road. PG&E's 2025 Q4 QDR data reported that it completed work on September 30, 2025 under its Tree Removal Inventory program under VM ID VP_AV114-K19_564613, where a 15-inch diameter at breast height, 28-foot-tall black oak tree was removed. Energy Safety's inspector observed that two cut and dry black oak tree branches remained

onsite in piles approximately 35 and 47 inches tall. The branches have not been lopped into smaller pieces. The inspector's observations are documented in Exhibit A photographs, which are attached to this report. Photo 1 depicts metal tags "55," "JP," and "JA". Photos 2, 3, 4, and 5 depict the black oak tree branches left on site.

Photo 2: Photo of the first cut black oak tree branch, now dry, left onsite.

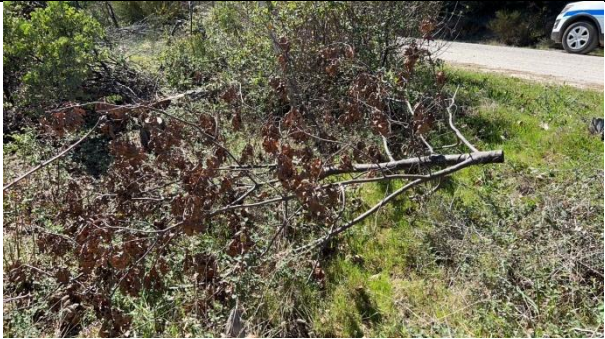
Photo 3: Photo of the second cut black oak tree branch, now dry, left onsite.

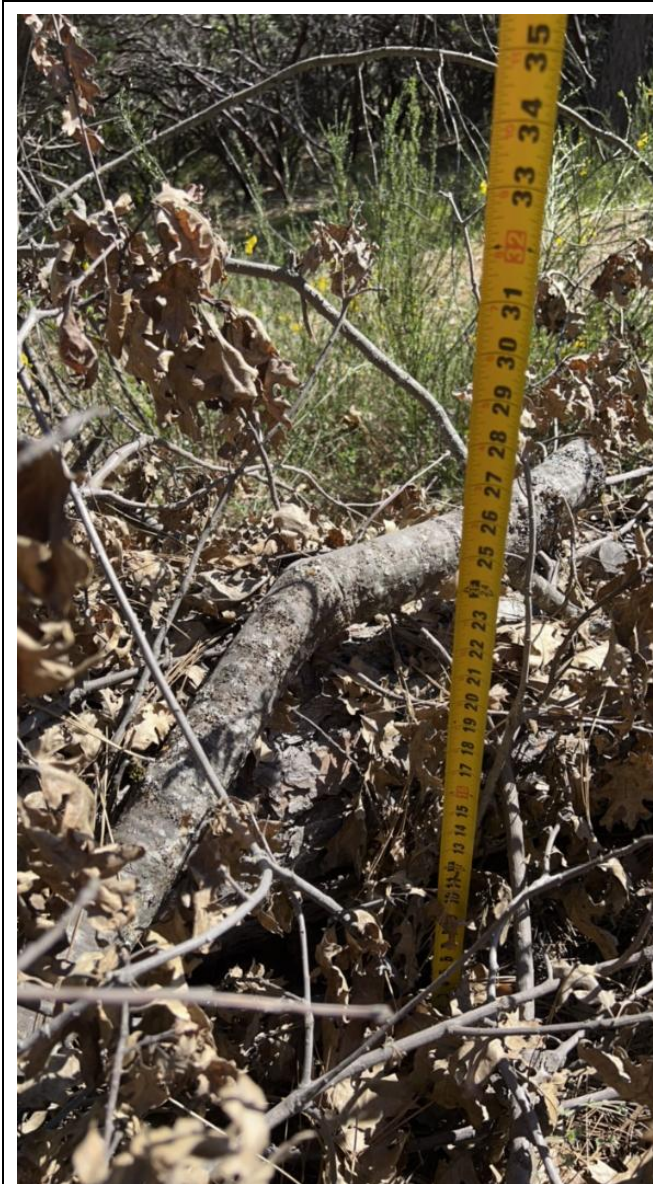
Energy Safety considers this deficiency "Moderate" because the slash pile is over 18-inches in height, creating a potential fuel source for wildfire.

Photo 4: Photo of the first cut black oak tree branch measuring approximately 35 inches in height.

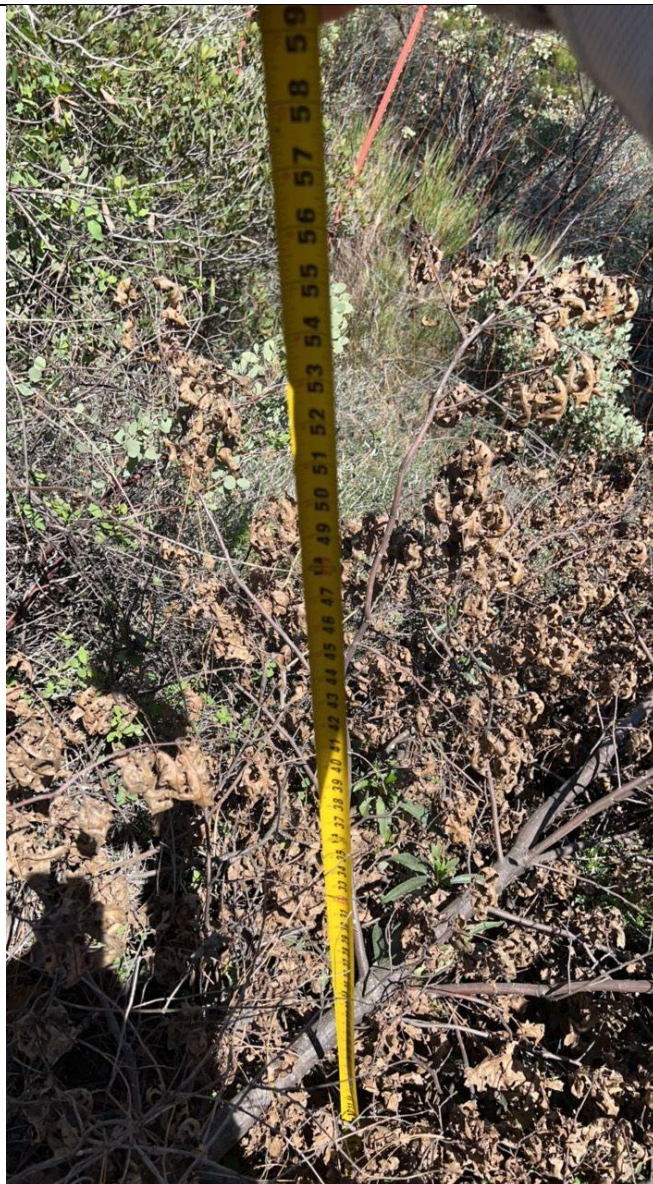
Photo 5: Photo of the second cut black oak tree branch measuring approximately 47 inches in height.
