NOTICE OF NON-PERFORMANCE

INSPECTION REPORT

Electrical Corporation:	PG&E
Report Number:	NON_ESD_PGE_AKM_20260311_1409
Inspector:	Akiko Masuda
WMP Year Inspected:	2025
Quarterly Data Report (QDR) Referenced:	Quarter 4 (Q4) 2025
Inspection Selection:	Energy Safety inspected the locations based on PG&E’s Q4 QDR.
Relevant WMP Initiative(s):	8.2.3.2 Wood and Slash Management
Date of inspection:	March 11, 2026
City and/or County of Inspection:	North San Juan, Yuba County

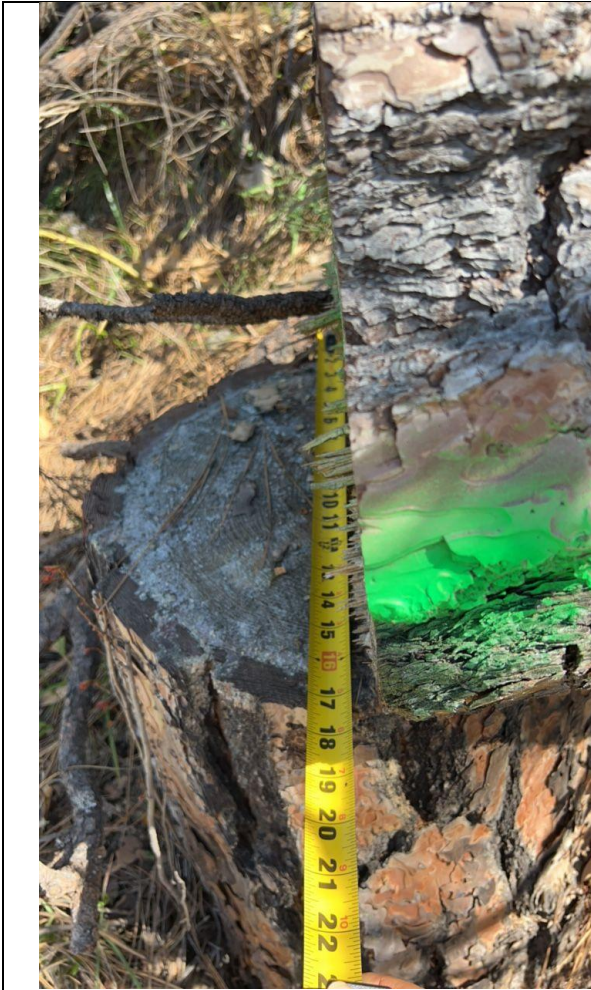
2, 2025. Energy Safety’s inspector observed that slash and woody debris from tree removal activities remained onsite, forming piles approximately 43 inches at its tallest point. The inspector’s observations are documented in Exhibit A photographs, which are attached to this report. Photos 1 and 2 depict the removed ponderosa pine tree trunks. Photos 3, 4, 5, and 6 depict the piles of wood and slash debris left on site.

Photo 1: Photo of the ponderosa pine tree trunk measuring approximately 17 inches in diameter, consistent with the description for VMP ID VP_AV114-K19_561995.

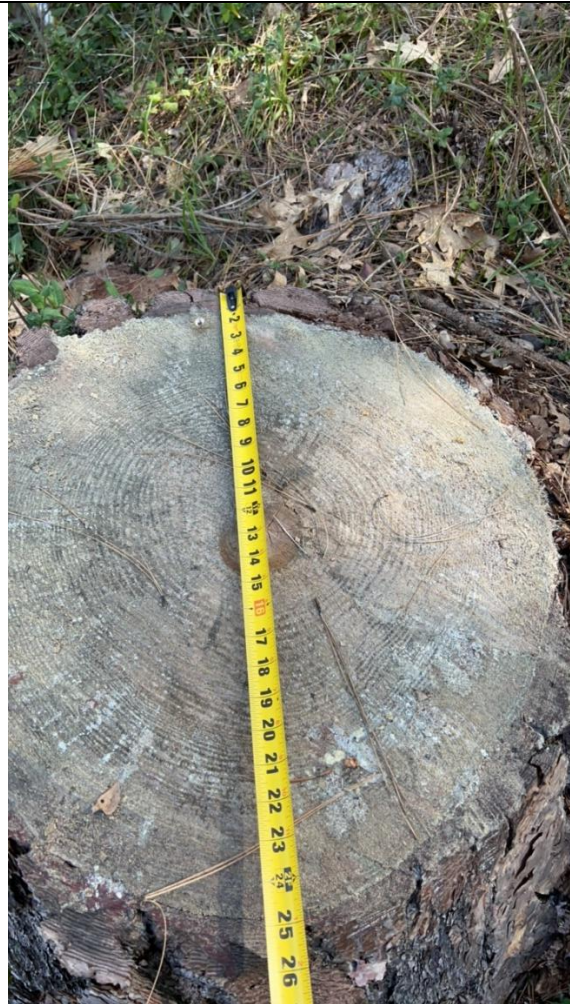
Photo 2: Photo of another ponderosa pine tree trunk measuring approximately 25 inches in diameter, consistent with the description for VMP ID VP_AV114-K19_562057.

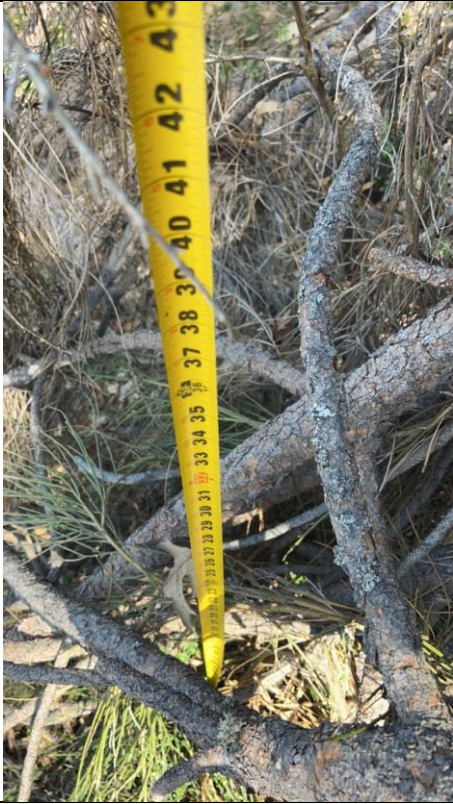
Energy Safety considers this deficiency "Moderate" because the slash pile is over 18-inches in height, creating a potential fuel source for wildfire.

Photo 3: Photo of the pile of wood and slash debris measuring approximately 43 inches in height.

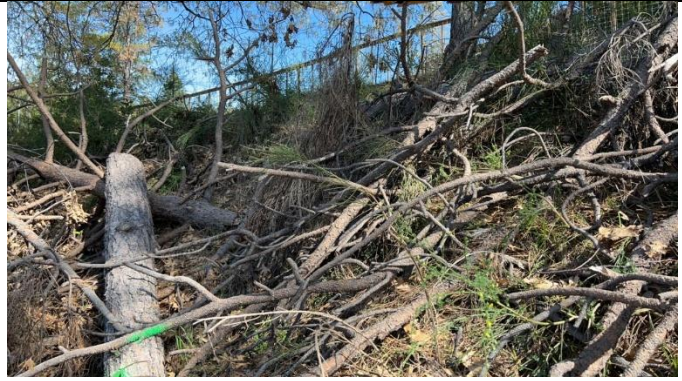
Photo 4: Additional photo of the pile of wood and slash debris left onsite.

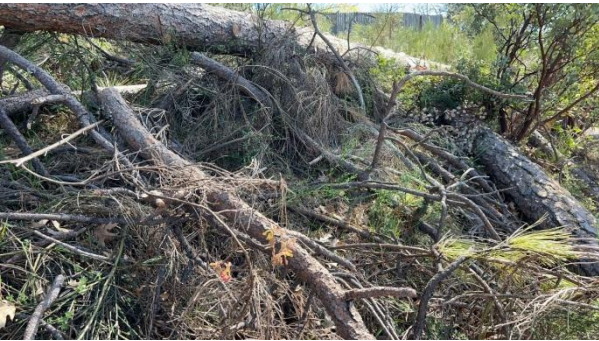
Photo 5: Additional photo of the pile of wood and slash debris left onsite.

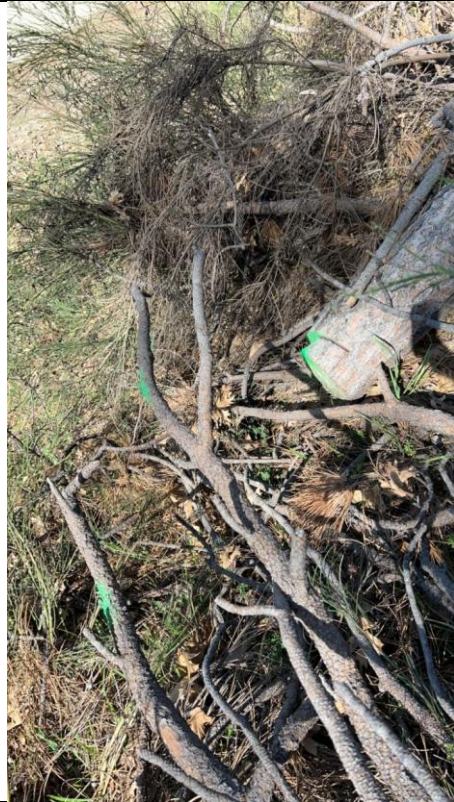
Photo 6: Additional photo of the pile of wood and slash debris left onsite.
