NOTICE OF NON-PERFORMANCE

INSPECTION REPORT

Electrical Corporation:	PG&E
Report Number:	NON_ESD_PGE_RGA_20260407_1108
Inspector:	Ricardo Garcia
WMP Year Inspected:	2025
Quarterly Data Report (QDR) Referenced:	Quarter 4 (Q4) 2025
Inspection Selection:	Energy Safety inspected the locations based on PG&E’s Q4 QDR.
Relevant WMP Initiative(s):	8.2.3.2 Wood and Slash Management
Date of inspection:	April 7, 2026
City and/or County of Inspection:	Robinson Mill, California

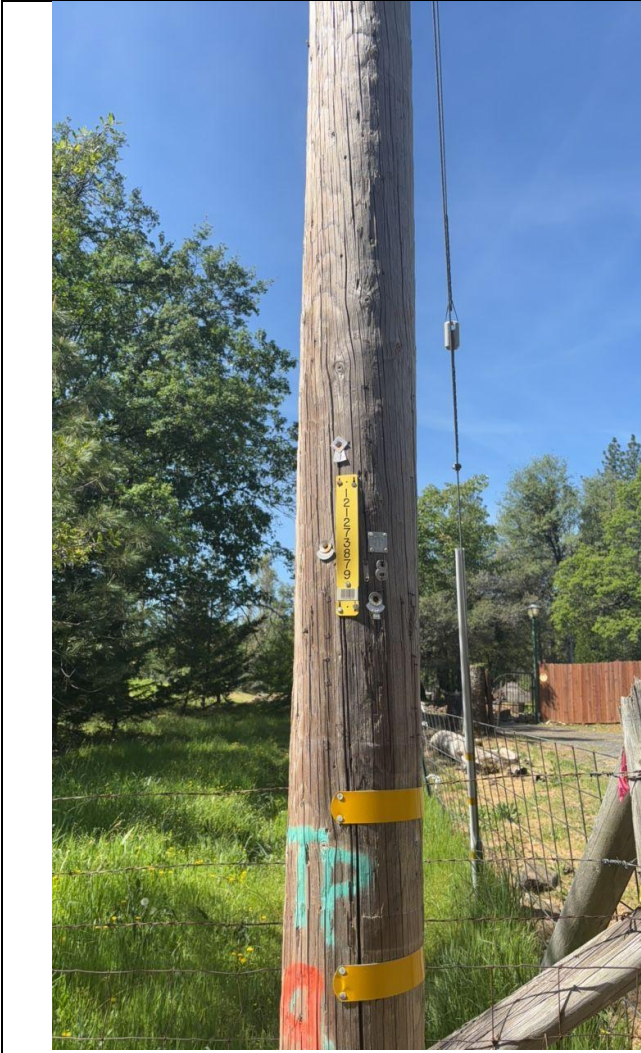
Photo 1: Photo of pole ID 121273879

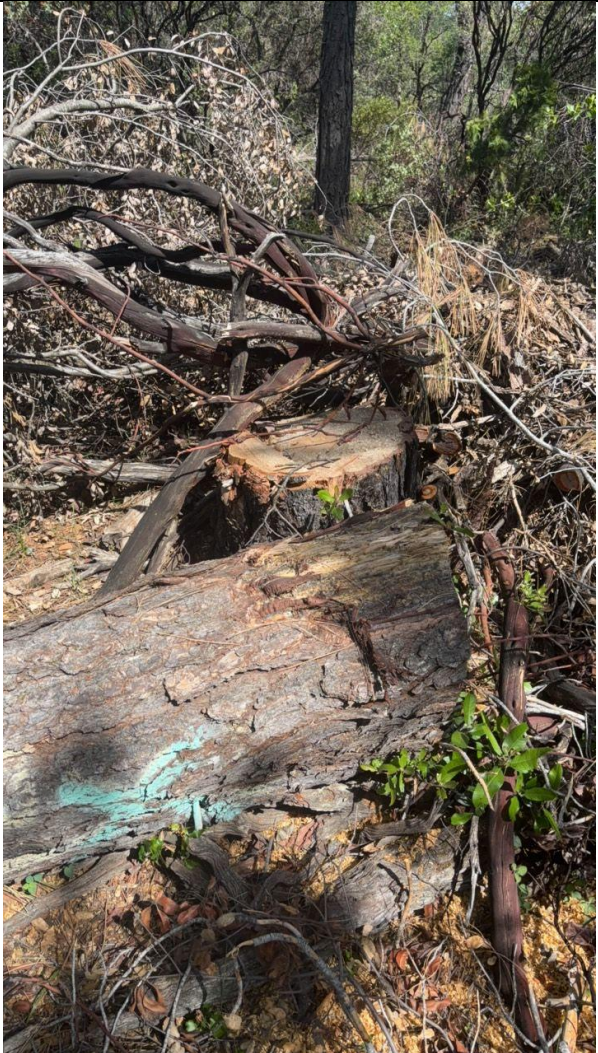
which are attached to this report. Photo 1 depicts pole ID 121273879. Photo 2 depicts the removed grey pine tree. Photos 3 and 4 depict the pile of wood and slash debris left on site.

Photo 2: Photo of the cut grey pine tree.

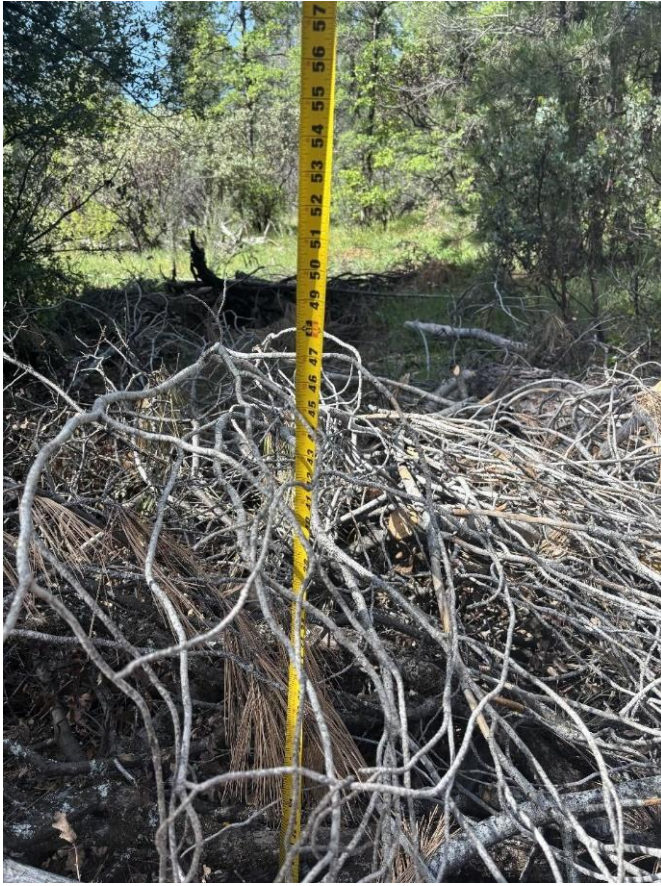
Energy Safety considers this deficiency "Moderate" because the slash pile is over 18-inches in height, creating a potential fuel source for wildfire.

On April 7, 2026, Energy Safety conducted an inspection of PG&E's WMP initiatives in the vicinity of Robinson Mill, California. During the inspection, Energy Safety observed woody debris left onsite near pole ID 121273879 and coordinates 39.48531, -121.32264 along Robinson Mill Road. PG&E's 2025 Q4 data reported that it completed work on December 15, 2025, under its Tree Removal Inventory Program, under VMP ID VP_AT114-H05_3580428_2022, where an 18-inch diameter at breast height, 80-foot-tall gray pine tree was cut down. Energy Safety's inspector observed slash and woody debris from the vegetation management remained onsite, in piles approximately four feet tall. The inspector's observations are documented in Exhibit A photographs,

Photo 3: Photo of the pile of wood and slash debris measuring approximately four feet in height.

Deficiency 1. Energy Safety observed that in implementing 2025 WMP initiative 8.2.2.2.4, PG&E failed to adhere to its protocol of wood and slash management near pole ID 121273879 and Vegetation Management ID VP_AT114-H05_3580428_2022 at coordinates 39.48531, -121.32264. Energy Safety considers this non-performance to be in the Moderate risk category. PG&E must complete a corrective action for this non-performance by two months from the date of this notice.¹

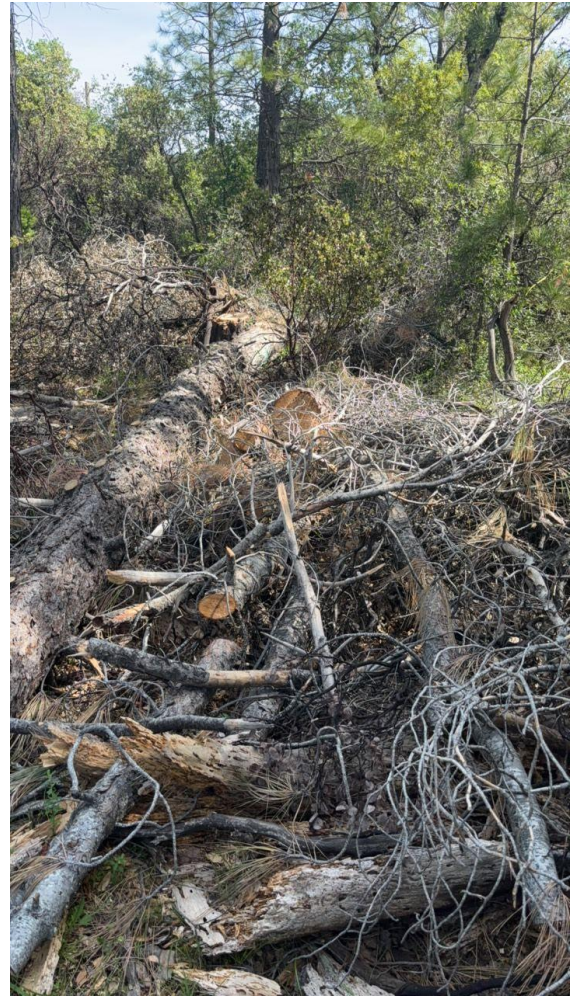
Photo 4: Photo of the pile of wood and slash debris.
