NOTICE OF NON-PERFORMANCE

INSPECTION REPORT

Electrical Corporation:	Pacific Gas and Electric Company
Report Number:	PAD_PGE_BKA_20251105_1153
Inspector:	Babak Kaviani
WMP Year Inspected:	2025
Quarterly Data Report (QDR) Referenced:	Quarter (Q2)
Inspection Selection:	Energy Safety viewed the contents of the Q2 QDR and performed an analysis that resulted in the selection of the WMP initiatives and locations referenced in this report.
Relevant WMP Initiative(s):	8.1.2.1 - Covered conductor installation - Distribution
Date of Inspection:	November 5, 2025
City and/or County of Inspection:	Greenwood, El Dorado County
Inspection Purpose:	Assess the accuracy of Pacific Gas and Electric Company’s QDR data, completeness of its work, and performance of WMP requirements.

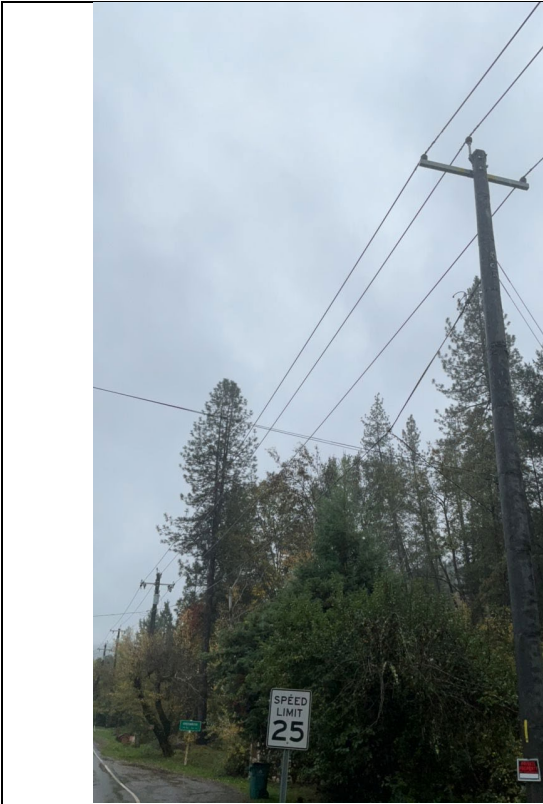
G1mg1: Overall Structure

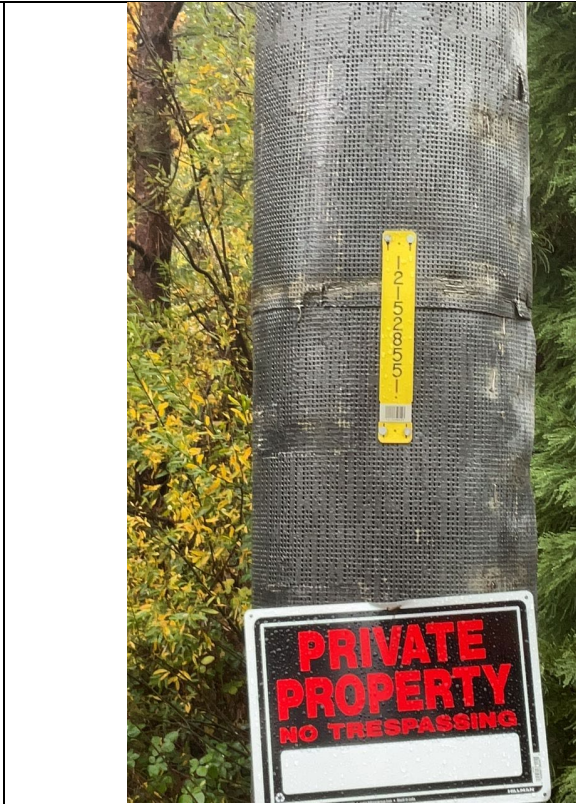
G1mg2: Structure ID

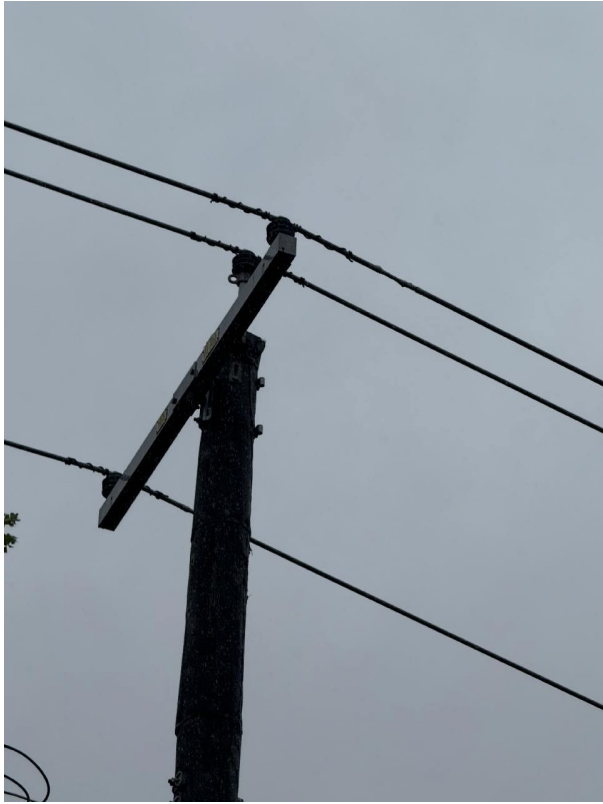
On Pole ID 121528551, Grid Hardening ID 35293664 at 4010 Main St, Greenwood, CA, 95635, USA, 38.8985125146323, -120.914299826552, the inspector observed that a portion of the covered conductor on the two outer phases on the southeast side of the pole was taped due to damage to the insulator. The inspector's observation is documented in Deficiency 1 photographs, which are attachments to this report.

Photo numbers IA1Img1, IA1Img2, and IA1Img3 depict tape applied over a portion of the covered conductor on the southeast side of the pole. In the 2025 Q2 Quarterly Data Report submission, PG&E reported that work on WMP initiative 8.1.2.1 -Covered Conductor Installation – Distribution was completed at this location.

IA1Img1: Overall view showing tape applied over the conductor on the southeast side of the pole 121528551.

Deficiency 1. Energy Safety observed that in implementing its 2025 WMP initiative related to Grid Design and System Hardening, PG&E failed to install covered conductor on Pole ID 121528551, Grid Hardening ID 35293664 at coordinates 38.8985125146323, -120.914299826552. Energy Safety considers this non-performance to be in the Minor risk category. PG&E must complete a corrective action for this deficiency by 12 months of this notice.

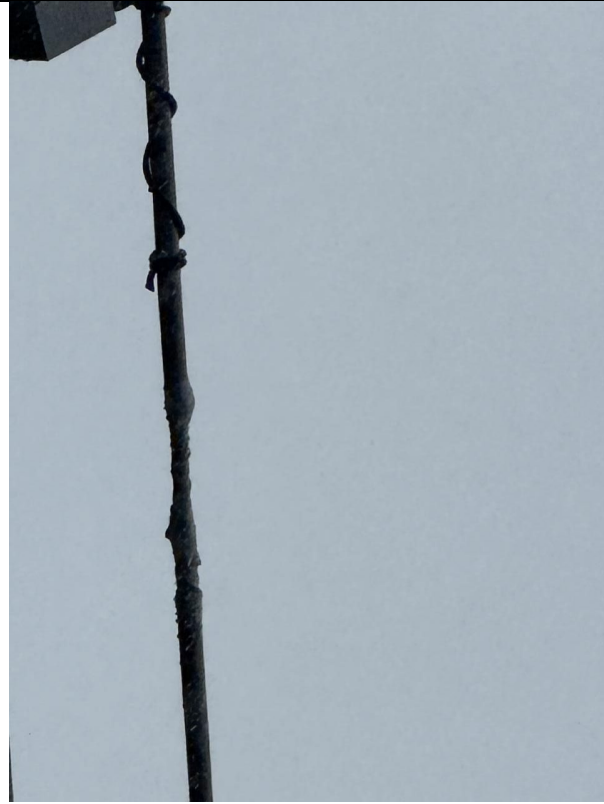
IA1Img2: Close up view of one phase showing tape applied over the conductor on the southeast side of the pole 121528551

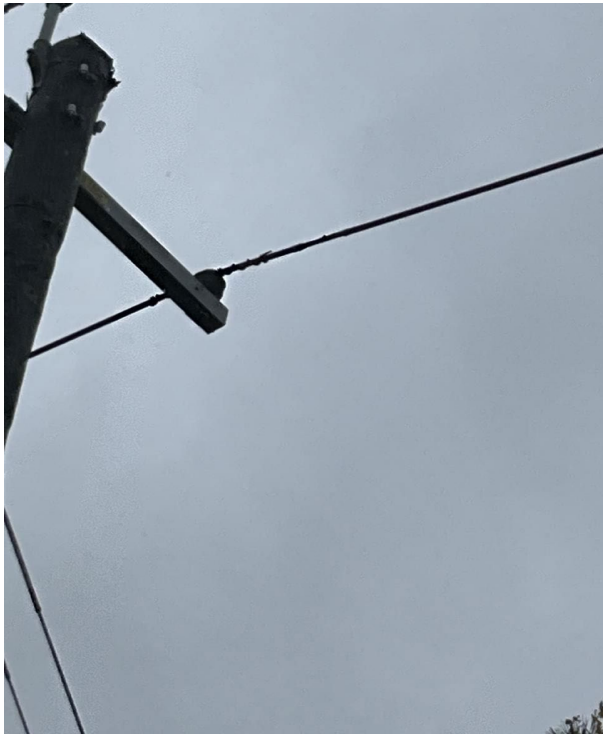
IA1Img3: Another phase showing tape applied over the conductor on the southeast side of the pole 121528551
