SUBJECT: Southern California Edison Company's Response to Notice of Non-Performance (NON_ESD_SCE_GCA_20260326_0845)

Notice	#	Structures
NON_ESD_SCE_GCA_20260326_0845	1	At coordinates 34.150924, -118.746338 and Vegetation Management ID 1WLRn0000019PD7OAM-2025_4.

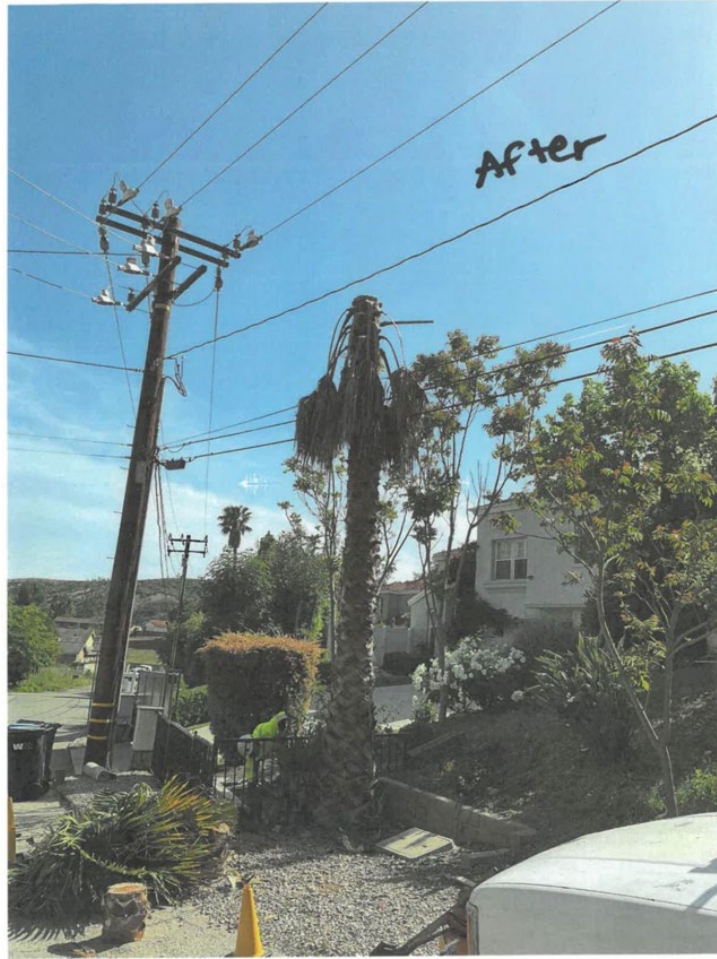
Energy Safety’s Notice states that SCE failed to implement its 2025 WMP initiative 8.2.3.3.1 Expanded Clearing (VM-7), which requires compliance with Public Resource Code section 4293, by not maintaining a four-foot clearance distance around the primary conductors near pole ID 4848157E, at coordinates 34.150924, -118.746338 and Vegetation Management ID 1WLRn0000019PD7OAM-2025_4.

On April 15, 2026, OEIS issued a Notice of Non-Performance related to this palm. In response, SCE promptly dispatched an inspector on the same day to reassess the condition of the palm. Based on the findings, follow-up mitigation was completed on April 16, 2026, to address the identified concerns (see image below).

For additional context, this palm was last inspected on August 5, 2025, as part of a routine inspection cycle. Mitigation work was completed on November 19, 2025, which included a crown reduction to achieve clearance in accordance with applicable vegetation management standards.
