SUBJECT: Southern California Edison Company's Response to Notice of Non-Performance (NON_ESD_SCE_RGA_20260324_1433)

Notice	#	Structures
NON_ESD_SCE_RGA_20260324_1433	1	Near coordinates 34.079208, -118.687734

Energy Safety's Notice states that SCE failed to implement its 2025 WMP initiative 8.2.3.3.1 Distribution Expanded Clearing by not maintaining a four-foot clearance distance around the primary conductors near coordinates 34.079208, -118.687734

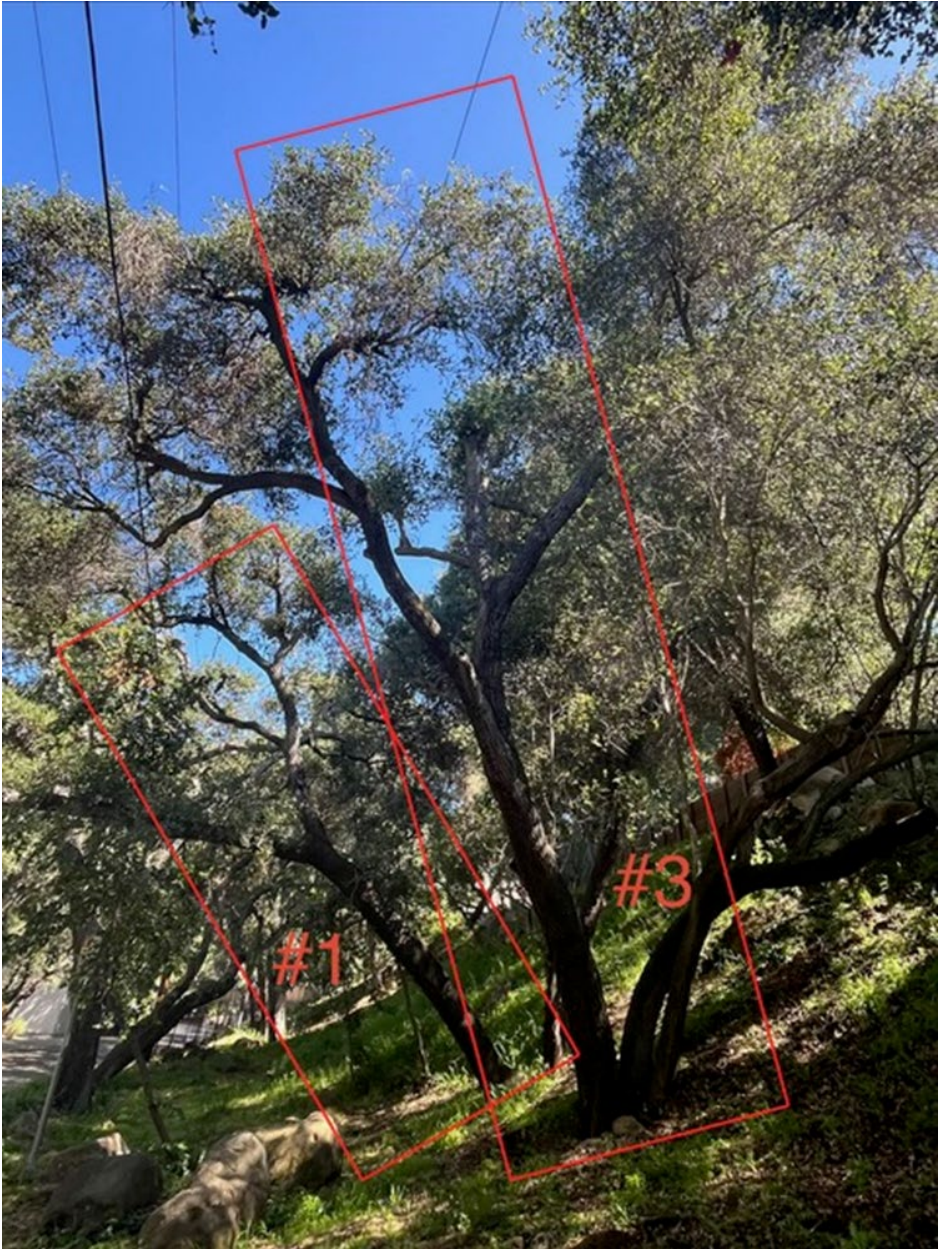
On April 15, 2026, OEIS issued a Notice of Non-Performance related to this tree #3 as shown below. In response, SCE promptly dispatched an inspector on the same day to reassess the condition of the oak. Based on the findings, follow-up mitigation was completed on April 16, 2026, to address the identified concerns (see image below).²

² Although clearance is difficult to ascertain from the photo angle, mitigation and clearance was achieved.

The additional work consisted of trimming to restore required clearances while maintaining compliance with Santa Monica Mountains Local Coastal Program (SMMPLCP) pruning restrictions.

For additional context, this oak tree was last inspected on November 12, 2025, as part of a routine inspection cycle. Mitigation work was completed on January 8, 2026, which included a directional prune to achieve clearance in accordance with applicable

vegetation management standards. Due to its species and location, the tree is subject to SMMPLCP pruning restrictions, which limit the extent of allowable trimming.
