SUBJECT: Southern California Edison Company's Response to Notice of Non-Performance (NON_ESD_SCE_RGA_20260324_1443)

SCE Response

Notice	#	Structures
NON_ESD_SCE_RGA_20260324_1443	1	Near coordinates 34.079224, -118.6878.

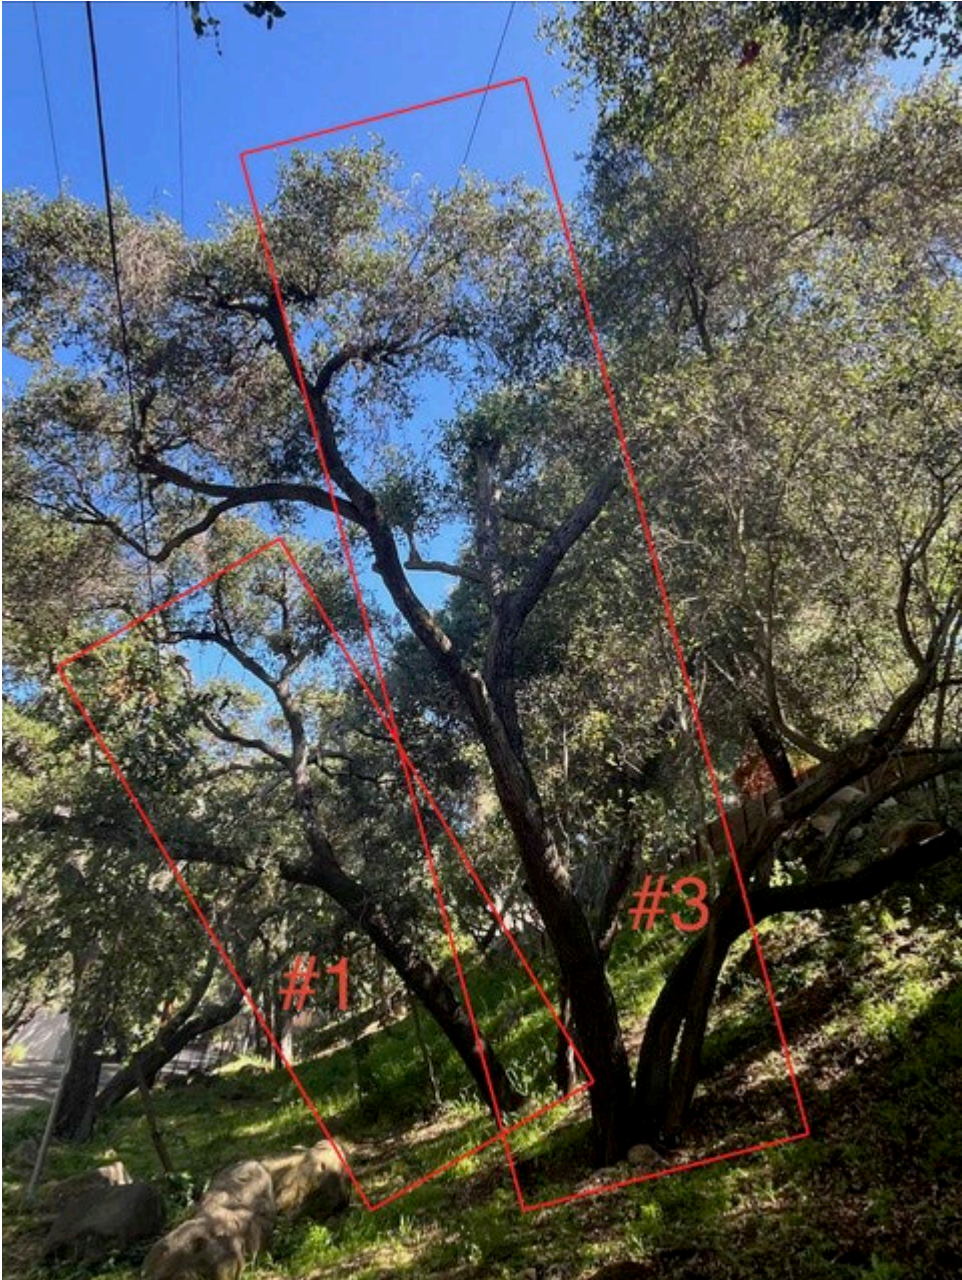
Energy Safety’s Notice states that SCE failed to implement its 2025 WMP initiative 8.2.3.3.1 Distribution Expanded Clearing by not maintaining a four-foot clearance distance around the primary conductors near coordinates 34.079224, -118.6878.

On April 15, 2026, OEIS issued a Notice of Non-Performance related to this tree #1 as shown below. In response, SCE promptly dispatched an inspector on the same day to reassess the condition of the oak. Based on the findings, follow-up mitigation was completed on April 16, 2026, to address the identified concerns (see image below).²

² Although clearance is difficult to ascertain from the photo angle, mitigation and clearance was achieved.

The additional work consisted of targeted trimming to restore required clearances while maintaining compliance with the Santa Monica Mountains Local Coastal Program (SMMPLCP) pruning restrictions.

For additional context, the oak tree was last inspected on November 12, 2025, as part of a routine inspection cycle. Mitigation work was subsequently completed on December 10, 2025, which included directional prunes to achieve clearance in accordance with applicable vegetation management standards. Due to its species and location, the tree

is subject to SMMPLCP pruning restrictions, which limit the extent of allowable trimming.
