SUBJECT: Southern California Edison Company's Response to Notice of Non-Performance (NON_ESD_SCE_GCA_20260326_0756)

Notice	#	Structures
NON_ESD_SCE_GCA_20260326_0756	1	Near pole ID 4382726E and coordinates 34.15106162767872, - 118.7405848910039.

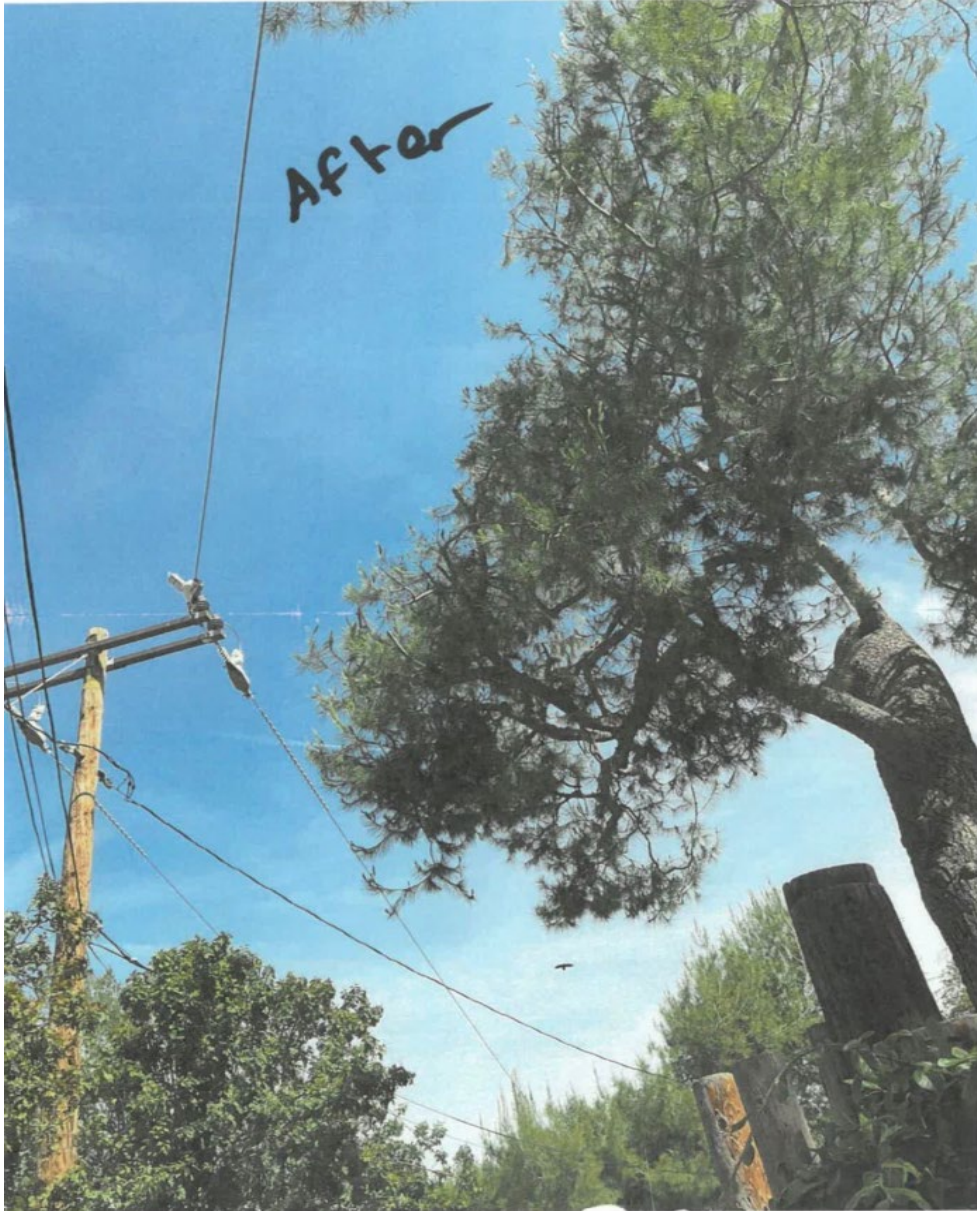
Energy Safety’s Notice states that SCE failed to implement its 2025 WMP initiative 8.2.3.3.1 Expanded Clearing (VM-7), which requires compliance with Public Resource Code section 4293, by not maintaining a four-foot clearance distance around the primary conductors near pole ID 4382726E and coordinates 34.15106162767872, - 118.7405848910039.

On April 15, 2026, OEIS issued a Notice of Non-Performance related to this tree. In response, SCE promptly dispatched an inspector on the same day to reassess the condition of the pine tree. Based on the findings, follow-up mitigation was completed on April 16, 2026, to address the identified concerns (see image below).²

² Although clearance is difficult to ascertain from the photo angle, mitigation and clearance was achieved.

For additional context, this pine tree was last inspected on August 5, 2025, as part of a routine inspection cycle. Mitigation work was completed on November 25, 2025, which included a directional prune to achieve clearance in accordance with applicable vegetation management standards.
