NOTICE OF NON-PERFORMANCE

INSPECTION REPORT

Electrical Corporation:	Southern California Edison Company
Report Number:	PAD_SCE_CYA_20260128_1511
Inspector:	Cecilia Yaniz
WMP Year Inspected:	2025
Quarterly Data Report (QDR) Referenced:	Quarter 3 (Q3)
Inspection Selection:	Energy Safety viewed the contents of the Q3 QDR and performed an analysis that resulted in the selection of the WMP initiatives and locations referenced in this report.
Relevant WMP Initiative(s):	8.1.3.1 - Distribution Detailed Inspections and Remediations (IN-1.1)
Date of Inspection:	January 28, 2026
City and/or County of Inspection:	Canyon Country, Los Angeles County
Inspection Purpose:	Assess the accuracy of Southern California Edison Company’s QDR data, completeness of its work, and performance of WMP requirements.

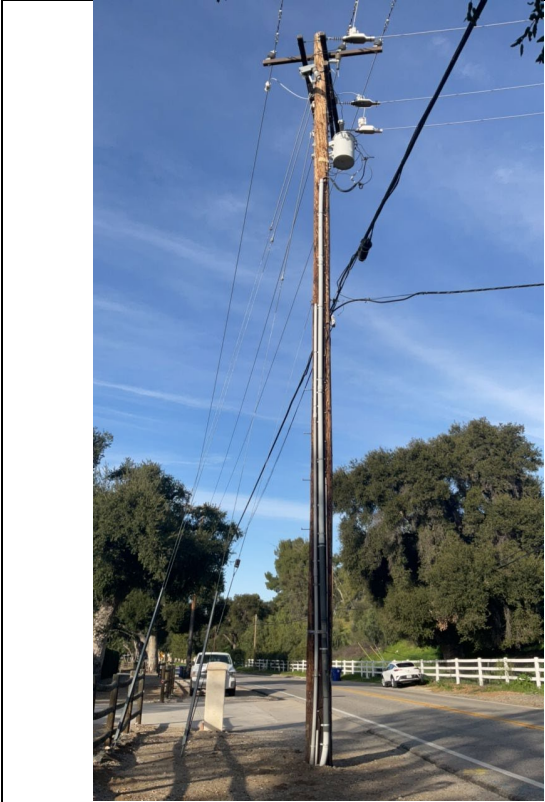
IA1Img1: Overall Structure

On Pole ID 4925994E, Grid Hardening ID 414606467-4925994E at 27505 Sand Canyon Rd, Canyon Country, CA, 91387, USA, 34.4078317001898, -118.420343456959, the inspector observed acorns were present within the avian protection guard. The inspector's observation is documented in Deficiency 1 photographs, which are attachments to this report. Photo numbers IA1Img1, IA1Img2, IA1Img3 and IA1Img4 depict that the avian cover was filled with acorns.

1. Per information submitted by SCE to Energy Safety, an inspector observed acorns in multiple avian protection guards at the location in April 2025.
2. Southern California Edison Company's 2025 Quarter 3 QDR identified this location as having completed work under 2025 WMP initiative number 8.1.3.1 Distribution Detailed Inspections and Remediations, related to the condition of multiple avian protection guards being filled with acorns.
3. One of the avian protection covers was filled with acorns at the time of Energy Safety's inspection.

Deficiency 1. Energy Safety observed that in implementing 2025 WMP initiative 8.1.3.1 - Distribution High Fire Risk-Informed (HFRI) Inspections and Remediations (IN-1.1), SCE failed to complete the remediation of multiple avian guards with obstructions on Pole ID 4925994E, Grid Hardening ID 414606467-4925994E at coordinates 34.4078317001898, -118.420343456959. Energy Safety considers this non-performance to be in the Minor risk category. SCE must complete a corrective action for this deficiency by 12 months from the date of this notice.¹

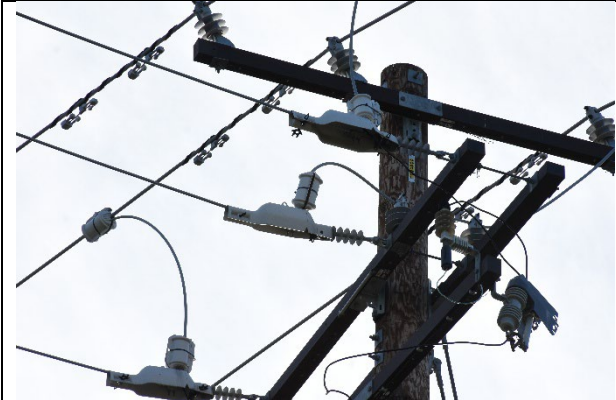
IA1Img3: Avian protection covers overview

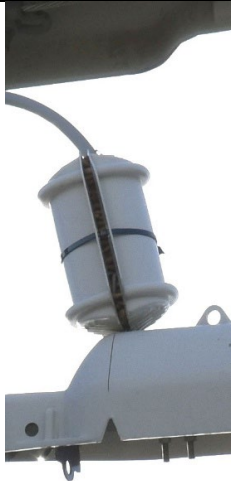
IA1Img4: View of acorns inside avian protection cover
