NOTICE OF NON-PERFORMANCE

On February 25, 2026, Energy Safety conducted an inspection of Southern California Edison Company's WMP initiatives in the vicinity of the city of Temecula, California. The inspection report is enclosed herewith. Energy Safety found the following deficiencies:

INSPECTION REPORT

Electrical Corporation:	Southern California Edison Company
Report Number:	PAD_SCE_LOK_20260225_1112
Inspector:	Lovepreet Kaur
WMP Year Inspected:	2025
Quarterly Data Report (QDR) Referenced:	Quarter 3 (Q3)
Inspection Selection:	Energy Safety viewed the contents of the Q3 QDR and performed an analysis that resulted in the selection of the WMP initiatives and locations referenced in this report.
Relevant WMP Initiative(s):	8.1.3.1 - Distribution Detailed Inspections and Remediations (IN-1.1)
Date of Inspection:	February 25, 2026
City and/or County of Inspection:	Temecula, Riverside County
Inspection Purpose:	Assess the accuracy of Southern California Edison Company’s QDR data, completeness of its work, and performance of WMP requirements.

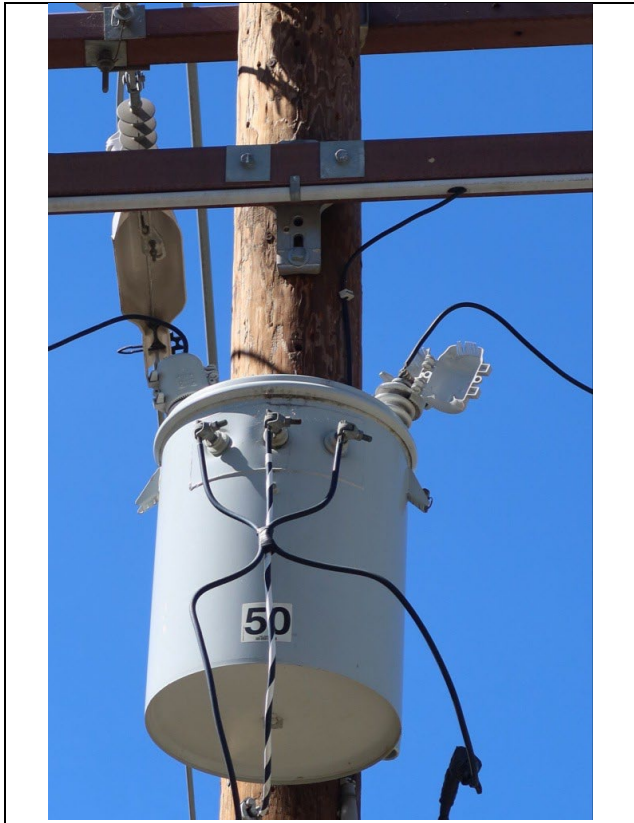
On Pole ID 2091164E, Grid Hardening ID 414478355-2091164E at 27070 Avenida del Oro, Temecula, CA, 92590, USA, 33.4996301120858, -117.194118064684, the inspector observed that the transformer bushing cover was open. The inspector's observation is documented in Deficiency 1 photographs, which are attachments to this report. Photo numbers G1mg1, G1mg2, and G1mg3 depict an open transformer bushing cover.

1. Southern California Edison Company's work on 2025 WMP initiative number 8.1.3.1, Distribution Detailed Inspections and Remediations, identified that the remediation of missing transformer bushing caps was completed at the location.
2. The transformer bushing cover was left open.
3. SCE Distribution Construction Standard DC-535 states that "wildlife-safe power line construction standards are intended to protect lines from wildlife and vice versa by constructing sufficient phase-to-phase and phase-to-ground clearances as well as installing approved protective materials on high voltages lines and equipment. In addition, installing wildlife covers in the correct application will mitigate other contact-related faults from foreign materials."⁸

Glm3: Transformer bushing cover is open.

Deficiency 1. Energy Safety observed that in implementing 2025 WMP initiative 8.1.3.1 - Distribution High Fire Risk-Informed (HFRI) Inspections and Remediations (IN-1.1), SCE failed to complete the remediation of missing transformer bushing caps on Pole ID 2091164E, Grid Hardening ID 414478355-2091164E at coordinates 33.4996301120858, -117.194118064684. Energy Safety considers this non-performance to be in the Minor risk category. SCE must complete corrective action for this deficiency within 12 months from the date of the notice.¹
