## NOTICE OF NON-PERFORMANCE

# INSPECTION REPORT

Electrical Corporation:	Liberty
Report Number:	NON_ESD_LU_KJO_20260428_1248
Inspector:	Kelsea Jones
WMP Year Inspected:	2025
Quarterly Data Report (QDR) Referenced:	Quarter 4 (Q4) 2025
Inspection Selection:	Energy Safety inspected the locations based on Liberty’s Q4 QDR.
Relevant WMP Initiative(s):	8.2.3.4 Fall-In Mitigation
Date of inspection:	April 28, 2026
City and/or County of Inspection:	South Lake Tahoe, California

## Deficiency 1

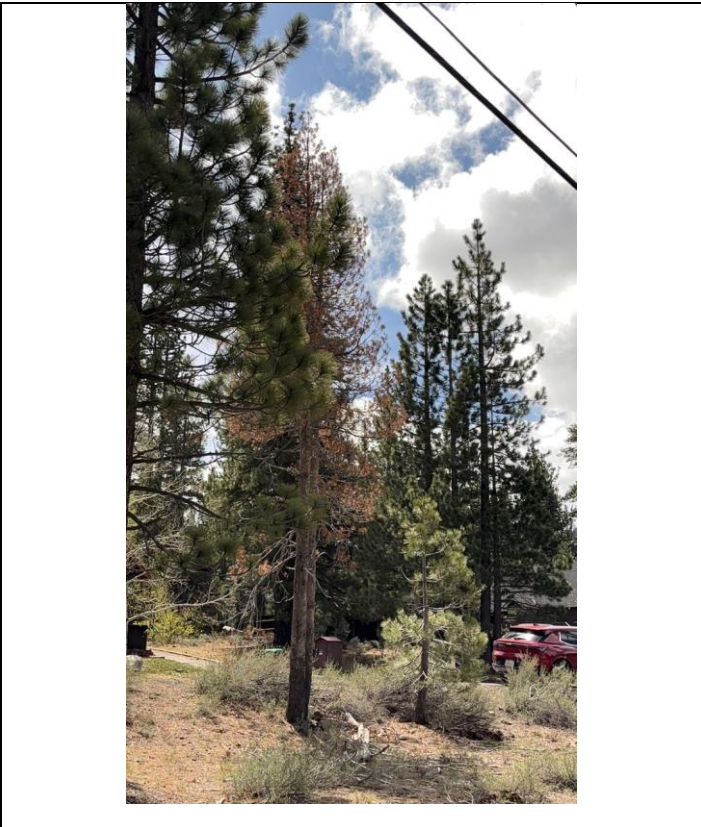
Energy Safety considers this deficiency as "Moderate" because Liberty has not removed the dying lodgepole pine tree located within striking distance of the conductors, consistent with the requirements of Public Resources Code section 4293. The existence of this tree presents an ongoing wildfire risk.

On April 28, 2026, Energy Safety conducted an inspection of Liberty's WMP's initiatives in the vicinity of South Lake Tahoe, California. During the inspection, Energy Safety identified a dying codominant lodgepole pine tree southeast of pole ID 259697 and near coordinates 38.84969752545917, -120.02454878367814 along Pomo Street. It is located within SRA. The tree is approximately 38 feet tall, with a combined diameter at breast height of 19 inches (one stem measuring 9 inches and the other 10 inches). The codominant lodgepole pine

stands approximately 31.7 feet from the conductors. It exhibits yellowing needles throughout the canopy and visible crown dieback. The inspector's observations are documented in Exhibit A photographs, which are attached to this report. Photo 1 depicts pole ID 259697 and other markings on the pole. Photos 2, 3 and 4 depict the dying codominant lodgepole pine tree.

**Photo 2:** Photo of the dying lodgepole pine located southeast of pole ID 259697.

Deficiency 1. Energy Safety observed that Liberty failed to implement its 2025 WMP initiative 8.2.3.4, which requires compliance with Public Resources Code section 4293, by not removing a dead, declining or dying tree near coordinates 38.84969752545917, -120.02454878367814. Energy Safety considers this non-performance to be in the Moderate risk category. Liberty must complete a corrective action for this non-performance by six months from the date of this notice.<sup>1</sup>

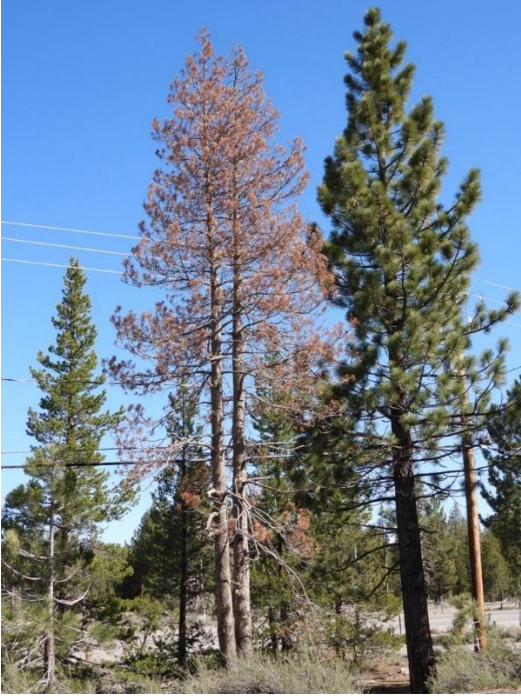
**Photo 3:** Photo of the dying lodgepole pine with codominant trunks. The photo was taken from Pomo Street. It exhibits yellowing needles throughout the canopy and visible crown dieback.

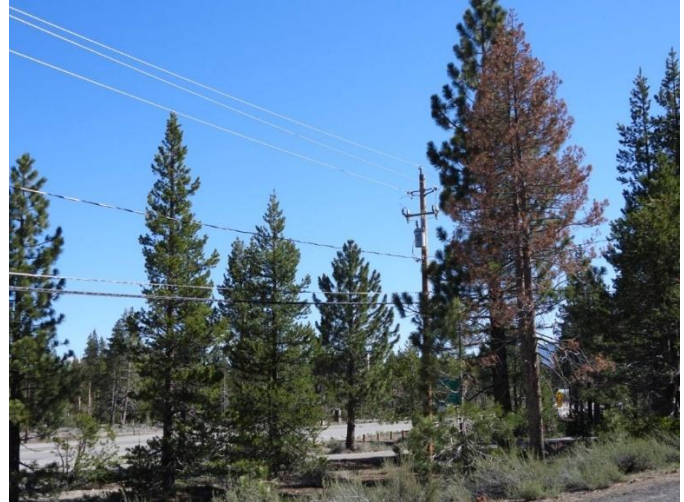
**Photo 4:** Photo of the dying lodgepole pine southeast of pole ID 259697. The photo was taken from Pomo Street.
