Liberty Utilities

NOTICE OF NON-PERFORMANCE

INSPECTION REPORT

Electrical Corporation:	Liberty
Report Number:	NON_ESD_LU_KJO_20260428_1334
Inspector:	Kelsea Jones
WMP Year Inspected:	2025
Quarterly Data Report (QDR) Referenced:	Quarter 4 (Q4) 2025
Inspection Selection:	Energy Safety inspected the locations based on Liberty’s Q4 QDR.
Relevant WMP Initiative(s):	8.2.3.4 Fall-In Mitigation
Date of inspection:	April 28, 2026
City and/or County of Inspection:	South Lake Tahoe, California

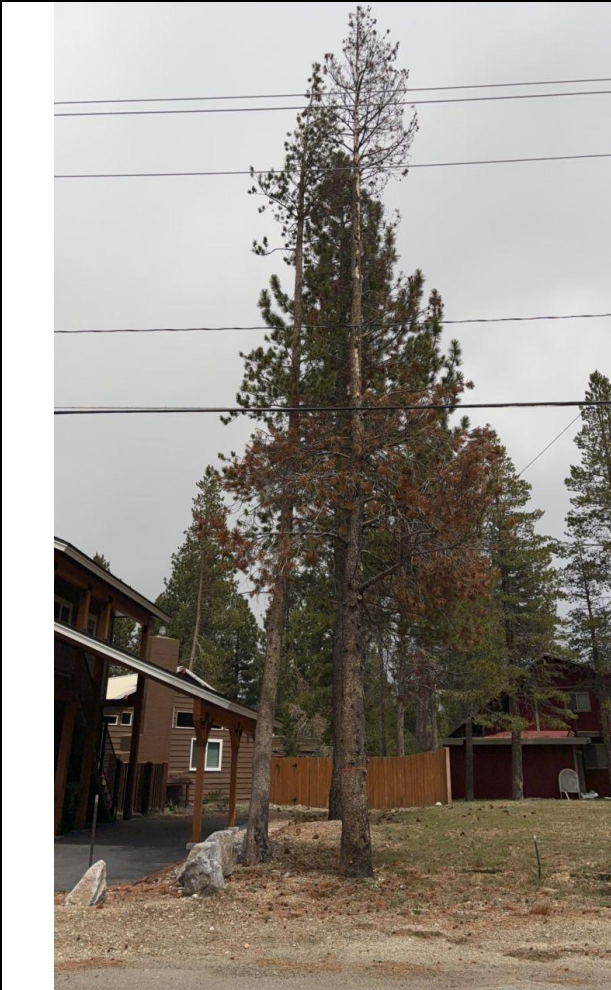
Energy Safety considers this deficiency as "Moderate" because Liberty has not removed the dying lodgepole pine tree located within striking distance of the conductors, consistent with the requirements of Public Resources Code section 4293. The presence of this tree presents an ongoing wildfire risk.

On April 28, 2026, Energy Safety conducted an inspection of Liberty's WMP's initiatives in the vicinity of South Lake Tahoe, California. During the inspection, Energy Safety identified a dying lodgepole pine tree east of pole ID 294763 and near coordinates 38.85421650951253, -120.01976566893579 near the intersection of Hopi Avenue and Arrowhead Avenue. It is located within SRA. The lodgepole pine has a diameter at breast height of 14 inches and is approximately 53 feet tall. It is located approximately four feet from the conductors. It exhibits yellowing needles throughout the canopy and visible crown dieback. The inspector's observations are

Photo 2: Photo of the dying lodgepole pine located south of the primary conductors.

Deficiency 1. Energy Safety observed that Liberty failed to implement its 2025 WMP initiative 8.2.3.4, which requires compliance with Public Resources Code section 4293, by not removing a dead, declining or dying tree near coordinates 38.85421650951253, -120.01976566893579. Energy Safety considers this non-performance to be in the Moderate risk category. Liberty must complete a corrective action for this non-performance by six months from the date of this notice.¹

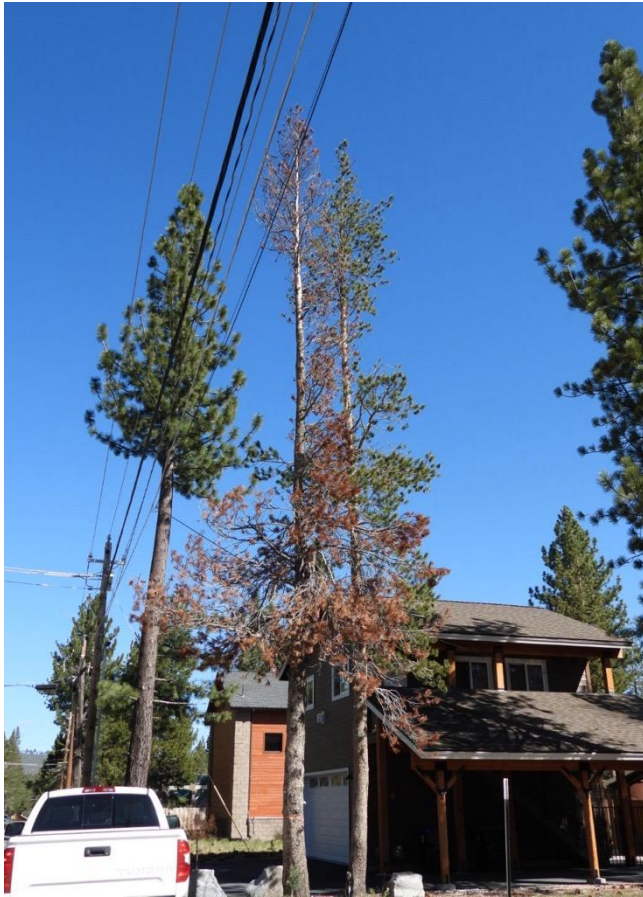
Photo 3: Photo of the dying lodgepole pine located east of pole ID 294763. It exhibits yellowing needles throughout the canopy and visible crown dieback.

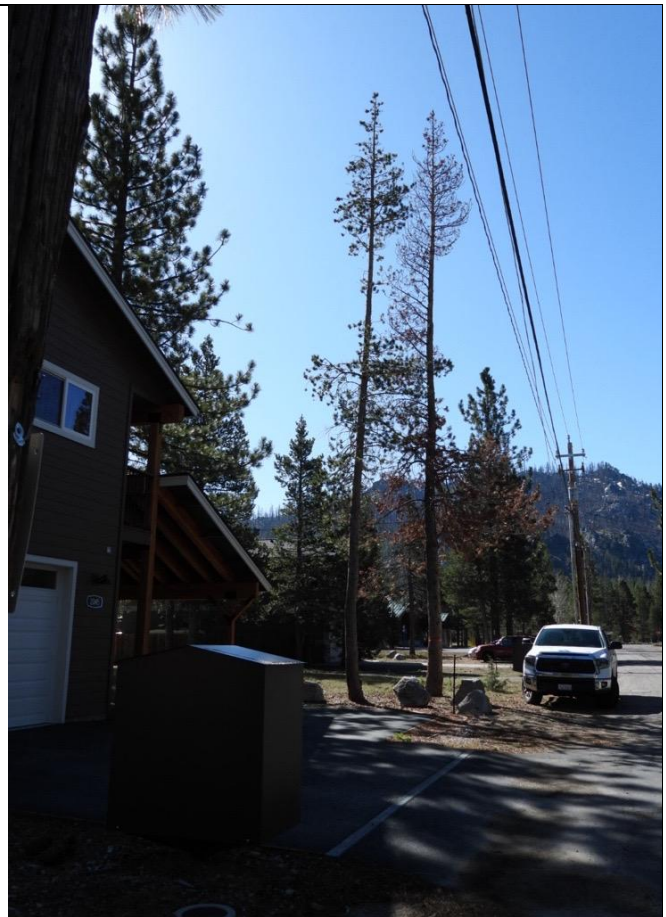
Photo 4: Photo of the dying lodgepole pine located east of pole ID 294763.
