## **NOTICE OF NON-PERFORMANCE**

# INSPECTION REPORT

Electrical Corporation:	PacifiCorp
Report Number:	NON_ESD_PC_MAZ_20260513_1021
Inspector:	Max Zazzeron
WMP Year Inspected:	2025
Quarterly Data Report (QDR) Referenced:	Quarter 4 (Q4) 2025
Inspection Selection:	Energy Safety inspected the locations based on PacifiCorp’s Q4 QDR.
Relevant WMP Initiative(s):	8.2.3.3 Fall-In Mitigation
Date of inspection:	May 13, 2026
City and/or County of Inspection:	Seiad Valley, California

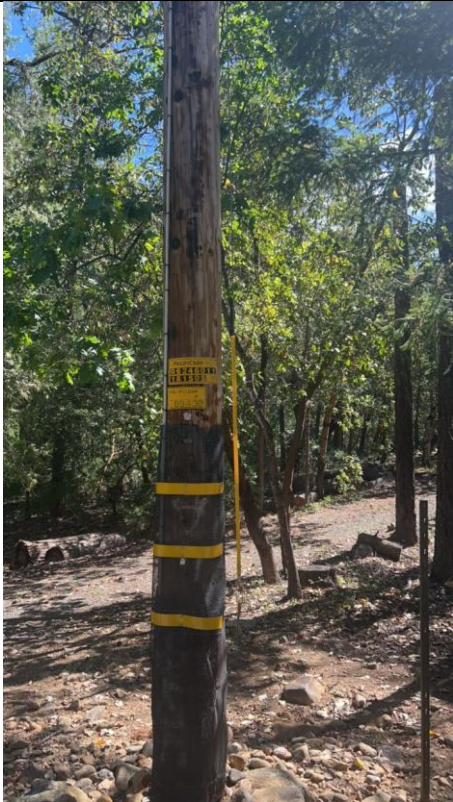
On May 13, 2026, Energy Safety conducted an inspection of PacifiCorp's WMP initiatives in the vicinity of Seiad Valley, California. During the inspection, Energy Safety identified a dying pine tree near pole ID06246011.0181505 and near coordinates 41.8311663903587, -123.172164580112 along Walker Creek Road. The pine tree is located within HFTD Tier 2 and SRA. The pine tree has a diameter at breast height of 22 inches and is approximately 80 feet tall. It is located approximately 15 feet northeast of the conductors at 0.5 span southeast of pole ID 06246011.0181505. It exhibits yellowing needles throughout the canopy and visible crown dieback. The inspector's observations are documented in Exhibit A photographs, which are attached to this report. Photo 1 depicts pole ID 06246011.0181505. Photos 2, 3, and 4 depict the dying pine tree.

Photo 2: Photo of pole ID 06246011.0181505.

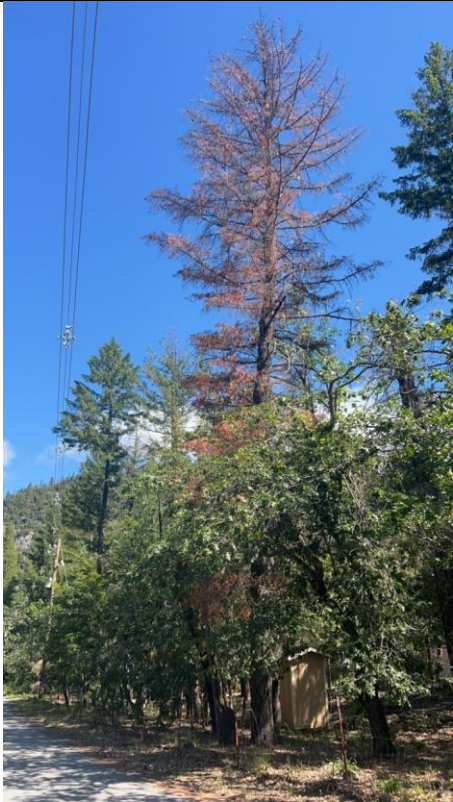
Energy Safety considers this deficiency as "Moderate" because PacifiCorp has not removed the dying pine tree located within striking distance of conductors, consistent with the requirements of Public Resources Code section 4293. The existence of this tree presents an ongoing wildfire risk.

Photo 2: Photo of the dying pine tree with yellowing needles throughout the canopy and visible crown dieback.

Deficiency 1. Energy Safety observed that PacifiCorp failed to implement its 2025 WMP initiative 8.2.3.3 Fall-In Mitigation, by not removing a dead, rotten, or diseased tree near coordinates 41.8311663903587, -123.172164580112. Energy Safety considers this non-performance to be in the Moderate risk category. PacifiCorp must complete a corrective action for this non-performance by six months from the date of this notice.<sup>1</sup>

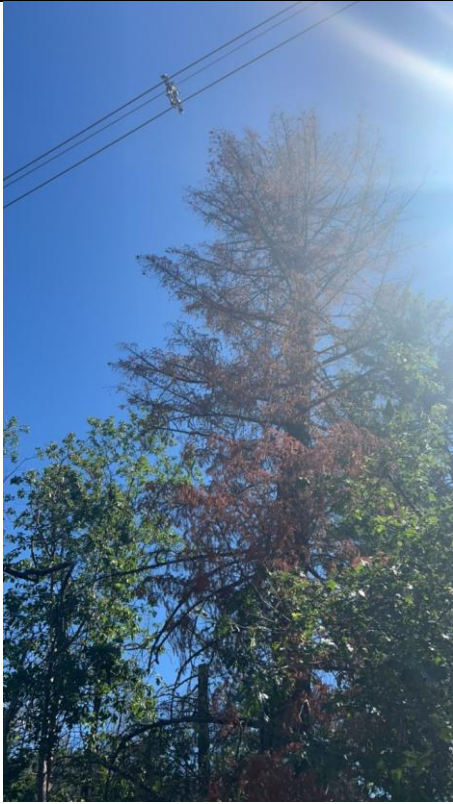
Photo 3: Photo of the dying pine tree located approximately 15 feet northeast of the primary conductors.

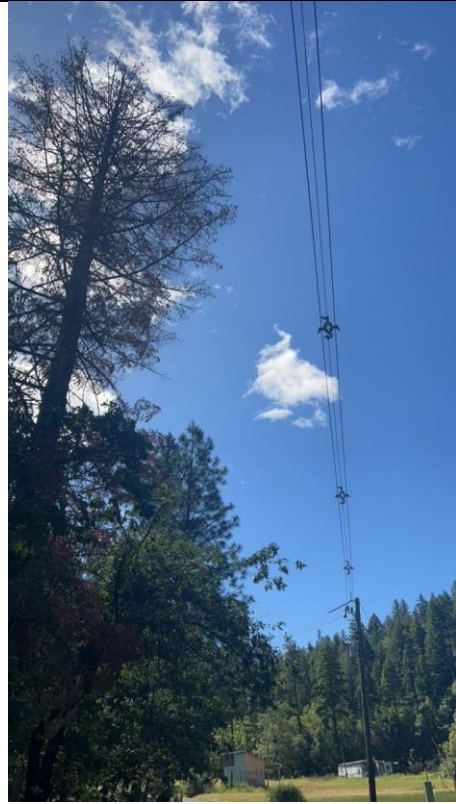
Photo 4: Photo of the dying pine tree located southeast of pole ID 06246011.0181505.
