**SUBJECT:** Southern California Edison Company's Response to Notice of Non-Performance (NON\_PAD\_SCE\_LOK\_20260225\_1112)

Notice	#	Structures
NON_PAD_SCE_LOK_20260225_1112	1	2091164E

Energy Safety’s Notice states that in implementing 2025 WMP initiative 8.1.3.1 - Distribution High Fire Risk-Informed (HFRI) Inspections and Remediations (IN-1.1), SCE failed to complete the remediation of missing transformer bushing caps on Pole ID 2091164E, Grid Hardening ID 414478355-2091164E at coordinates 33.4996301120858, -117.194118064684.

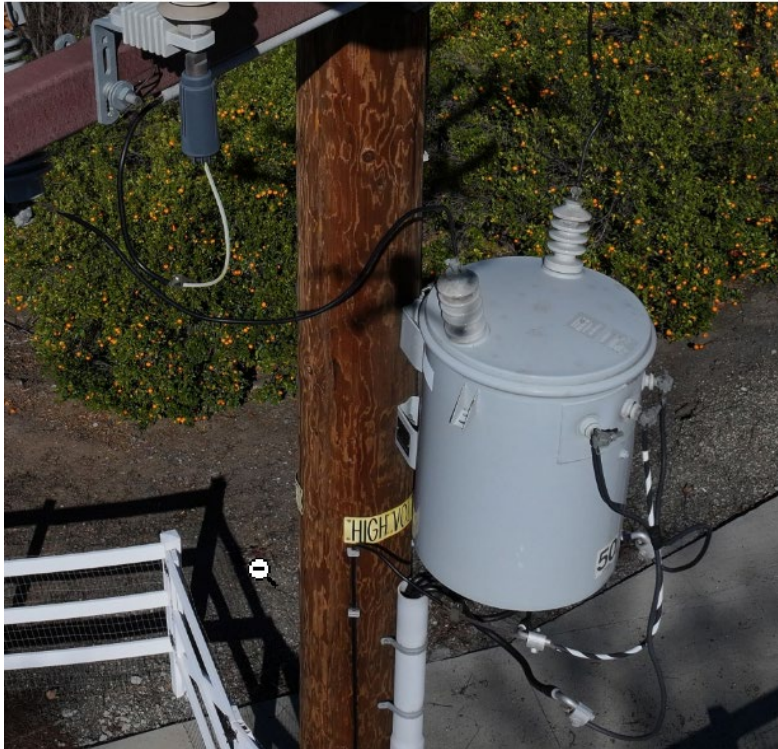
SCE confirms that notification #414478355 to remove acorns from the connector covers on structure 2091164E was completed on July 8, 2025.

During a subsequent aerial inspection conducted on March 5, 2026, SCE observed that a transformer bushing cap on the same structure was open. SCE confirms that this condition was newly identified at the time of the March 5, 2026 inspection and did not relate to the scope of notification #414478355 (Photo 1), which was limited to the removal of acorns from connector covers.

**Bushing Cap Closed (Photo from Notification #414478355, July 8, 2025)**

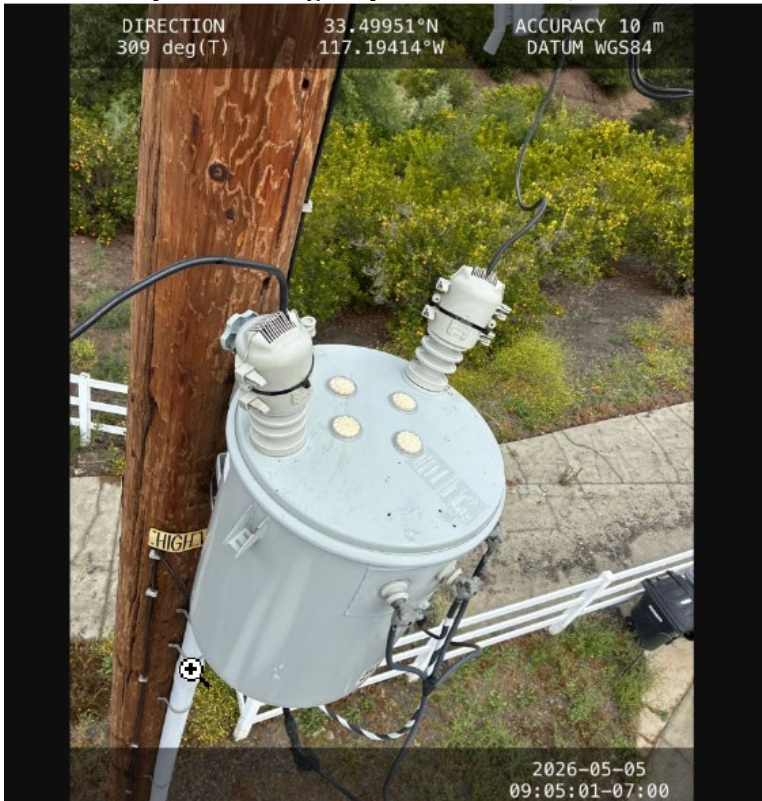
**Photo 2: Open Bushing Cap Remediation, Notification #415189667, May 5, 2026**

Following identification of the open bushing cap condition, notification #415189667 was created, and remediation was completed on May 5, 2026. Please see Photo 2 below.
