## NOTICE OF NON-PERFORMANCE

# INSPECTION REPORT

| Report Number: | PAD_SCE_SIS_20260617_1224 |
| City and/or County of Inspection: | Corona, Riverside County |

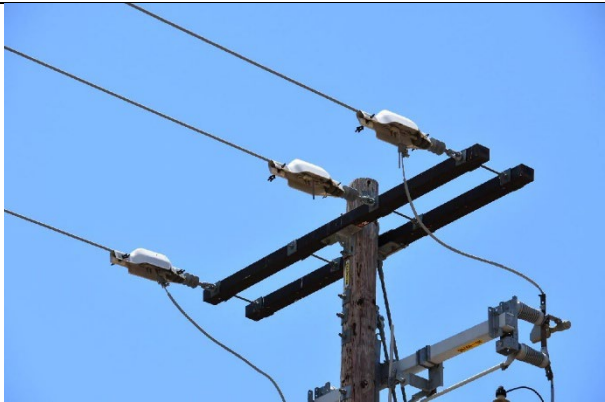
In the 2025 Q4 Quarterly Data Report Submission, Southern California Edison Company reported that work to remediate missing connection covers was completed at Structure ID 4433322E, Grid Hardening ID 414433095-4433322E at 3950 S. Main St., Corona, CA, 92882, 33.827317849068, -117.576067920235. At this location, the inspector observed that the primary connection covers were missing. The inspector's observation is documented in Deficiency 1 photographs, which are attached to this report. Photo numbers Asset Image 1, Asset Image 2, and Asset Image 3 depict that the connection covers are missing.

1. Southern California Edison Company's 2025 WMP initiative number 8.1.3.1 Distribution Detailed Inspections and Remediations work identified that the replacement of missing connection covers was complete at this location.
2. The inspector observed that connection covers were missing.

Asset Image 1: Missing connection covers

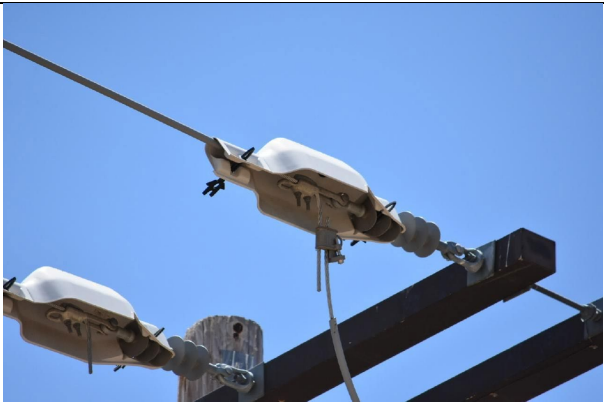
Asset Image 2: Missing connection cover

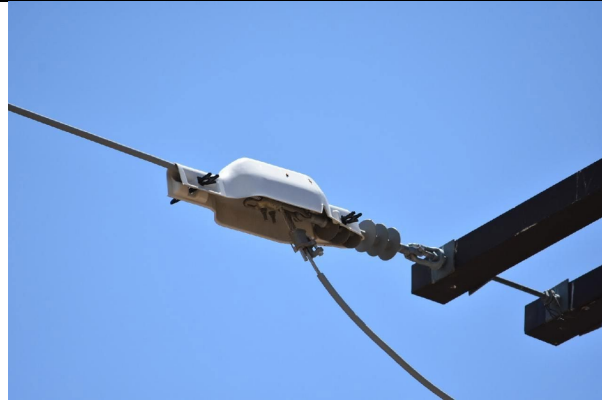
**Asset Image 3:** Missing connection cover
