## **NOTICE OF NON-PERFORMANCE**

# INSPECTION REPORT

| Report Number: | PAD_SCE_SIS_20260617_1231 |

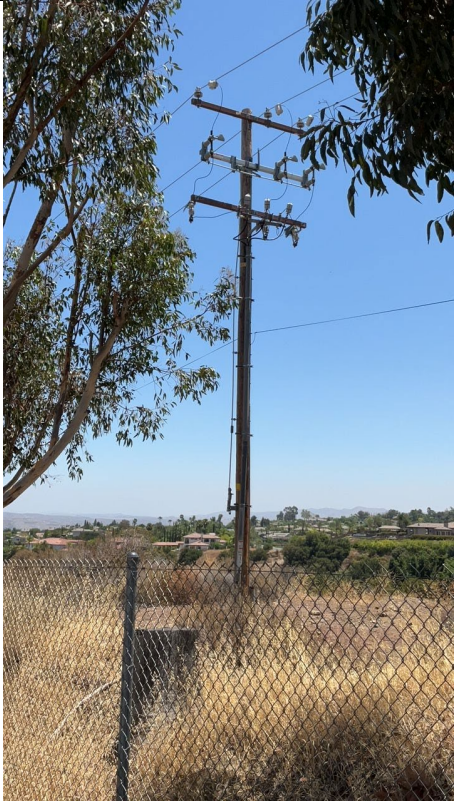
| <b>General Image 1:</b> Overall Structure | <b>General Image 2:</b> Structure ID |

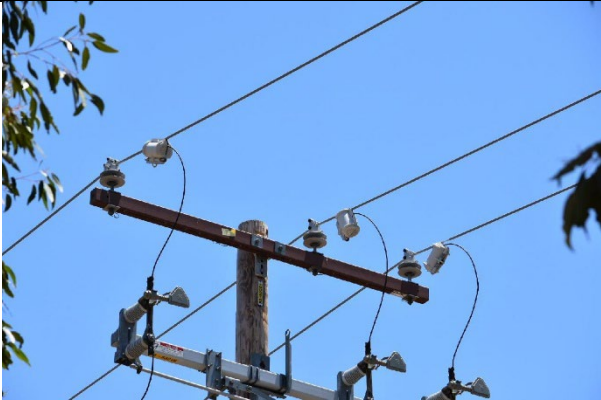
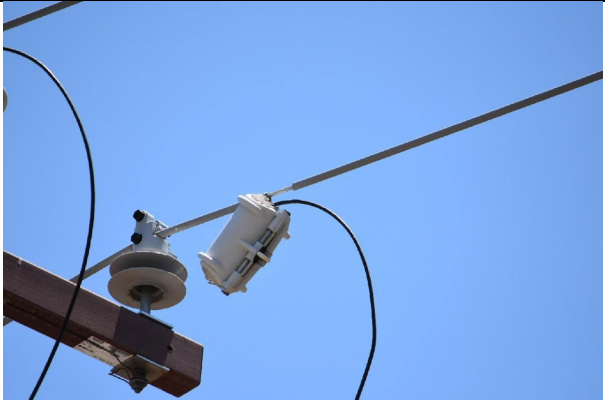
| Deficiency # | Structure ID | Grid Hardening ID | Lat/Long | HFTD | Initiative Number | Severity | Deficiency Description |
|---|---|---|---|---|---|---|---|
| Deficiency 1 | 1904215E | 414433083-1904215E | 33.8277250445338, -117.575228522755 | Tier 2 | 8.1.3.1 - Distribution Detailed Inspections and Remediations (IN-1.1) | Minor | Failure to complete replacing missing avian protection cover |

In the 2025 Q4 Quarterly Data Report Submission, Southern California Edison Company reported that work to replace missing covers under its Distribution Remediation WMP initiative was completed at Structure ID 1904215E, Grid Hardening ID 414433083-1904215E at 3230 Manning Ave. Corona, CA, 92882, 33.8277250445338, -117.575228522755. At this location, the inspector observed that the primary tab cover was dislodged and the bare conductor was exposed. The inspector's observation is documented in Deficiency 1 photographs, which are attachments to this report. Photo numbers Asset Image 1 and Asset Image 2 depict that primary conductor tab cover is dislodged.

1. Southern California Edison Company's 2025 WMP initiative number 8.1.3.1 Distribution Detailed Inspections and Remediations work identified that the replacement of missing covers was complete at this location.
2. The tab cover was dislodged, and the bare conductor was exposed.

| <b>Asset Image 1:</b> Tab cover dislocated; bare conductor exposed | <b>Asset Image 2:</b> Tab cover dislocated; bare conductor exposed |

Deficiency 1. Energy Safety observed that in implementing 2025 WMP initiative 8.1.3.1 – Distribution High Fire Risk-Informed (HFRI) Inspection and Remediations (IN-1.1), SCE failed to complete replacement of missing covers on Structure ID 1904215E, Grid Hardening ID 414433083-1904215E at coordinates 33.8277250445338, -117.575228522755. Energy Safety considers this non-performance to be in the Minor risk category. SCE must complete a corrective action for this deficiency by 12 months from the date of this notice.<sup>1</sup>
