## NOTICE OF NON-PERFORMANCE

On June 16, 2026, Energy Safety conducted an inspection of Southern California Edison Company's WMP initiatives in the vicinity of the city of Norco, California. The inspection report is enclosed herewith. Energy Safety found the following deficiencies:

# INSPECTION REPORT

| Report Number: | PAD_SCE_YLO_20260616_0912 |

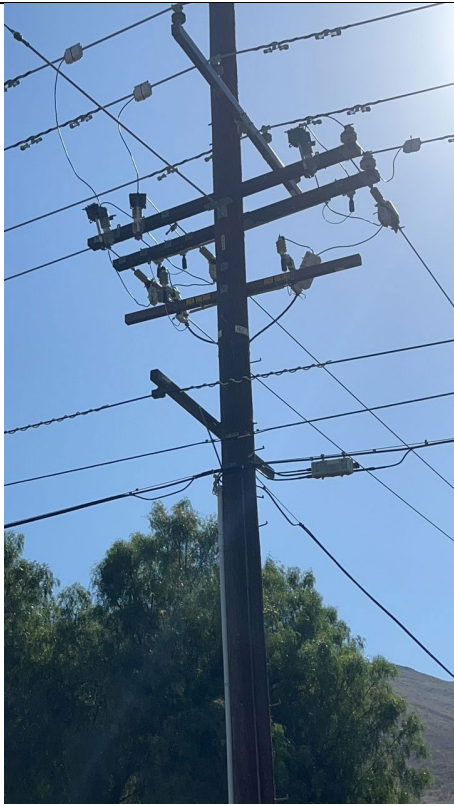
| Deficiency # | Structure ID | Grid Hardening ID | Lat/Long | HFTD | Initiative Number | Severity | Deficiency Description |
|---|---|---|---|---|---|---|---|
| Deficiency 1 | 1819024E | 414549011-1819024E | 33.9432383850025, -117.523685570462 | Tier 2 | 8.1.3.1 - Distribution Detailed Inspections and Remediations (IN-1.1) | Moderate | Failure to complete remediation of missing lightning arrester cover |

In the 2025 Q4 Quarterly Data Report Submission, SCE reported that work on Distribution Remediation was completed at Structure ID 1819024E, Grid Hardening ID 414549011-1819024E at 4162-4210 Crestview Dr, Norco, CA, 92860, 33.9432383850025, -117.523685570462. At this location, the inspector observed that a lightning arrester cover was dislodged. The inspector's observation is documented in Deficiency 1 photographs, which are attached to this report. Photo numbers Asset Image 1 and Asset Image 2 depict that the lightning arrester cover was dislodged.

1. Southern California Edison Company's 2025 Q4 Quarterly Data Report Submission reported that work related to 2025 WMP initiative number 8.1.3.1 Distribution Detailed Inspections and Remediations was complete at this location.
2. The original notification at issue at this location identified that remediation of a missing lightning arrester cover was required.
3. Although the work was reported as complete by SCE, the inspector observed that the lightning arrester cover was dislodged upon inspection.

**Asset Image 1:** View showing dislodged lightning arrester cover

Deficiency 1. Energy Safety observed that in implementing 2025 WMP initiative 8.1.3.1 - Distribution High Fire Risk-Informed (HFRI) Inspections and Remediations (IN-1.1), SCE failed to complete remediation of missing lightning arrester cover on Structure ID1819024E, Grid Hardening ID 414549011-1819024E at coordinates 33.9432383850025, -117.523685570462. Energy Safety considers this non-performance to be in the Moderate risk category. SCE must complete a corrective action for this deficiency by 6 months from the date of this notice.<sup>1</sup>

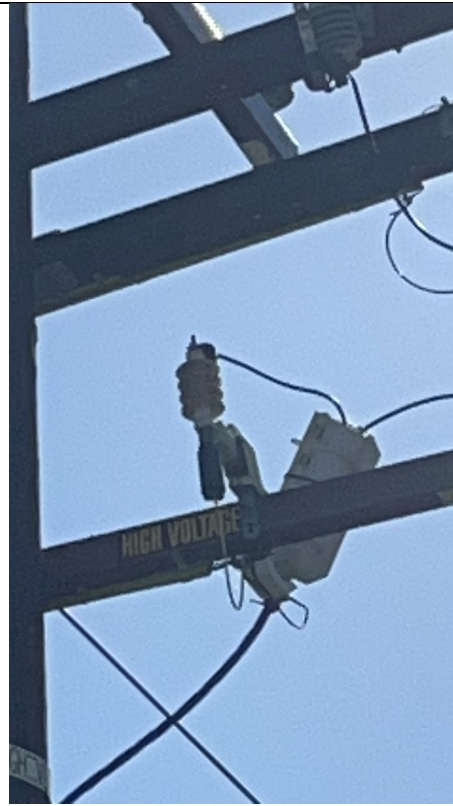
**Asset Image 2:** View showing dislodged lightning arrester cover
