## NOTICE OF NON-PERFORMANCE

# INSPECTION REPORT

| Report Number: | PAD_SCE_YLO_20260616_1319 |
| Relevant WMP Initiative(s): | 8.1.2.1.1 – Covered Conductor |

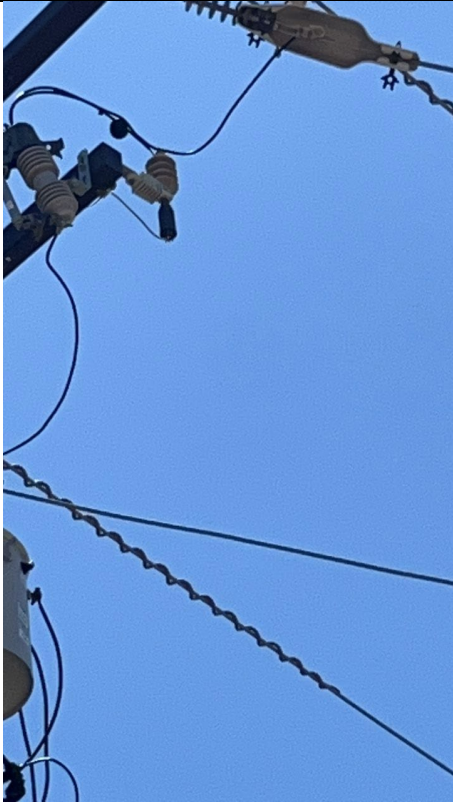
In the 2025 Q4 Quarterly Data Report Submission, Southern California Edison Company reported that work on 8.1.2.1.1 - Covered Conductor was completed at Structure ID 5037269E, Grid Hardening ID TD2244140-5037269E at 7020-7662 Wildlife Rd, Corona, CA, 92881, USA, 33.849071999277, -117.52490100003. At this location, the inspector observed that a lightning arrester cover was dislodged. The inspector's observation is documented in Deficiency 1 photographs, which are attached to this report. Photo numbers Asset Image 1 and Asset Image 2 depict a dislodged lightning arrester cover.

1. Southern California Edison Company's work on 2025 WMP initiative number 8.1.2.1.1 - Covered Conductor installation, identified that covered conductor work was completed at this location.
2. A dislodged lightning arrester cover was observed at the inspection location.
3. SCE Distribution Construction Standard CC-150 states that "Covered Conductor systems shall be an all-covered system. This means that wildlife covers shall be used on dead-ends, terminations, connectors, and equipment bushings. By covering other equipment, contact with object faults may be prevented not only with the conductor, but with other energized sources as well."<sup>7</sup>

**Asset Image 1:** View showing dislodged lightning arrester cover

Deficiency 1. Energy Safety observed that in implementing 2025 WMP initiative 8.1.2.1.1 – Covered Conductor, SCE failed to complete work on covered conductor on Structure ID 5037269E, Grid Hardening ID TD2244140-5037269E at coordinates 33.849071999277, -117.52490100003. Energy Safety considers this non-performance to be in the Minor risk category. SCE must complete a corrective action for this deficiency by 12 months from the date of this notice.<sup>1</sup>

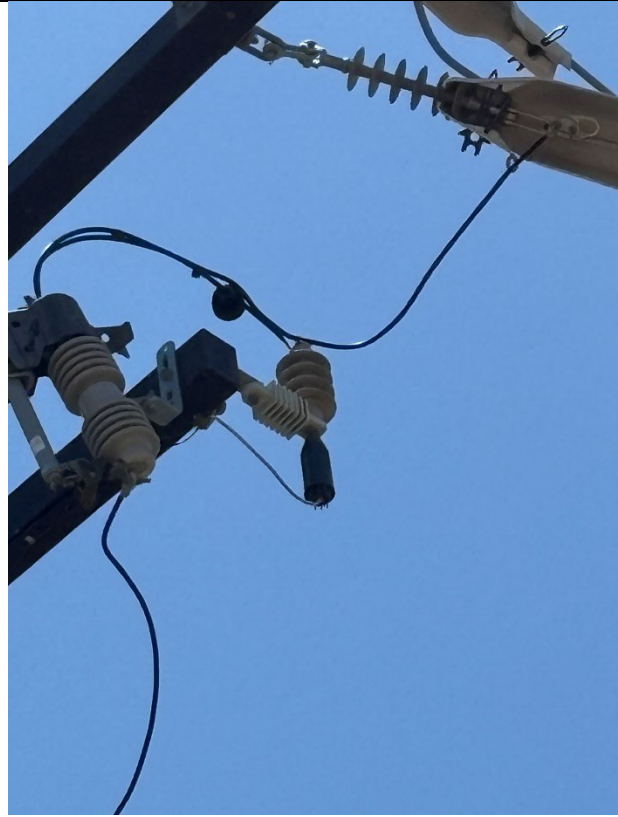
**Asset Image 2:** View showing dislodged lightning arrester cover
