## NOTICE OF NON-PERFORMANCE

# INSPECTION REPORT

| Report Number: | PAD_SCE_YLO_20260617_0912 |

| Deficiency # | Structure ID | Grid Hardening ID | Lat/Long | HFTD | Initiative Number | Severity | Deficiency Description |
|---|---|---|---|---|---|---|---|
| Deficiency 1 | 4818185E | 414446527-4818185E | 33.9459594595294, -117.622435328988 | Non-HFTD | 8.1.3.1 - Distribution Detailed Inspections and Remediations (IN-1.1) | Minor | Failure to complete remediation related to avian protection cover |

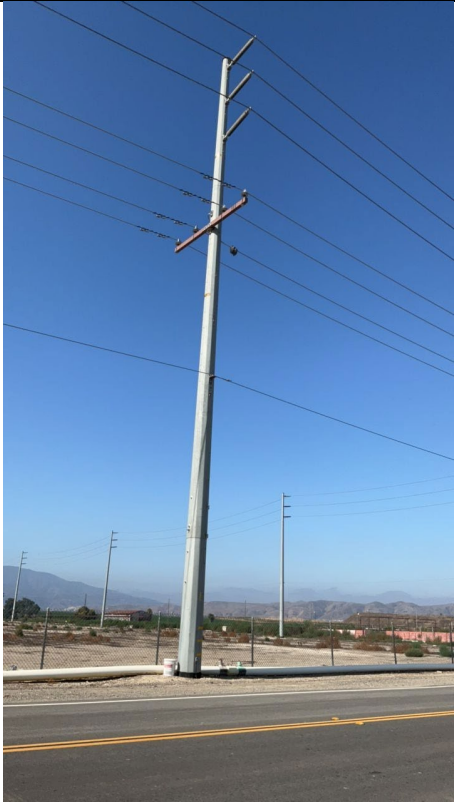
| <b>General Image 1:</b> Overall Structure | <b>General Image 2:</b> Structure ID |

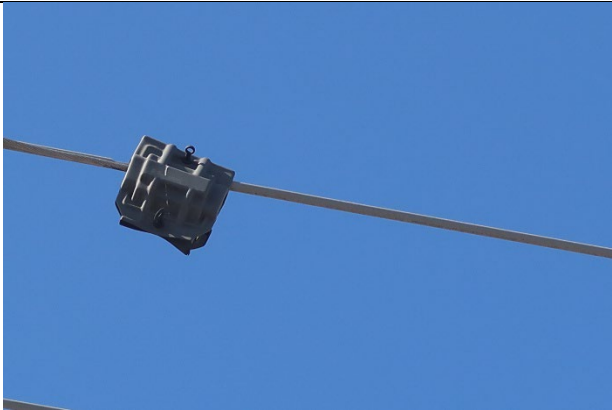
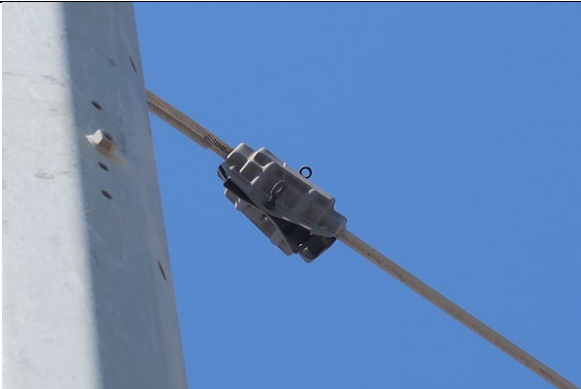
In the 2025 Q4 Quarterly Data Report Submission, Southern California Edison Company reported that work on Distribution Remediation was completed at Structure ID 4818185E, Grid Hardening ID 414446527-4818185E at 8476 Chino Corona Rd, Chino, CA, 91708, 33.9459594595294, -117.622435328988. At this location, the inspector observed that bare wire was exposed next to the avian protection cover. The inspector's observation is documented in Deficiency 1 photographs, which are attachments to this report. Photo numbers Asset Image 1, Asset Image 2, and Asset Image 3, depict exposed bare wire next to the avian protection cover.

1. Southern California Edison Company's 2025 Q4 Quarterly Data Report Submission reported that work related to 2025 WMP initiative number 8.1.3.1 Distribution Detailed Inspections and Remediations was complete at this location.
2. The original notification at issue at this location identified avian protection on bare tap slid off to mid span leaving bare conductor exposed.
3. Although the work was reported as complete by SCE, the inspector observed that the bare wire was still exposed upon inspection.

| <b>Asset Image 1:</b> View showing exposed bare wire next to avian protection cover | <b>Asset Image 2:</b> View showing exposed bare wire next to avian protection cover |

Deficiency 1. Energy Safety observed that in implementing 2025 WMP initiative 8.1.3.1 - Distribution High Fire Risk-Informed (HFRI) Inspections and Remediations (IN-1.1), SCE failed to complete remediation related to avian protection cover on Structure ID 4818185E, Grid Hardening ID 414446527-4818185E at coordinates 33.9459594595294, -117.622435328988. Energy Safety considers this non-performance to be in the Minor risk category. SCE must complete a corrective action for this deficiency by 12 months from the date of this notice.<sup>1</sup>

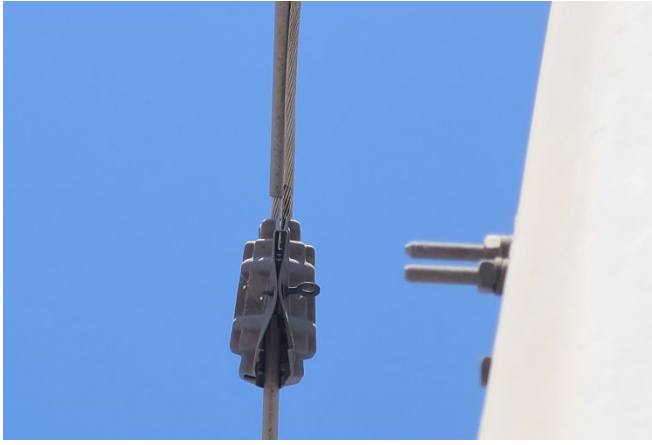
**Asset Image 3:** View showing exposed bare wire next to avian protection cover
