## NOTICE OF NON-PERFORMANCE

# INSPECTION REPORT

| Report Number: | PAD_SCE_YLO_20260617_0938 |

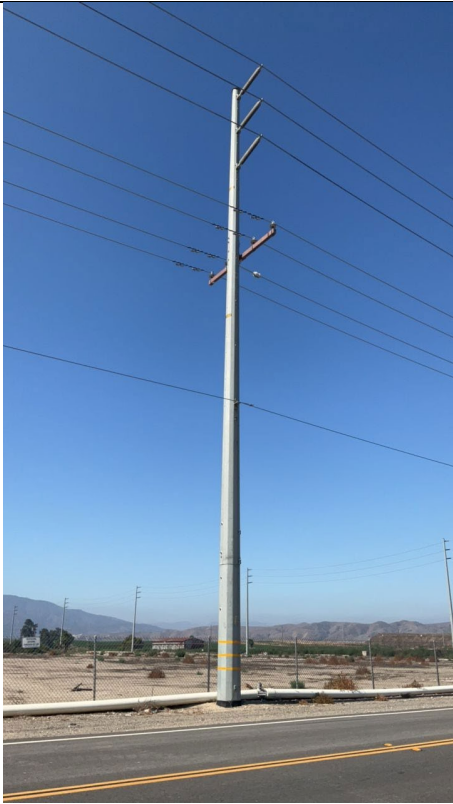
| <b>General Image 1:</b> Overall Structure | <b>General Image 2:</b> Structure ID |

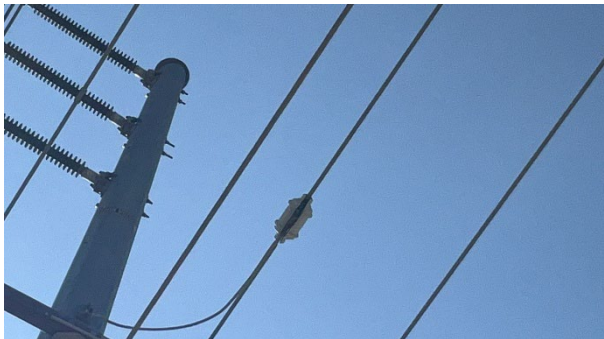
In the 2025 Q4 Quarterly Data Report Submission, Southern California Edison Company reported that work on Distribution Remediation was completed at Structure ID 4818186E, Grid Hardening ID 414446525-4818186E at 8364-8396 Chino Corona Rd, Corona, CA, 92880, 33.9459558727957, -117.62203775654. At this location, the inspector observed that tap cover was unsecured and bare wire was exposed. The inspector's observation is documented in Deficiency 1 photographs, which are attachments to this report. Photo numbers Asset Image 1, Asset Image 2, Asset Image 3, Asset Image 4, Asset Image 5, and Asset Image 6 depict unsecured tap cover and exposed bare wire.

1. Southern California Edison Company's 2025 Q4 Quarterly Data Report Submission reported that work related to 2025 WMP initiative number 8.1.3.1 Distribution Detailed Inspections and Remediations was complete at this location.
2. The original notification at issue at this location identified that remediation of exposed bare wire due to a missing bare tap cover was required.
3. Although the work was reported as complete by SCE, the inspector observed that the tap cover was unsecured and bare wire was exposed upon inspection.

| <b>Asset Image 1:</b> View showing unsecured tap cover and exposed bare wire | <b>Asset Image 2:</b> View showing unsecured tap cover and exposed bare wire |

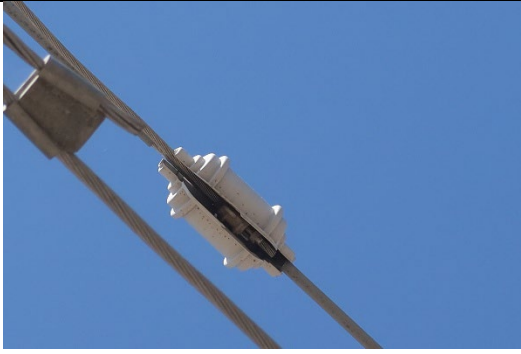
**Asset Image 3:** View showing unsecured tap cover and exposed bare wire

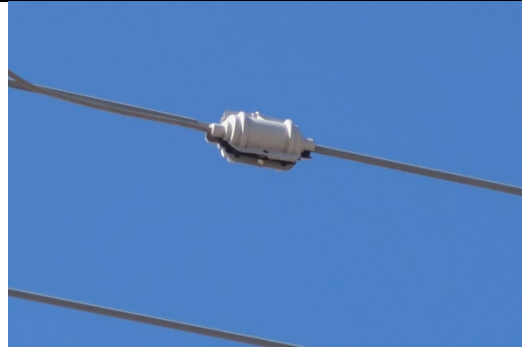
**Asset Image 4:** View showing unsecured tap cover and exposed bare wire

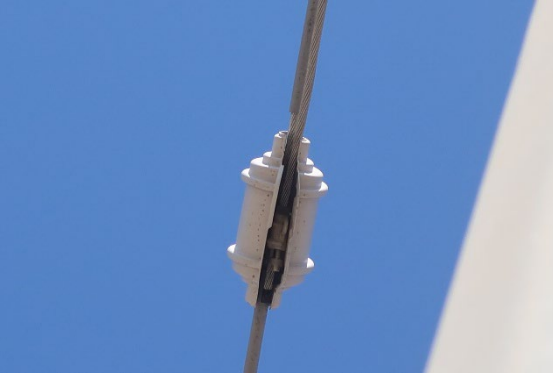
**Asset Image 5:** View showing unsecured tap cover and exposed bare wire

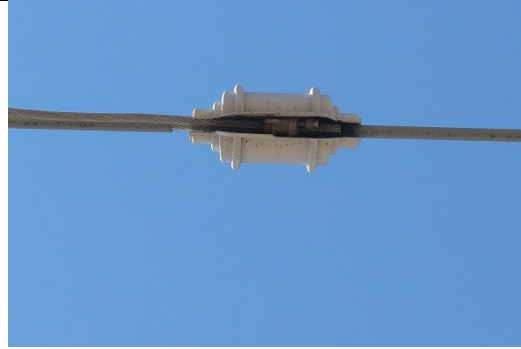
**Asset Image 6:** View showing unsecured tap cover and exposed bare wire
