## NOTICE OF NON-PERFORMANCE

# INSPECTION REPORT

| Report Number: | PAD_PGE_AXS_20251118_1057 |

## Deficiency 1

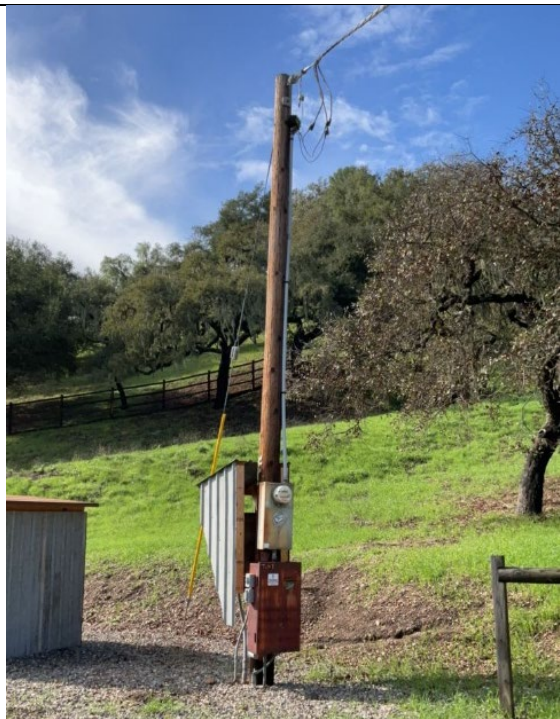
**G1mg1:** Overall Structure.

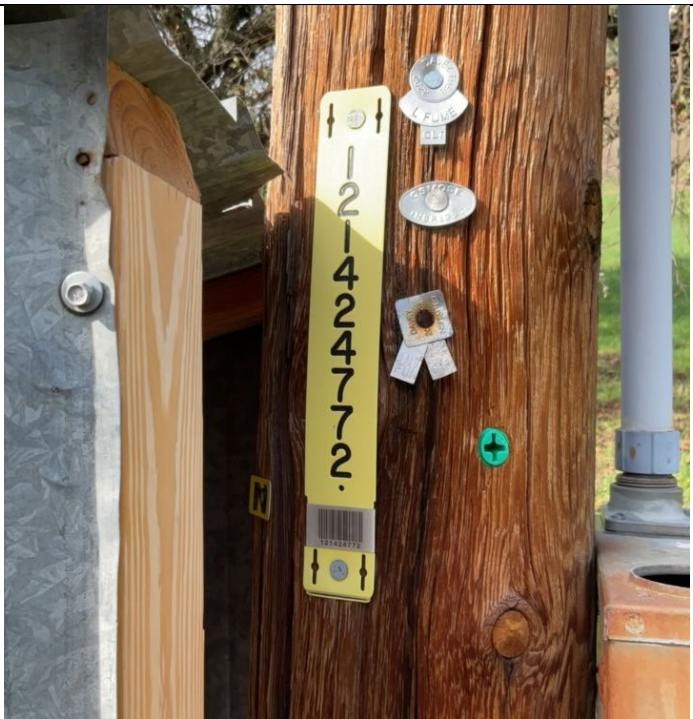
**G1mg2:** Structure ID.

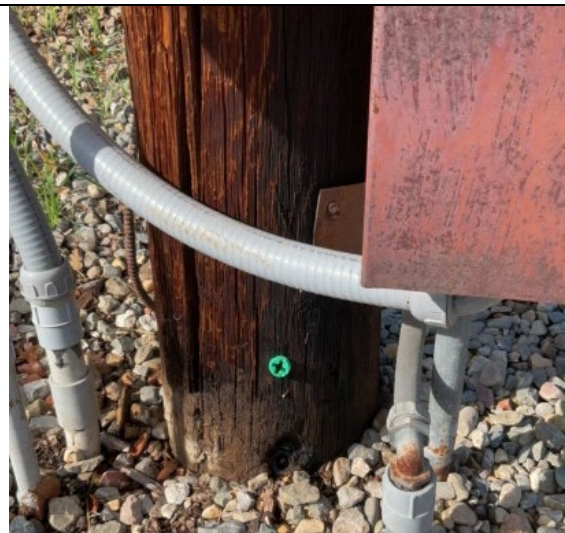
**G1mg3:** Multiple plugs for sampling taken.

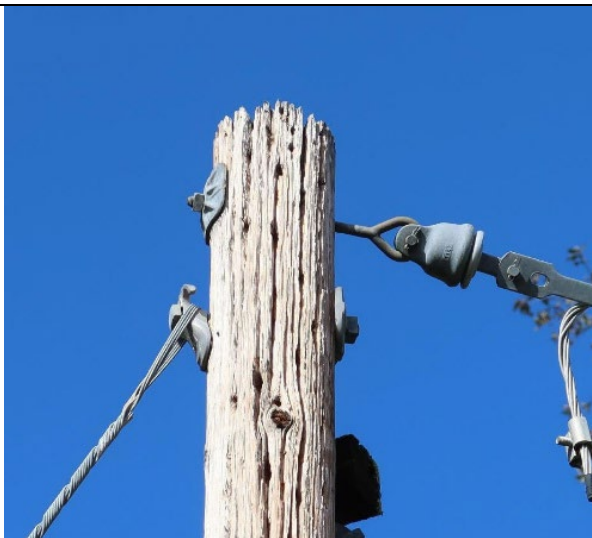
1. PG&E's Field Safety Reassessment (FSR) was completed for a pole that was originally determined to need replacement, and the FSR deemed the scheduled replacement to be unnecessary.
2. The inspector observed decay at the pole top from ground level.
3. The inspector observed a large mass of the pole missing within 6" of pole top, and near a span guy wire, which warrants pole replacement per PG&E document TD-2305M-JA02.

**IA11mg1:** Evidence of pole decay.

Deficiency 1. Energy Safety observed that in implementing 2025 WMP initiative 8.1.7.2 - Backlog Ignition Risk Reduction, PG&E failed to complete work on open work orders - distribution tags on Pole ID 121424772, Grid Hardening ID 124437925 at coordinates 34.677828396863, -120.083991788946. Energy Safety considers this non-performance to be in the Minor risk category. PG&E must complete a corrective action for this deficiency by 12 months of this notice.<sup>1</sup>

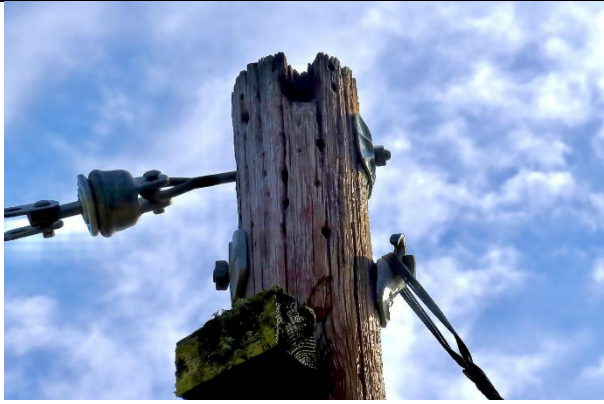
**IA1Img2:** Large piece of pole missing near critical strain point within 6" from top.

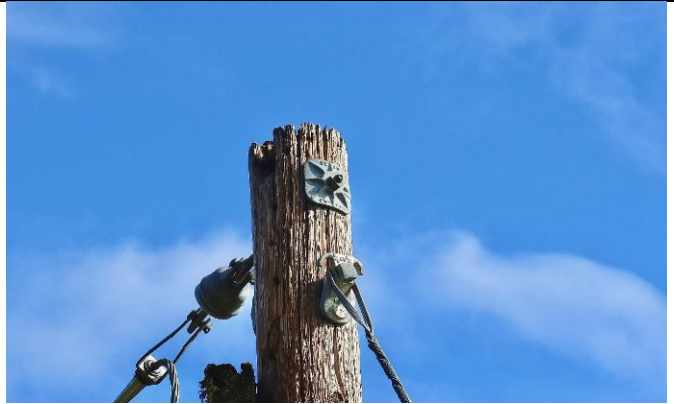
**IA1Img3:** Span/down guy anchor on decaying pole.
