## **NOTICE OF NON-PERFORMANCE**

| Report Number: | PAD_PGE_AXS_20251118_1152 |
| Relevant WMP Initiative(s): | 8.1.7.2 - Open Work Orders – Distribution Tags |

## Deficiency 1

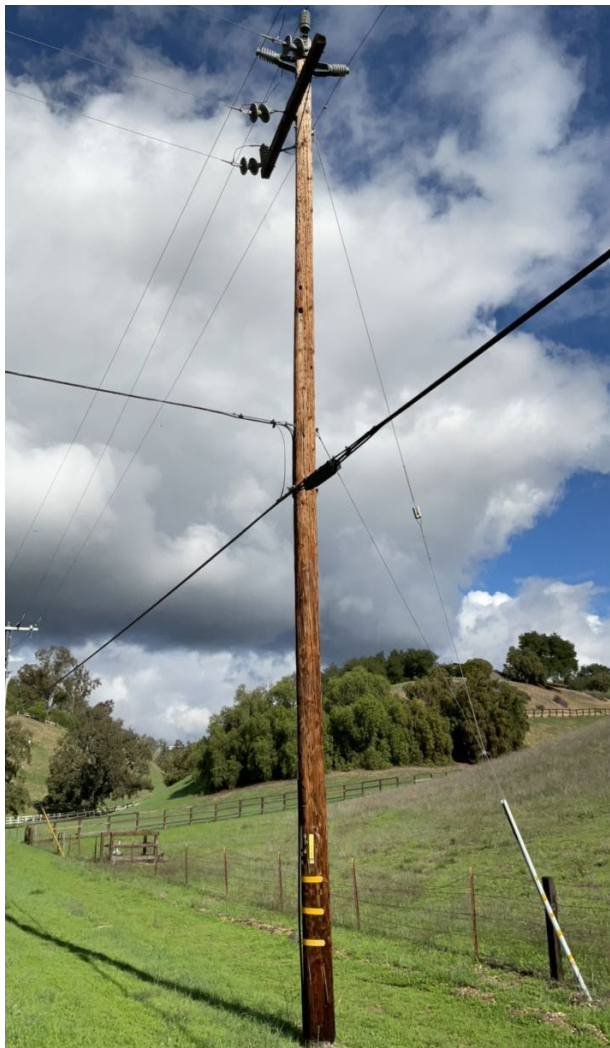
G1mg1: Overall Structure.

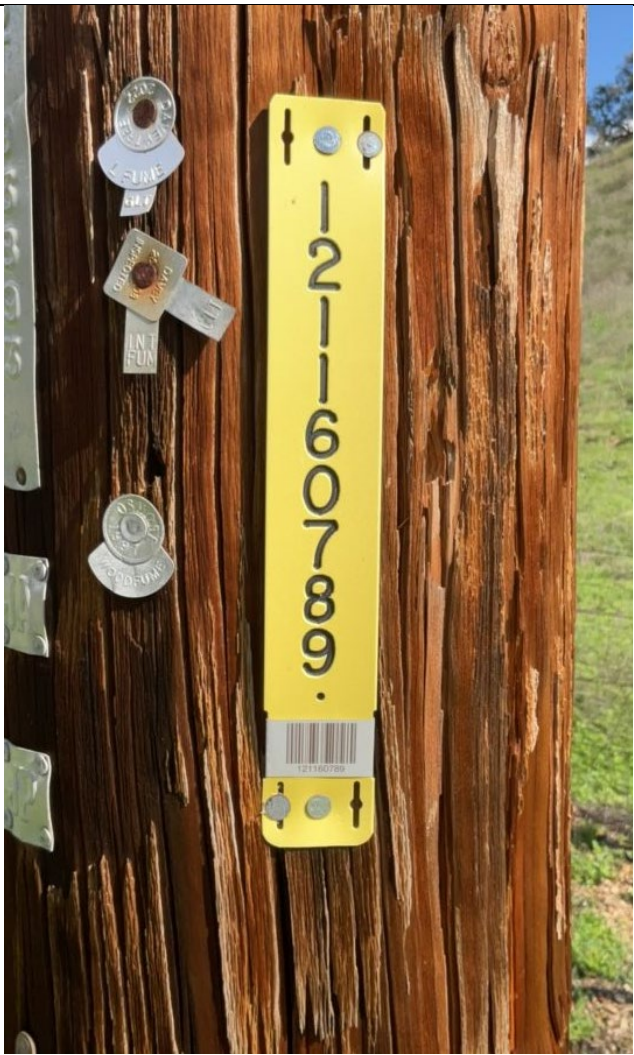
G1mg2: Structure ID.

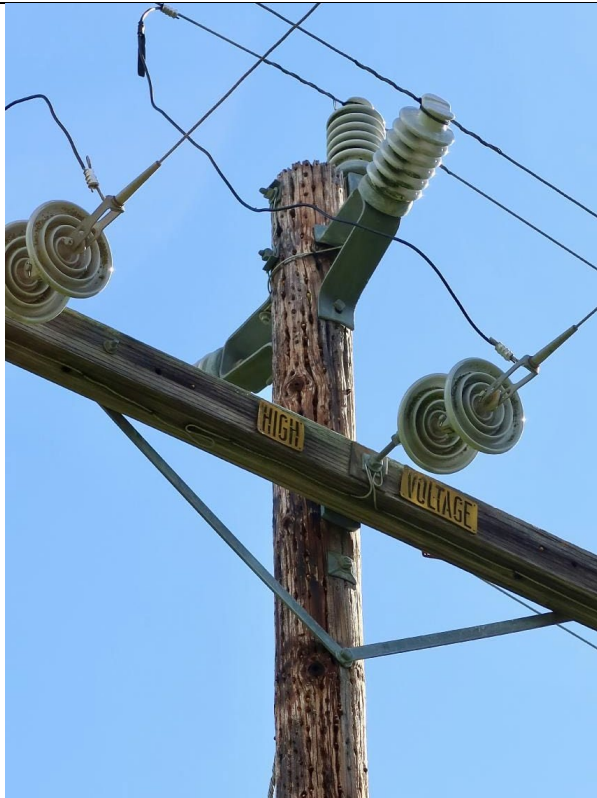
In the 2025 Q2 Quarterly Data Report submission, PG&E reported that work on WMP initiative 8.1.7.2 - Open Work Orders – Distribution Tags were completed at Pole ID 121160789, Grid Hardening ID 123958072 at 34.6739467793148, -120.08331151129. At this location, the inspector observed that the pole meets replacement criteria per TD-2305M-JA02 Rev. 14. The inspector noted that woodpecker (WP) damage, on a three-foot section, appeared to be greater than 50%. PG&E's original evaluation requested pole replacement, but when FSR was performed replacement was deemed unnecessary. The inspector's observation is documented in Deficiency 1 photographs, which are attachments to this report. Photo numbers IA1Img1, IA1Img2, IA1Img3, Item1IB1Img1-1, and Item1B1Img1-2, depict various views of WP damage and PG&E's inspection guidance of WP damage.

1. Field Safety Reassessment (FSR) was completed. Results of reassessment determined WP damage non-compelling, scheduled replacement was deemed unnecessary.
2. Inspector observed WP holes covering greater than 50% of the pole surface in a three-foot section at this location.
3. WP holes covering greater than 50% of the pole surface in a three-foot section warrants pole replacement per PG&E document TD-2305M-JA02 Rev 14.
4. Current WP activity observed at this location.

**IA1Img1:** WP damage 1.

Deficiency 1. Energy Safety observed that in implementing 2025 WMP initiative 8.1.7.2 - Open Work Orders – Distribution Tags, PG&E failed to complete work on open work orders distribution tags on Pole ID 121160789, Grid Hardening ID 123958072 at coordinates 34.6739467793148, -120.08331151129. Energy Safety considers this non-performance to be in the Minor risk category. PG&E must complete a corrective action for this deficiency by 12 months from date of this notice.<sup>1</sup>

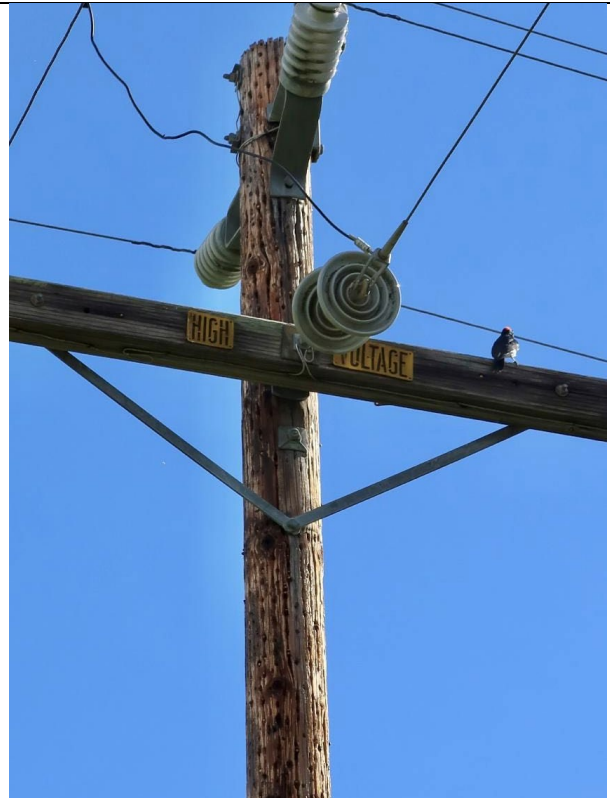
**IA1Img2:** WP damage 2.

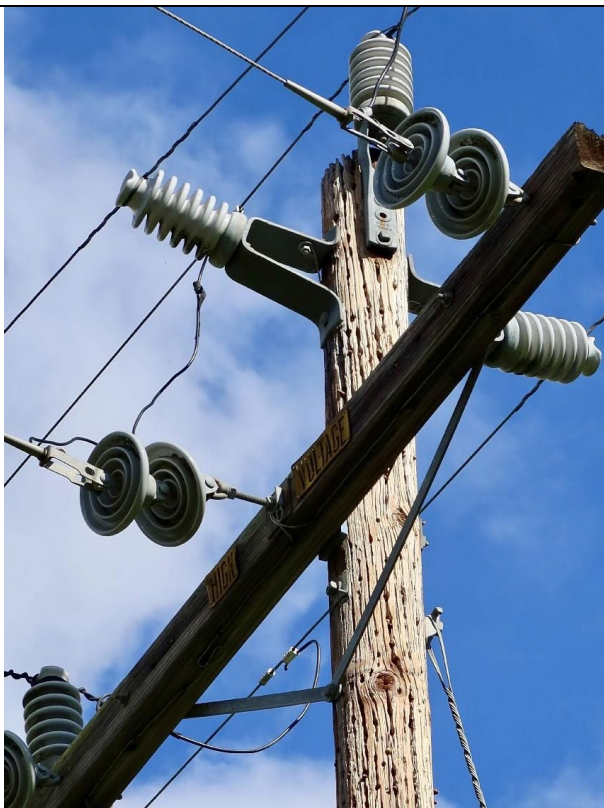
**IA1Img3:** WP damage 3.

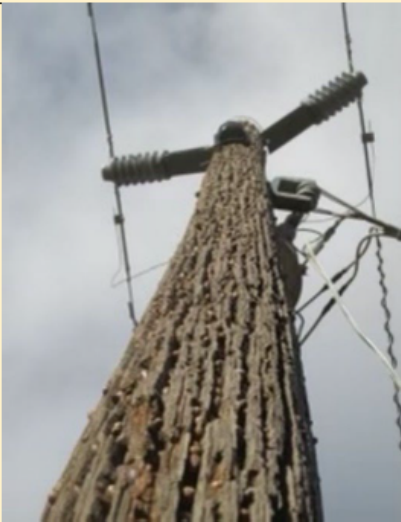
**Item1B1Img1-1** Pacific Gas and Electric Company TD-2305M-JA02 REV 14.

| WOODPECKER DAMAGE <1 INCH HOLES | |
|---|---|
| | <p><b>At this Location:</b> Holes are less than 1 inch in diameter and acorn/feeder holes cover more than 50% of the pole surface in a 3 ft section.</p> <p> </p> |
| | <p><b>Write EC Notification:</b> Yes</p> <p><b>FDA=</b> Pole / Woodpecker Damage / Replace</p> <p><b>Priority=</b> Minimum E Tag, depending on exposure.</p> |
