## NOTICE OF NON-PERFORMANCE

On June 17, 2026, Energy Safety conducted an inspection of Southern California Edison Company's WMP initiatives in the vicinity of the city of Corona, California. The inspection report is enclosed herewith. Energy Safety found the following deficiencies:

# Inspection Summary

| Report Number: | PAD_SCE_YLO_20260617_0957 |

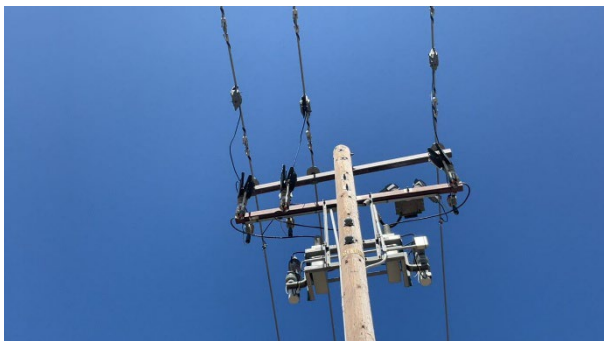
In the 2025 Q4 Quarterly Data Report Submission, Southern California Edison Company reported that work on Distribution Remediation was completed at Structure ID 4739126E, Grid Hardening ID 414445064-4739126E at 16876-16898 Chino Corona Rd, Corona, CA, 92880, 33.9461581785984, -117.634253792228. At this location, the inspector observed that the tap cover was unsecured. The inspector's observation is documented in Deficiency 1 photographs, which are attachments to this report. Photo numbers Asset Image 1, Asset Image 2, Asset Image 3, depict unsecured tap cover.

1. Southern California Edison Company's 2025 Q4 Quarterly Data Report Submission reported that work related to 2025 WMP initiative number 8.1.3.1 Distribution Detailed Inspections and Remediations was complete at this location.
2. The original notification at issue at this location identified that remediation of missing avian protection on fuse and center phase bare tap cover was required.
3. Although the work was reported as complete by SCE, the inspector observed that the tap cover was unsecured upon inspection.

Asset Image 1: View of unsecured tap cover

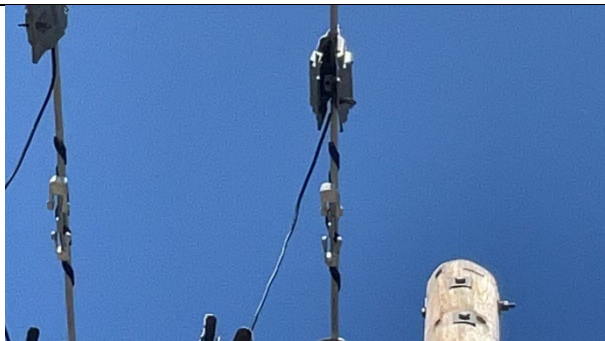
Asset Image 2: View of unsecured tap cover

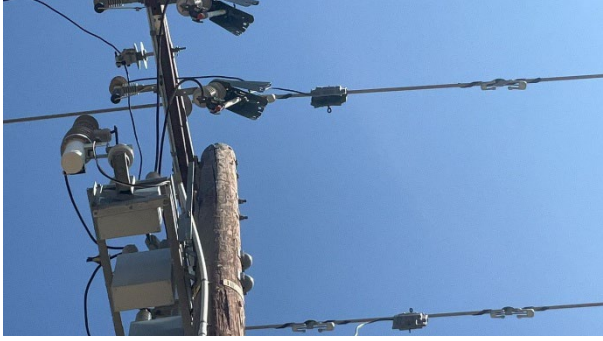
**Asset Image 3:** View of unsecured tap cover
