**SUBJECT:** Southern California Edison Company's Response to Notice of Non-Performance (NON\_PAD\_SCE\_SIS\_20260617\_1231)

| <b>Notice</b> | <b>#</b> | <b>Structures</b> |
|---|---|---|
| NON_PAD_SCE_SIS_20260617_1231 | 1 | 1904215E |

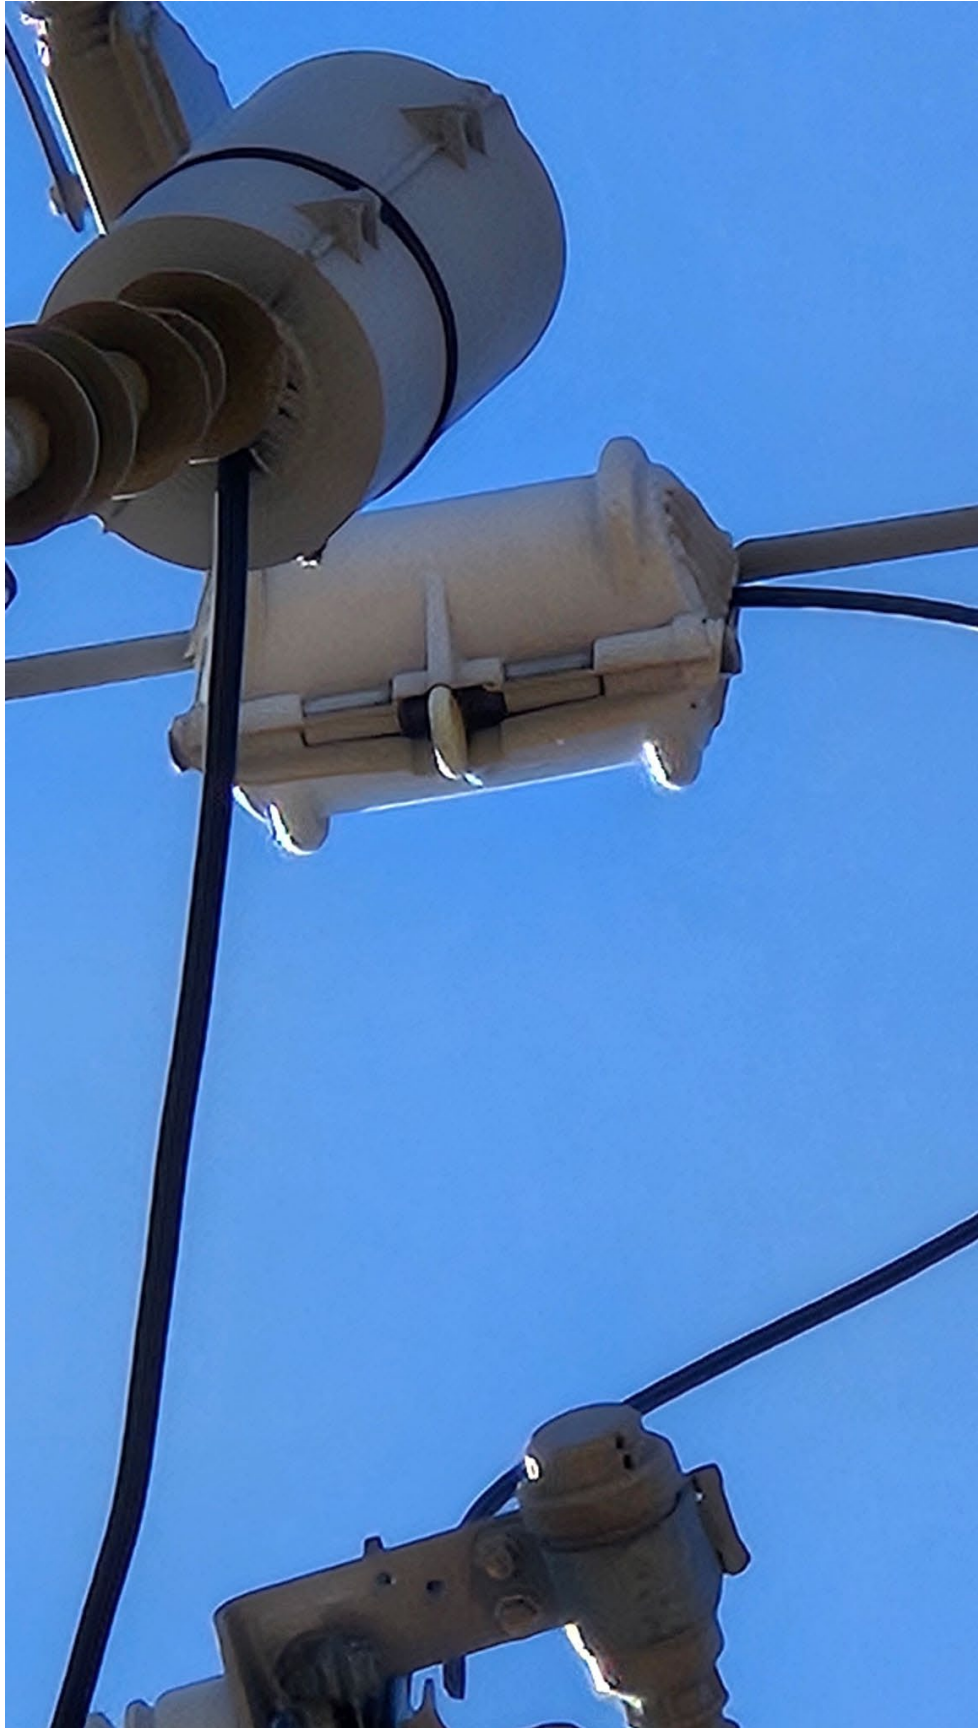
Deficiency 1. Energy Safety observed that in implementing 2025 WMP initiative 8.1.3.1 – Distribution High Fire Risk-Informed (HFRI) Inspection and Remediations (IN-1.1), SCE failed to complete replacement of missing covers on Structure ID 1904215E, Grid Hardening ID 414433083-1904215E at coordinates 33.8277250445338, - 117.575228522755.

SCE confirms that the avian protection cover on structure 1904215E was remediated on October 20, 2025. During a subsequent inspection in response to this Notice, SCE's Field Operations team identified that the previously installed avian protection cover had become dislodged likely due to environmental exposure or other external factors. On July 27, 2026, SCE field personnel remediated the avian protection cover on structure 1904215E. Please see the photos below of the most recently completed avian protection cover remediation.
