**SUBJECT:** Southern California Edison Company's Response to Notice of Non-Performance (NON\_PAD\_SCE\_YLO\_20260616\_1319)

| <b>Notice</b> | <b>#</b> | <b>Structures</b> |
|---|---|---|
| NON_PAD_SCE_YLO_20260616_1319 | 1 | 5037269E |

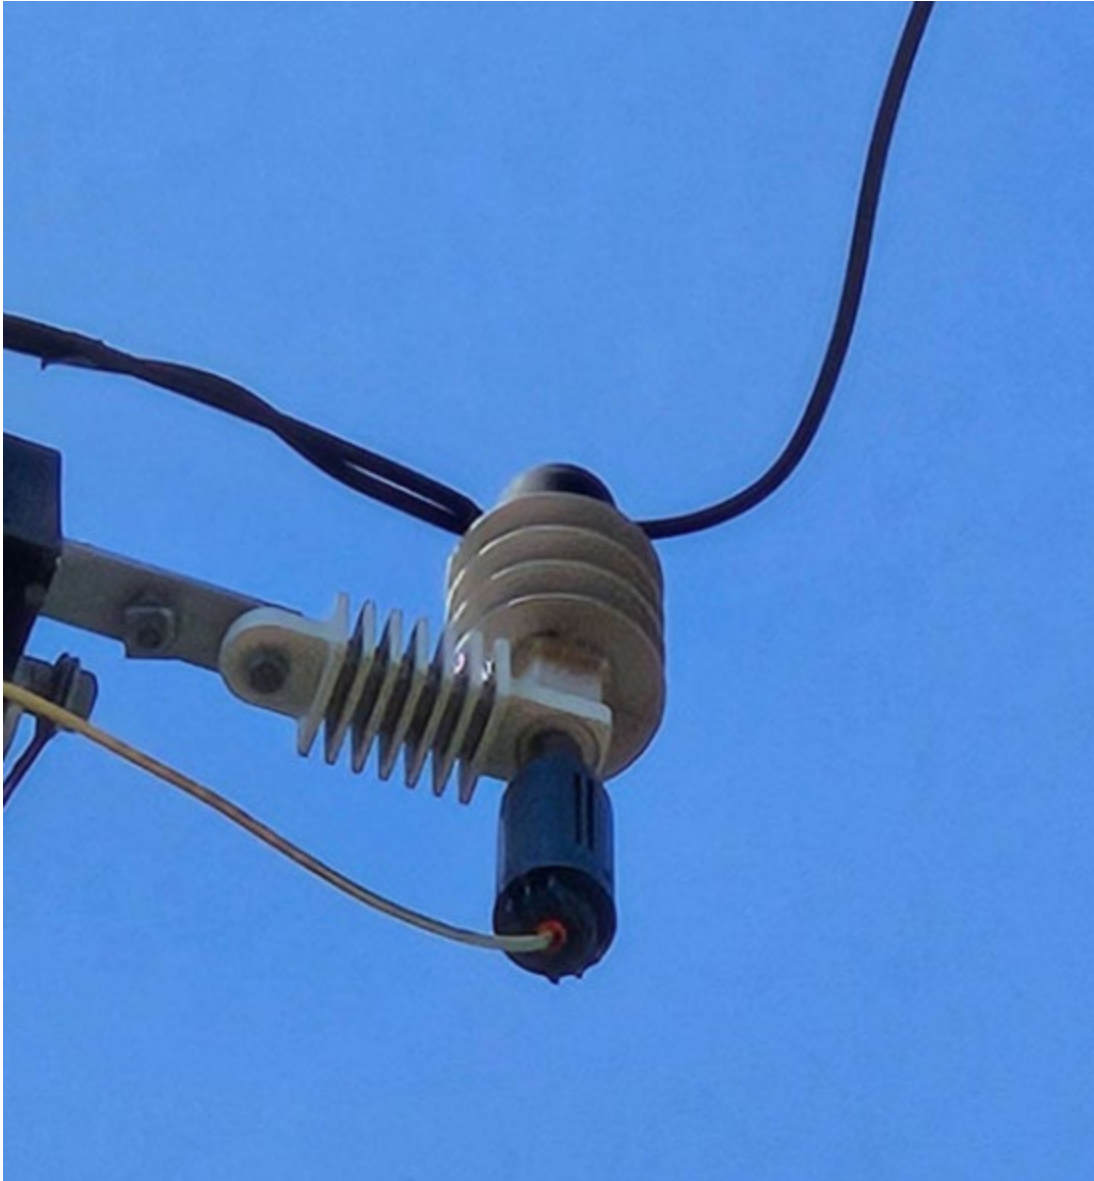
On June 16, 2026, Energy Safety conducted an inspection of Southern California Edison Company's WMP initiatives in the vicinity of the city of Corona, California. The inspection report is enclosed herewith. Energy Safety found the following deficiencies: Deficiency 1. Energy Safety observed that in implementing 2025 WMP initiative 8.1.2.1.1 – Covered Conductor, SCE failed to complete work on covered conductor on Structure ID 5037269E, Grid Hardening ID TD2244140-5037269E at coordinates 33.849071999277, -117.52490100003.

The Notice states that “a dislodged lightning arrester cover was observed at the inspection location.” SCE confirms that the lightning arrester cover on structure 5037269E was installed and in place as of November 21, 2025, as part of the subject covered conductor installation. During a subsequent inspection in response to this Notice, SCE's Field Operations team identified that the previously installed lightning arrester cover had become dislodged, likely due to environmental exposure or other external factors. On July 27, 2026, SCE field personnel remediated the lightning arrester cover on structure 5037269E. Please see the photo below showing the completed lightning arrester cover remediation.
