## **NOTICE OF NON-PERFORMANCE**

# INSPECTION REPORT

| Report Number: | PAD_SCE_SIS_20260707_0915 |

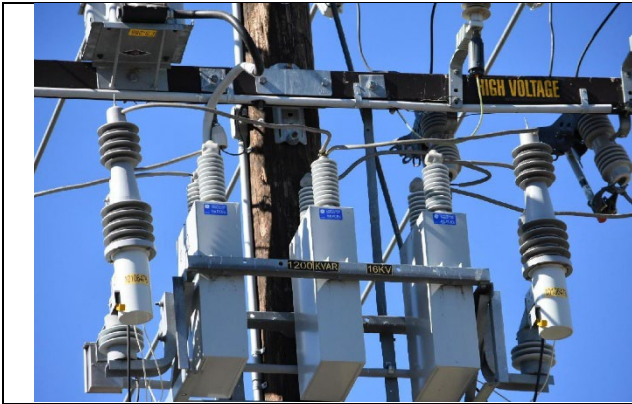
In the 2026 Q1 Quarterly Data Report Submission, Southern California Edison Company reported that work to replace a missing avian protection cover on a capacitor bushing under its Distribution Remediation WMP initiative (8.3.1) was completed at Structure ID 625650E, Grid Hardening ID 414841474-625650E at 27118 Crossglade Ave, Canyon Country, CA, 91351, at coordinates 34.4138635296778, -118.465373369502. At this location, the inspector observed that the middle capacitor bushing cover was missing. The inspector's observation is documented in Deficiency 1 photographs, which are attachments to this report. Photo numbers Asset Image 1, Asset Image 2, and Asset Image 3 depict that the middle capacitor bushing cover is missing.

1. Southern California Edison Company's 2026 WMP initiative number 8.3.1 - Distribution High Fire Risk-Informed (HFRI) Inspections work identified that the replacement of a missing cover was complete at this location.
2. The middle capacitor bushing cover was missing.

**Asset Image 1:** Missing capacitor bushing cover

Deficiency 1. Energy Safety observed that in implementing 2026 WMP initiative 8.3.1 – Distribution High Fire Risk-Informed (HFRI) Inspection – Ground and Aerial (IN-1.1), SCE failed to replace a missing primary avian protection cover on Structure ID 625650E, Grid Hardening ID 414841474-625650E at coordinates 34.4138635296778, -118.465373369502. Energy Safety considers this non-performance to be in the Minor risk category. SCE must complete a corrective action for this deficiency by 12 months from the date of this notice.<sup>1</sup>

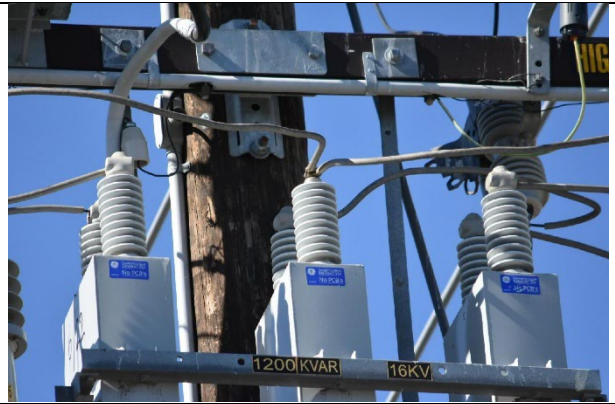
**Asset Image 2:** Missing capacitor bushing cover

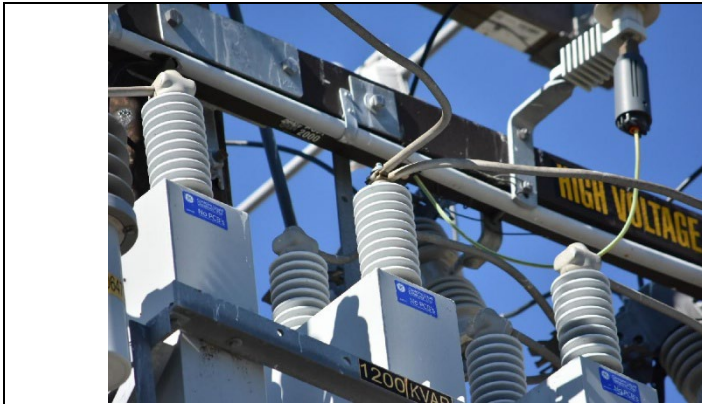
**Asset Image 3:** Missing capacitor bushing cover
