## **NOTICE OF NON-PERFORMANCE**

# INSPECTION REPORT

| Report Number: | PAD_SCE_YLO_20260707_0929 |

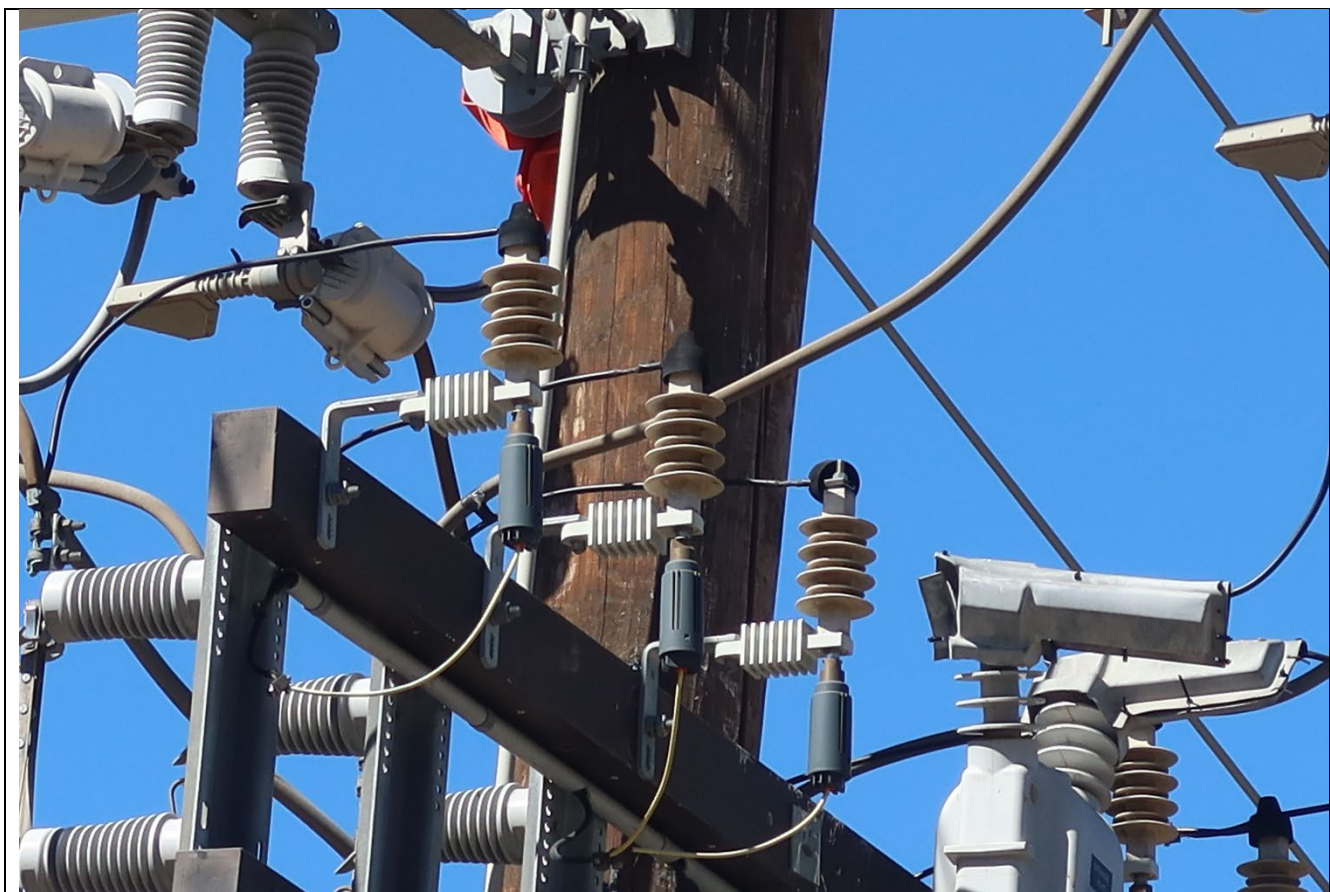
| Deficiency # | Structure ID | Grid Hardening ID | Lat/Long | HFTD | Initiative Number | Severity | Deficiency Description |
|---|---|---|---|---|---|---|---|
| Deficiency 1 | 4729770E | 413994354-4729770E | 34.330353083056, -118.340607258323 | Tier 3 | 8.3.1 Distribution High Fire Risk-Informed (HFRI) Inspections - Ground and Aerial (IN-1.1) | Minor | Failure to remediate the condition of loose lightning arrestor cap |

In the 2026 Q1 Quarterly Data Report Submission, Southern California Edison Company reported that work on Distribution Remediation was completed at Structure ID 4729770E, Grid Hardening ID 413994354-4729770E near San Fernando, CA, at coordinates 34.330353083056, -118.340607258323. At this location, the inspector observed that lightning arrestor cap was loose. The inspector's observation is documented in Deficiency 1 photographs, which are attachments to this report. Photo number Asset Image 1 depicts a loose lightning arrestor cap.

1. Southern California Edison Company's 2026 WMP initiative number 8.3.1 - Distribution High Fire Risk-Informed (HFRI) Inspections work identified that the remediation of a loose lightning arrestor cap was complete at this location.
2. The lightning arrestor cap was loose.

**Asset Image 1:** View showing loose lightning arrester cover

Deficiency 1. Energy Safety observed that in implementing 2026 WMP initiative 8.3.1 – Distribution High Fire Risk-Informed (HFRI) Inspection – Ground and Aerial (IN-1.1), SCE failed to remediate the condition of loose lightning arrestor cap on Structure ID 4729770E, Grid Hardening ID 413994354-4729770E at coordinates 34.330353083056, -118.340607258323. Energy Safety considers this non-performance to be in the Minor risk category. SCE must complete a corrective action for this deficiency by 12 months from the date of this notice.<sup>1</sup>
