**CALIFORNIA UNDERGROUND FACILITIES SAFE EXCAVATION BOARD  
INVESTIGATION DIVISION  
INVESTIGATION REPORT**

**CASE No.:** 20SA01279

**INCIDENT:** Excavator was digging a trench to install fiber optic cable and struck a natural gas distribution branch connection, causing a natural gas release. The natural gas ignited, the fire engulfed an adjacent restaurant and would spread to nearby buildings. Everyone was able to evacuate, and there were no injuries.

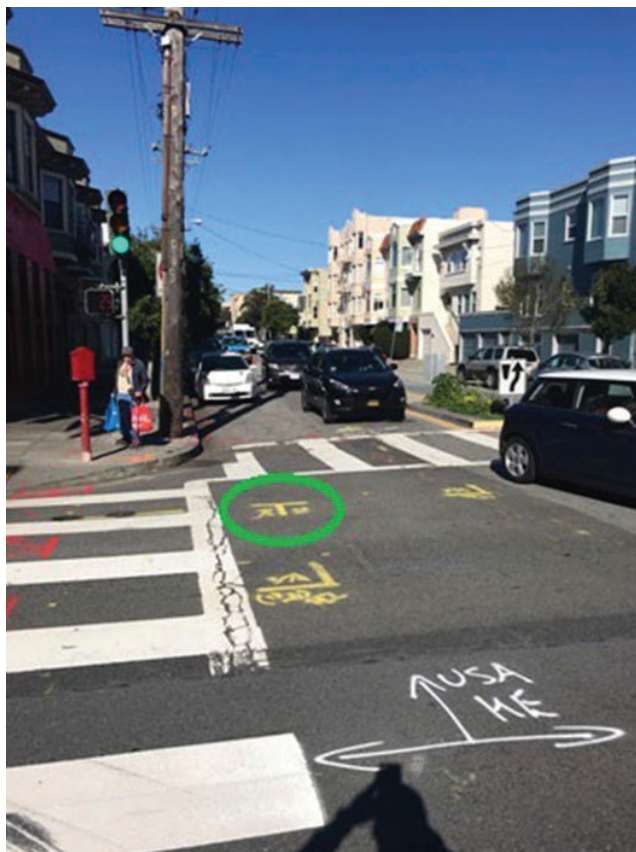
On 1/22/2019, a second USA ticket X902201229 (**Exh 8**) was requested by Kilford Engineering. The work area described in the second ticket was a 100-ft subset of ticket X90210166 and was rejected by PG&E, as the delineation extended from Parker through Emerson Street. On 1/28/2019, PG&E conducted a field meet with Kilford Engineering to resolve the confusion and marked and located the area of excavation. PG&E completed all mark/locates in phases and cleared the area for excavation on 1/31/2019 (**Figure 2**).

**Figure 2:** PG&E Locate & Mark Photo, pointing north along Parker Ave. The connection that was struck on February 6 is circled in green. Courtesy NTSB.

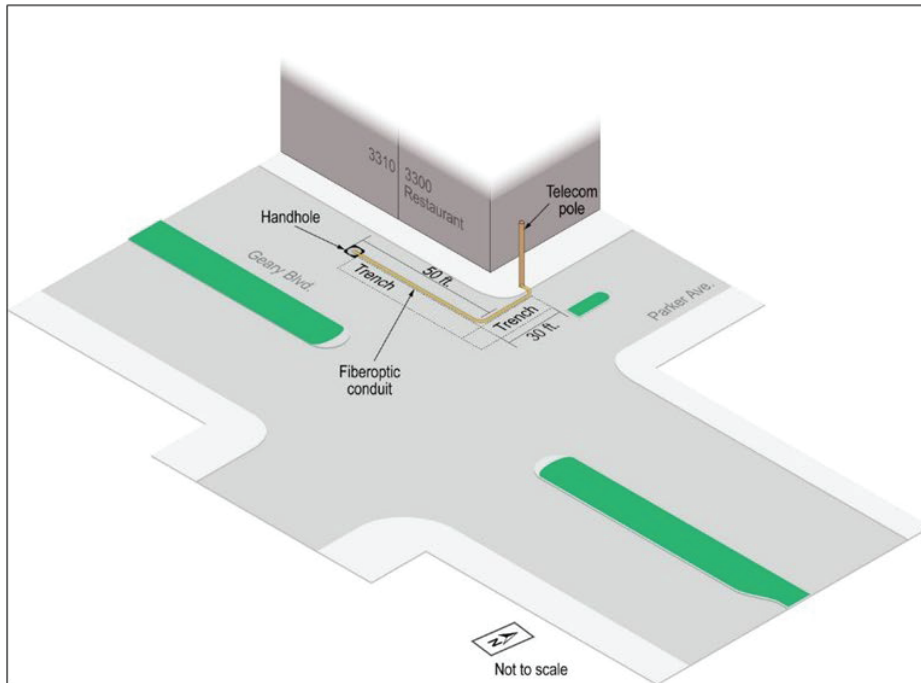
On February 6, 2019, Kilford employees arrived at the site around 7:30 a.m. and held a safety briefing (**Exh 9**). Once traffic control was in place, excavation work began about 9:00 a.m. The work plan for that day was for three lines of conduit to be placed along Geary Boulevard 50 feet west of the intersection with Parker Avenue, at a new handhole and run to the intersection where one of the three lines of conduit would then run north along Parker Avenue to a telecommunications pole (**Figure 3**).

**Figure 3:** Excavation work plan for 2/6/19. Courtesy NTSB.

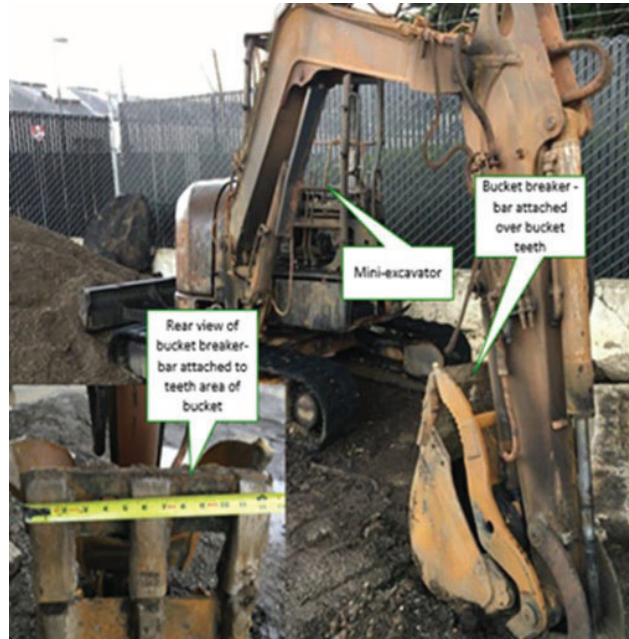
After 9:00am, the Kilford crew began breaking and removing the concrete (**Exh 5**, p. 16). The two-person Kilford crew for the excavation of the area consisted of a mini-excavator operator, Colin Codd (Codd), who is also a co-owner of Kilford, and a laborer for shoveling and to serve as the spotter for the mini-excavator operator. The mini excavator was a CAT 226 skid steer with a SBU 220 hydraulic breaker (**Figure 4**).

**Figure 4:** Post accident photo of mini excavator with enlarged view of bucket breaker. Courtesy NTSB.

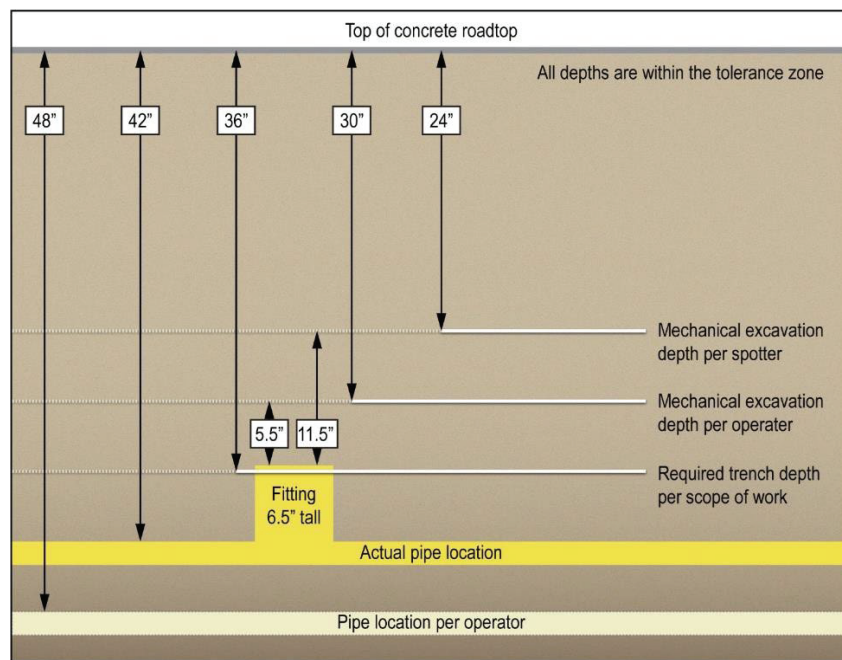
Codd also stated that he decided to dig to 30 inches, even though the scope of work called for 36-inch trench depth, citing that it was safer to have greater clearance from electrical and gas lines. He stated that it would have been too dangerous to excavate below the gas line (**Exh 7**, p.29). Martin stated that the trench was only 24 to 30 inches deep where the mini excavator was working at the intersection (**Figure 5**).

**Figure 5:** Comparisons of actual trench and pipe depths with the beliefs expressed by the operator of the excavator and the spotter, Courtesy NTSB.

Martin the spotter thought the trench depth was 24 inches at the time of the accident, and Codd the driver of the mini excavator thought he was digging at 30 inches. Although the Codd believed they had exposed the pipelines at a depth of 48 inches, post-accident evidence revealed that the pipelines were at a depth

of 42 inches. Based on an exemplar branch connection, the branch connection was about 6.5 inches above the 4-inch pipeline. Therefore, the depth of cover at the branch connection location was about 35.5 inches, about the same depth that was to be excavated by Kilford's crew. Although the crew thought they were digging above where they believed the pipelines were located, the evidence indicates that the pipelines and branch connection were higher than where they estimated, and Codd was likely using the excavator to dig deeper than they estimated.

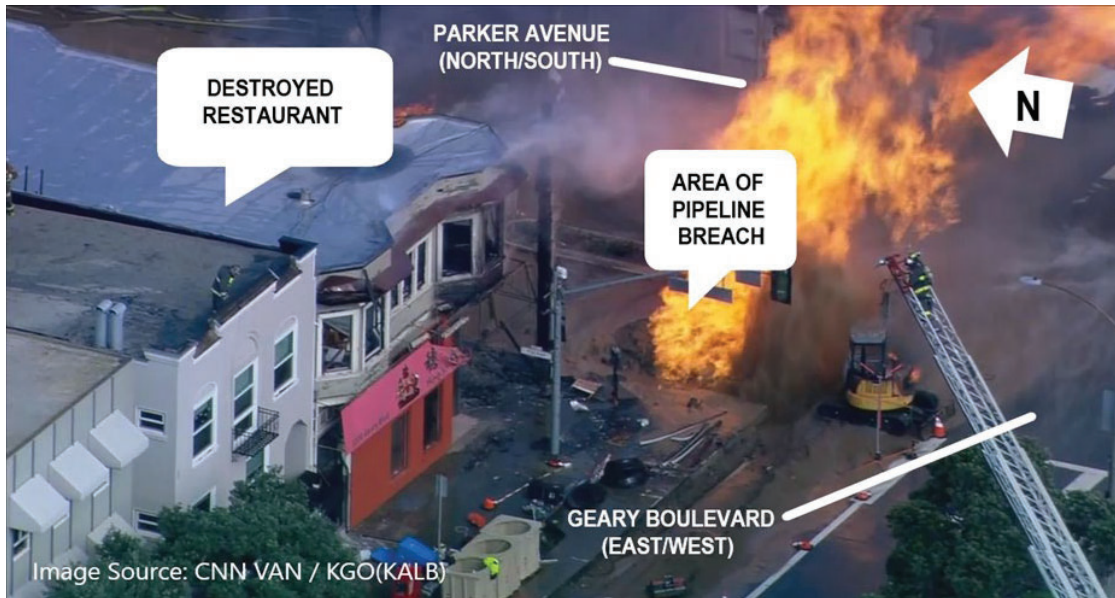
Once the gas ignited, the flames, which extended above the height of a 2-story building, impinged on a nearby, fully occupied restaurant at 3300 Geary Boulevard. This caused a structure fire at the restaurant. Employees and customers self-evacuated immediately. Later, the fire spread to neighboring buildings, causing smaller structure fires at 3308, 3310, and 3250 Geary Boulevard (**Figure 6**)

**Figure 6:** Aerial view of incident scene. Courtesy NTSB.

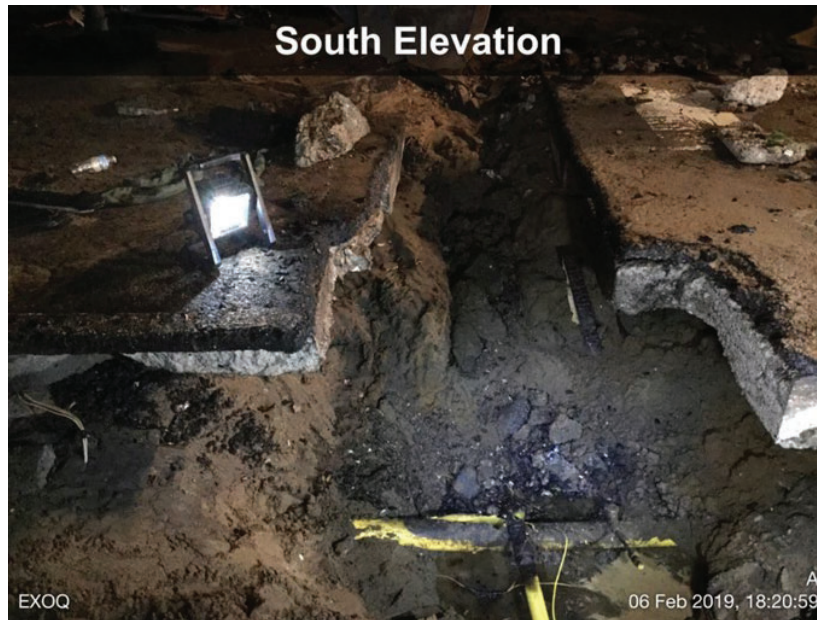
After the gas was shutoff and the fire was extinguished, PG&E later determined that a 4-inch plastic gas main had been damaged at the branch connection to a 2-inch plastic gas service line in the trench where the fire had started (**Figure 7**). An NTSB Materials Laboratory examination of the branch connection suggests that the bucket may have struck a polyethylene saddle-fused branch connection that likely extended above the 4-inch pipe 6.5 inches (**Exh 12**).

**Figure 7:** (from **Exh 13**) Damage at branch connection. Courtesy PG&E.

Kilford employees struck the PG&E natural gas distribution pipeline branch connection with an excavator bucket. NTSB Materials Laboratory examination indicates that the branch connection was likely struck at a

fused saddle connection that extended above the connection by 6.5 inches, at approximately 35.5 inches in depth. The operator of the excavator believed that he had exposed the 2-inch and 4-inch lines at a depth of 48 inches and that he was working at a depth of 30 inches at the time of the strike.
