NOV_SCE ATJ_20220406-01

NOTICE OF VIOLATION

Report Name: SCE_ATJ_20220406-01

On April 6, 2022, I performed a walking inspection of Southern California Edison (SCE) covered conductor installations, 2021 WMP initiative number 7.3.3.3.1, in the Tule River Reservation in Springwater, California. I also observed the overall vegetation management within the area. Detailed findings from this field inspection are laid out in Section II below.

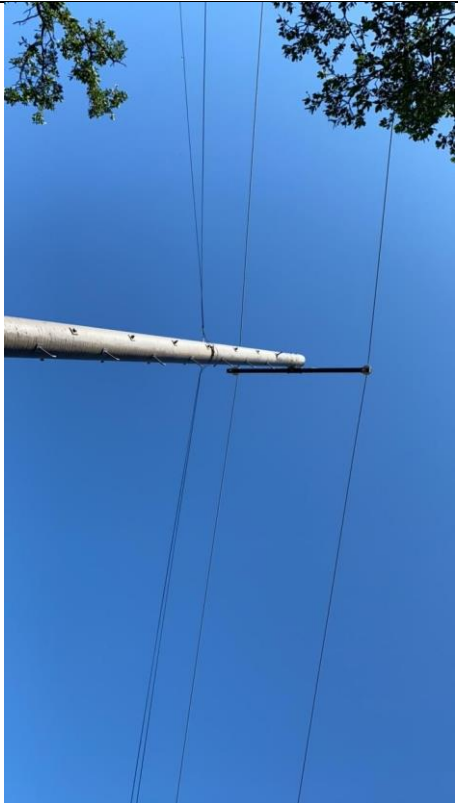
Structure ID: 4237077E

1. Violation 1: Per SCE's Distribution Design Standards (DDS), Section DDS-10, page 10-82, "for the 336 (30/7) ACSR covered conductor, vibration dampers shall be installed on every span in both light loading and heavy loading areas." Also, SCE's Distribution Overhead Construction Standards (DOH), Section CC 190, page 1 of 11, indicates that vibration dampers are required when installing covered conductor. Poles numbered 4237077E, 4237080E, 4477345E, 4465129E, and 4369478E had covered conductor installed but failed to install vibration dampers. Energy Safety considers this violation for failure of adhering to protocol to be in the Minor risk category.

| Item | Structure ID | HFTD | Initiative Number | Violation Type | Severity | Violation Description |
|---|---|---|---|---|---|---|
| 1 | 4237077E | Non-HFTD | 7.3.3.3.1 | Adherence to Protocol | Minor | Failure to install vibration dampers on a span |

Item1IA1img1: No vibration dampers

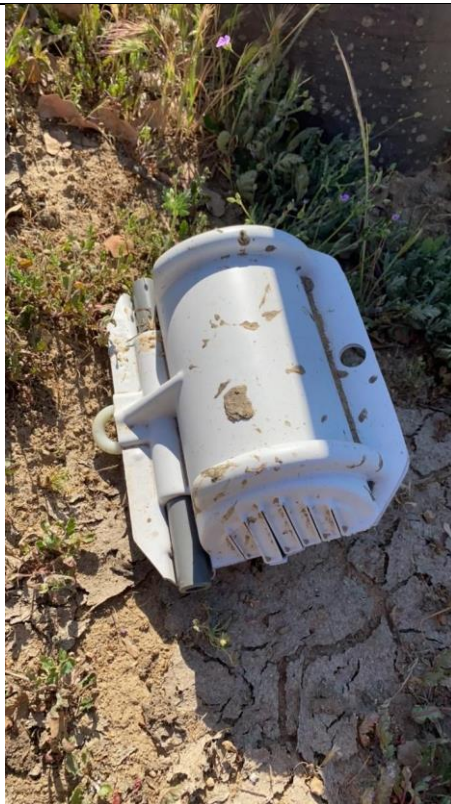
Structure ID: 4362869E

partially covered exposed conductor." Energy Safety observed structure numbered 4362869E that showed a pothead cover on the ground next to the structure with an uncovered splice on one phase of covered conductor. Energy Safety considers this violation for failure of adhering to protocol to be in the Minor risk category.

| Item | Structure ID | HFTD | Initiative Number | Violation Type | Severity | Violation Description |
|---|---|---|---|---|---|---|
| 2 | 4362869E | Tier 2 | 7.3.3.3.1 | Adherence to Protocol | Minor | Wildlife terminator/pothead covers found on ground |

Item3IA1Img1: Wildlife terminator/pothead on ground next to pole

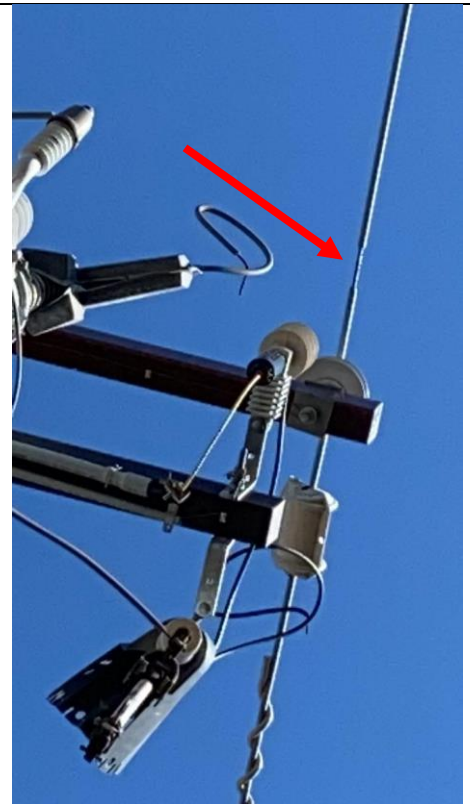
In accordance with SCE's protocols for covered conductor installation, DOH CC 180, "If conductor is exposed, install bolted wedge connector cover" and "If overhead equipment is located at a pole transition from bare wire to covered conductor, the equipment is considered part of the covered conductor system." During the inspection, Energy Safety found one instance where a pothead cover fell off the conductor and lying next to the pole. The structure where this protocol was not followed is

Item3IA1Img2: No Wildlife terminator/pothead on conductor, exposing conductor

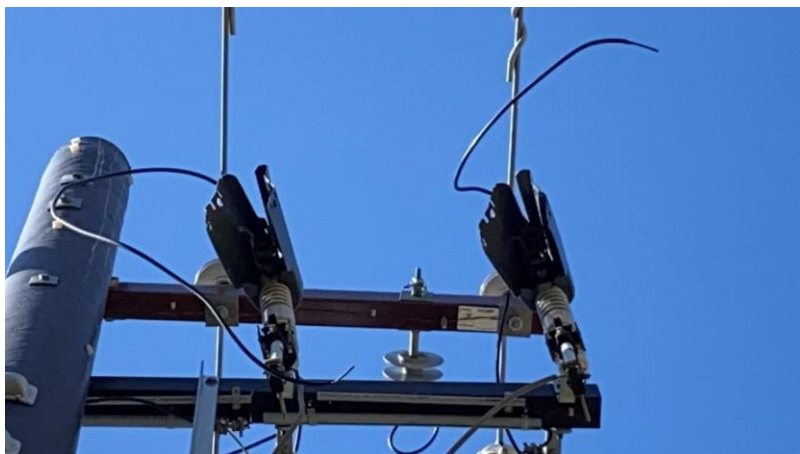
Item3IA1Img3: Observation, 3 Fuses are popped with jumpers hanging in air

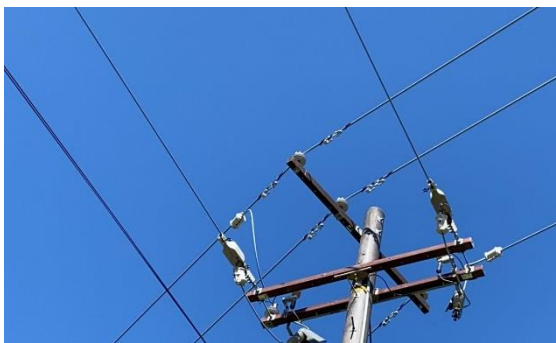
Structure ID: 4237080E

| Item | Structure ID | HFTD | Initiative Number | Violation Type | Severity | Violation Description |
|---|---|---|---|---|---|---|
| 3 | 4237080E | Tier 2 | 7.3.3.3.1 | Adherence to Protocol | Minor | Failure to install vibration dampers on a span |

Item4IA1Img1: No Vibration dampers on secondary phase level

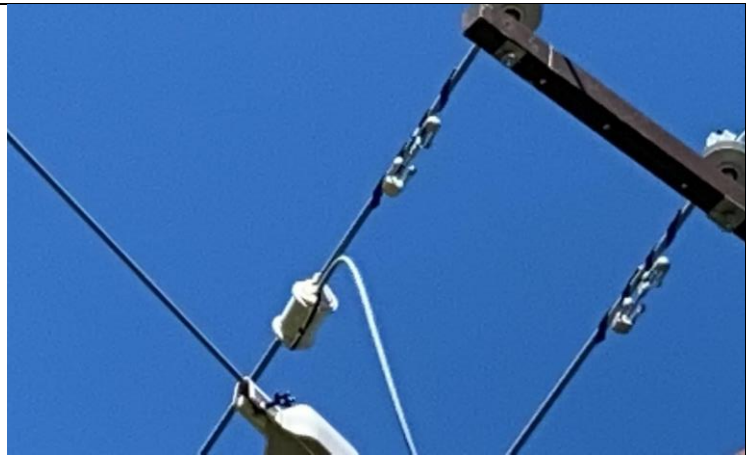
Item4IA1Img2: Observation: Close up showing vibration dampers on upper pole phase level between jumper and crossarms

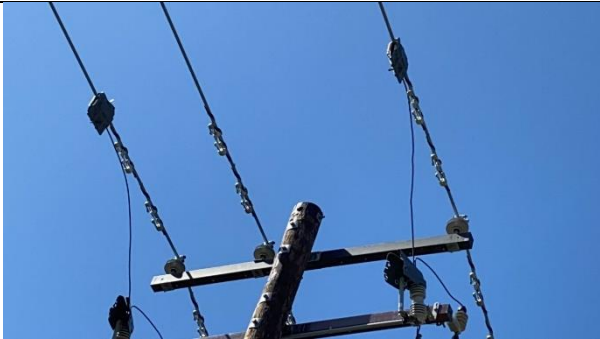
Structure ID: 4465119E

Item5IA1Img1: Observation: Vibration dampeners installed between bolted wedge connector cover and crossarm

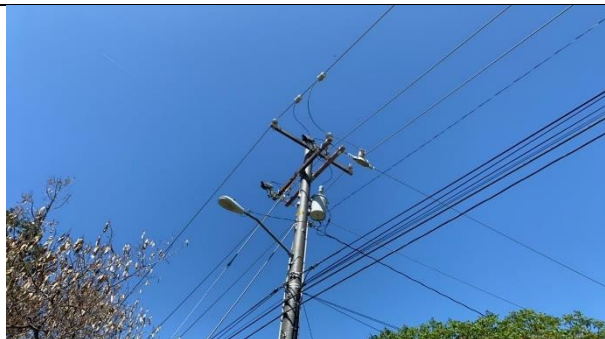
Structure ID: 4477345E

| Item | Structure ID | HFTD | Initiative Number | Violation Type | Severity | Violation Description |
|---|---|---|---|---|---|---|
| 4 | 4477345E | Tier 2 | 7.3.3.3.1 | Adherence to Protocol | Minor | Failure to install vibration dampers on a span |

Item6IA1Img1: No vibration dampers

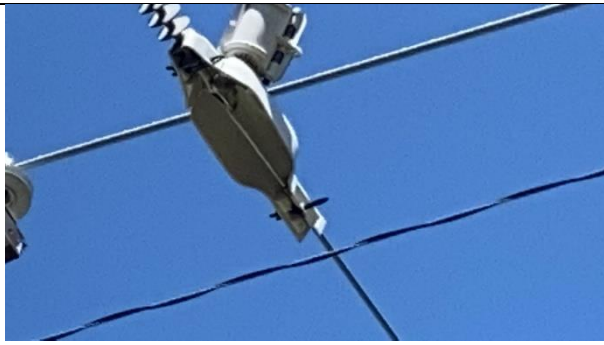
3. Violation 3: Per SCE's DOH, Table DC 535-1: Wildlife Protection Material, SCE requires that anti-rotation clips be used with Dead-End Clamp Covers.¹ Pole numbered 4477345E and 4465129E did not have anti-rotational clips installed in dead-end covers. Energy Safety considers this violation for failure of adhering to protocol to be in the Minor risk category.

| Item | Structure ID | HFTD | Initiative Number | Violation Type | Severity | Violation Description |
|---|---|---|---|---|---|---|
| 5 | 4477345E | Tier 2 | 7.3.3.3.1 | Adherence to Protocol | Minor | Failure to install anti-rotational clip on dead end cover |

Item6IA2Img1: No anti-rotation clip installed on dead end cover

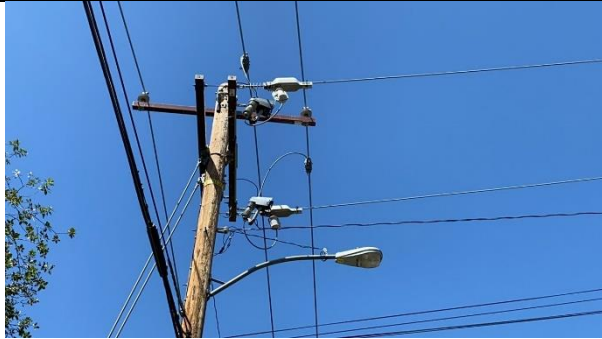
Structure ID: 4465129E

| Item | Structure ID | HFTD | Initiative Number | Violation Type | Severity | Violation Description |
|---|---|---|---|---|---|---|
| 6 | 4465129E | Tier 2 | 7.3.3.3.1 | Adherence to Protocol | Minor | Failure to install vibration dampers on a span |

Item7IA1mg1: No vibration dampers

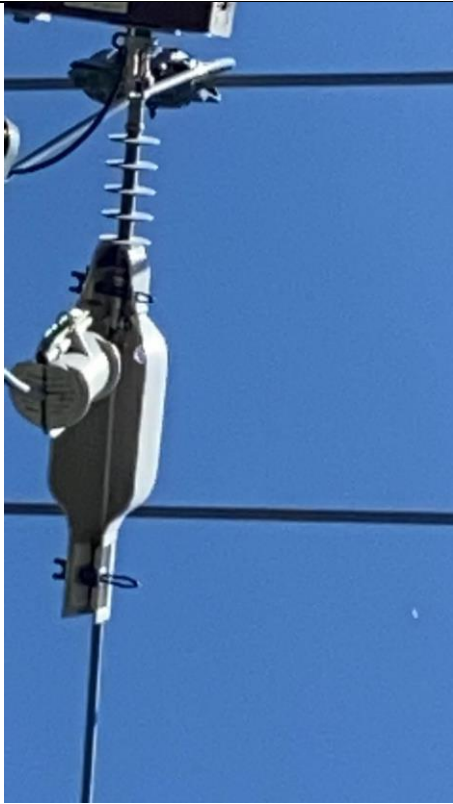
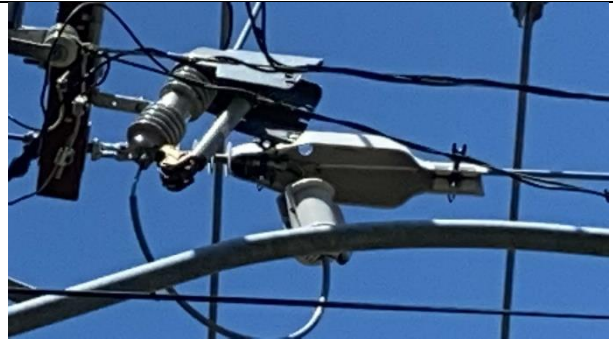
| Item | Structure ID | HFTD | Initiative Number | Violation Type | Severity | Violation Description |
|---|---|---|---|---|---|---|
| 7 | 4465129E | Tier 2 | 7.3.3.3.1 | Adherence to Protocol | Minor | Failure to install anti-rotational clip on dead end cover |

Item7IA2Img1: No anti-rotational clip installed on dead end cover

Item7IA2Img2: No anti-rotational clip installed on dead end cover

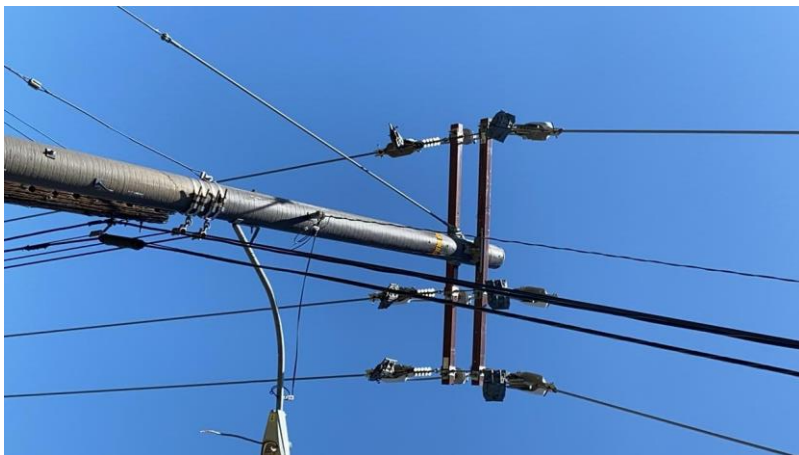
Structure ID: 4369478E

| Item | Structure ID | HFTD | Initiative Number | Violation Type | Severity | Violation Description |
|---|---|---|---|---|---|---|
| 8 | 4369478E | Tier 2 | 7.3.3.3.1 | Adherence to Protocol | Minor | Failure to install vibration dampers on a span |

Item8IA1Img1: No vibration dampers

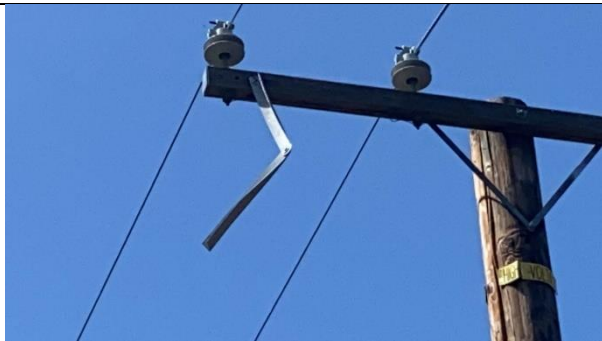
Structure ID: 4719578E

| Item | Structure ID | HFTD | Defect Type | Severity | Defect Description |
|---|---|---|---|---|---|
| 1 | 4719578E | Tier 2 | Cold End Hardware | Minor | Triangular wildlife Guard loose/detaching from crossarm |

In addition to the violations discovered during WMP inspections of SCE's covered conductor installations, Energy Safety discovered a triangular wildlife guard that was dislodged and falling off a crossarm. The structure where this was found is identified in Table 3 above.

Item11CA2Img1: Wildlife Mitigation device falling off crossarm
