NOTICE OF VIOLATION

INSPECTION REPORT

Electrical Corporation:	Southern California Edison Company
Report Number:	CAD_SCE_ATJ_20250520_1304
Inspector:	Anthony Trujillo
WMP Year Inspected:	2024
Quarterly Data Report (QDR) Referenced:	Quarter 4 (Q4)
Inspection Selection:	Energy Safety viewed the contents of the Q4 QDR and performed an analysis that resulted in the selection of the WMP initiatives and locations referenced in this report.
Relevant WMP Initiative(s):	8.1.3.1 - Distribution Detailed Inspections and Remediations (IN-1.1)
Date of inspection:	May 20, 2025
City and/or County of Inspection:	Canyon Country, Los Angeles County
Inspection Purpose:	Assess the accuracy of Southern California Edison’s QDR data, completeness of its work, compliance with WMP requirements, and compliance with its protocols.

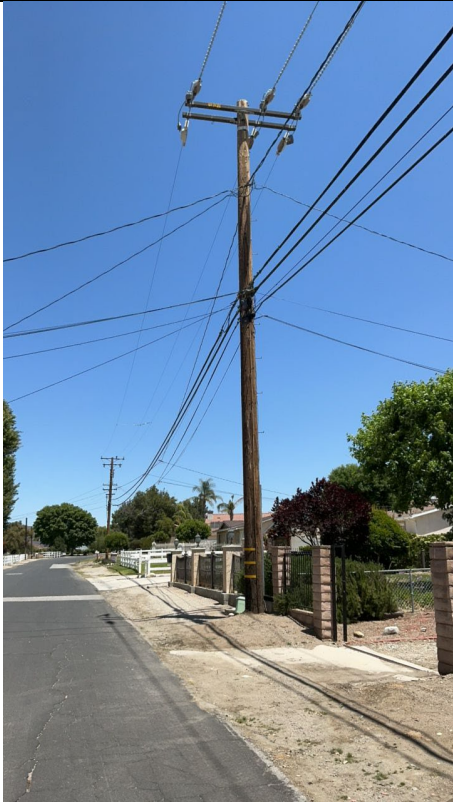
A close-up photograph of a blue identification tag attached to a wooden utility pole. The tag is oriented vertically and contains the alphanumeric string '104 69 01 01 10 00 10' printed on it.
<p>Item1Gimg1: Overall pole.</p>	<p>Item1Gimg2: Pole ID.</p>

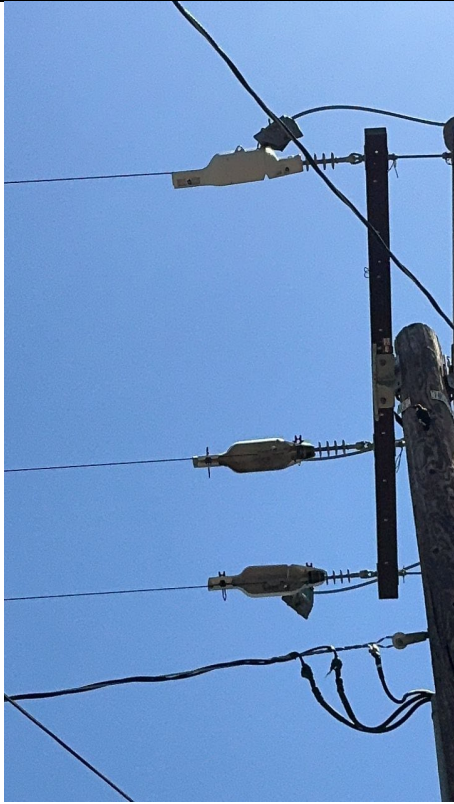
On pole ID 4864658E, Grid Hardening ID 413854385-4864658E at 16218-16234 Lost Canyon Rd, Canyon Country, CA, 91387, USA, 34.422765, -118.419019, the inspector observed two of three dead-end wildlife covers on primary conductor rotated with the canoe opening facing other conductors. Dead-end wildlife cover canoe openings should face the ground when installed properly. Per information provided by SCE to the Compliance Inbox on April 3, 2025, at approximately 12:15 pm, SCE identified that dead end covers were over rotated, and that remediation was required and completed.

The inspector's observation is documented in Violation 1 photographs, which are attachments to this report. Photo numbers Item1G1mg1, Item1G1mg2, Item1IA11mg1, Item1IA11mg2, Item1IA11mg3, and Item1IA11mg4 depict two of three dead-end wildlife covers seated improperly on the dead-end insulators.

1. Pursuant to Southern California Edison Company's 2023 WMP 8.1.3.1 Distribution Detailed Inspections and Remediations work, corrected dead-end wildlife cover rotation was identified as complete at this location.
2. Two of three dead-end wildlife covers are not properly seated on the dead-end insulators. Exhibit B shows the proper installation of the dead-end wildlife covers.

Item1IA1Img1: View showing dead-end wildlife covers seated at approximately ninety degrees.

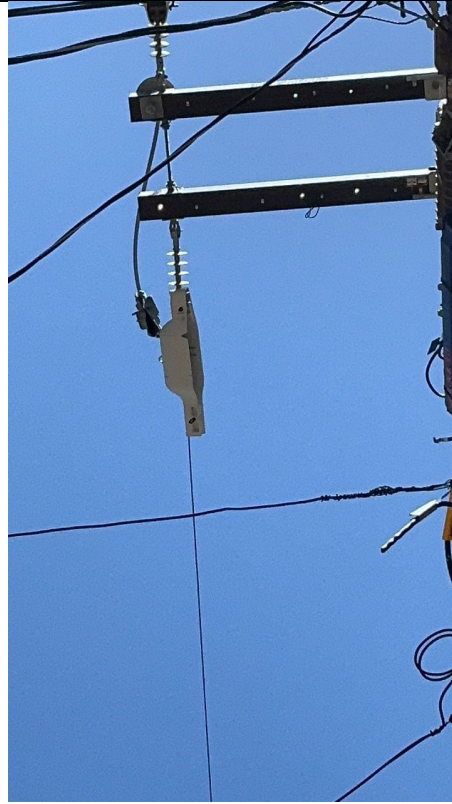
Item1IA1Img2: View showing dead-end wildlife covers seated at approximately ninety degrees.

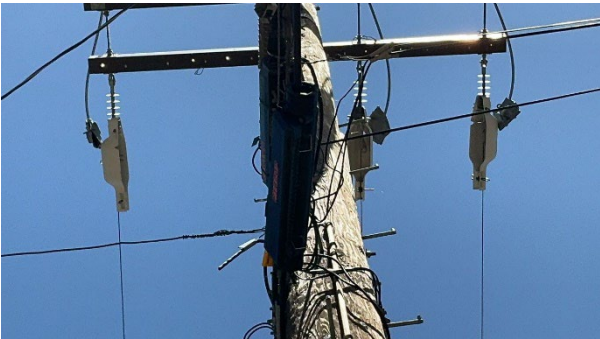
Item1IA1Img3: View showing dead-end wildlife covers seated at approximately ninety degrees.

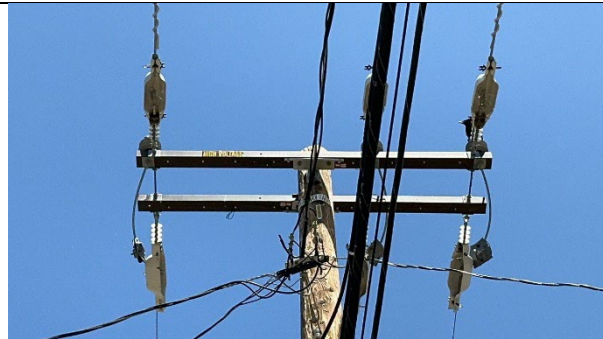
Item1IA1Img4: View showing dead-end wildlife covers seated at approximately ninety degrees.
