**RE: San Diego Gas & Electric Company's Response to Notice of Violation –
NOV_CAD_SDGE_ATJ_20250325_0829**

A. Violation 1 – Excessively Loose Down Guy Wire Resulting in Primary Fiberglass Strain Insulator to Rest on Crossarm Suspension Dead-End Insulator.

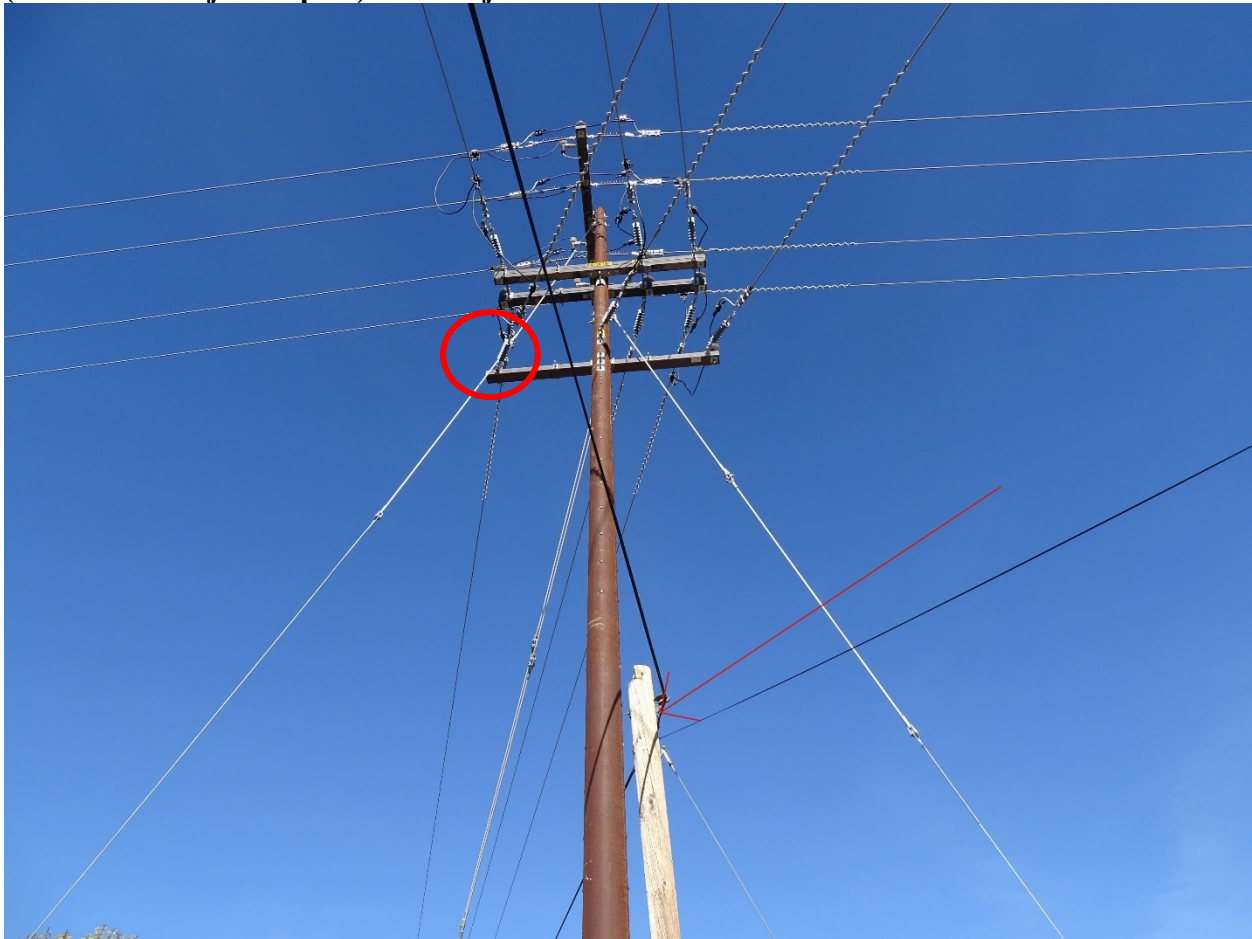
Imagery and documentation contemporaneous with the completion of construction and obtained on December 17, 2024 (see Figures 1–3) by QA/QC inspectors validate the facility's compliance at the time of inspection. Between December 17, 2024, and March 25, 2025, the only known modification to Pole P275777 was the transfer of the CIP's facilities to the newly constructed structure.

Figure 1 - Image acquired during QA/QC inspection on 12/17/2024, notating state of CIP (attached to adjacent pole) and subject hardware identified in notice of violation

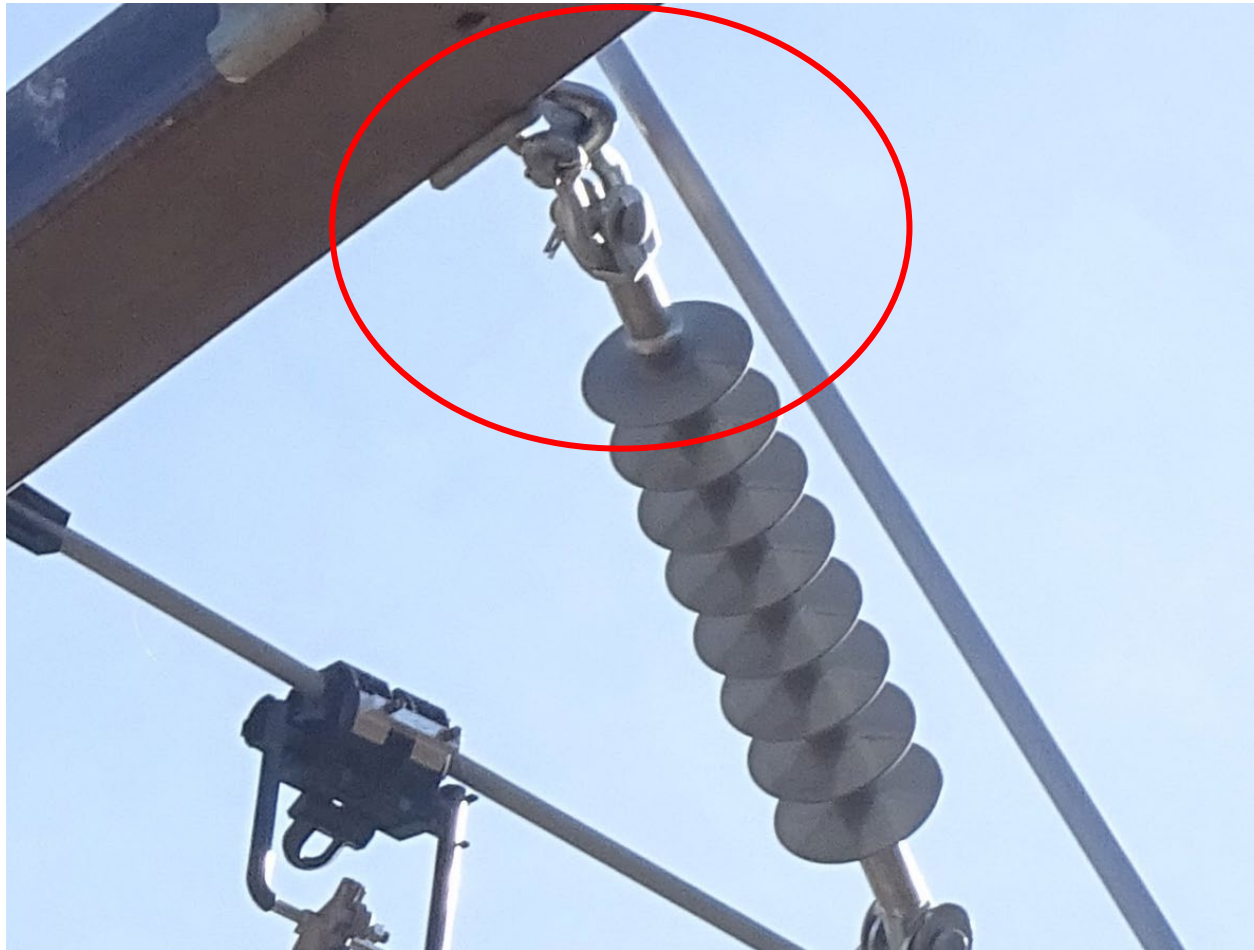
Figure 2 - Image acquired during QA/QC inspection on 12/17/2024 showing clearance between down guy and insulator

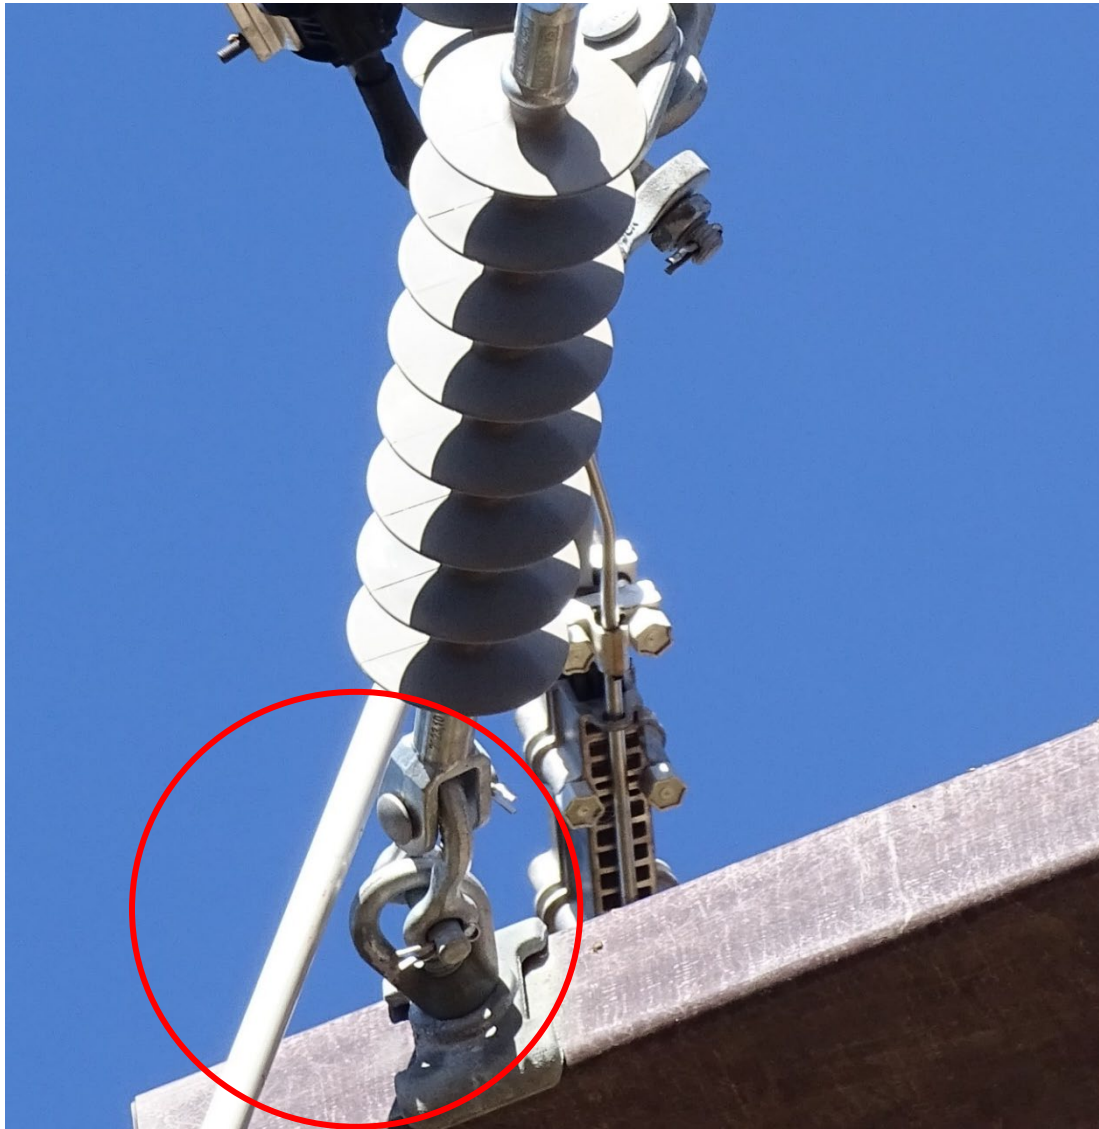
Figure 3 - Image acquired during QA/QC inspection on 12/17/2024 showing clearance between down guy and insulator

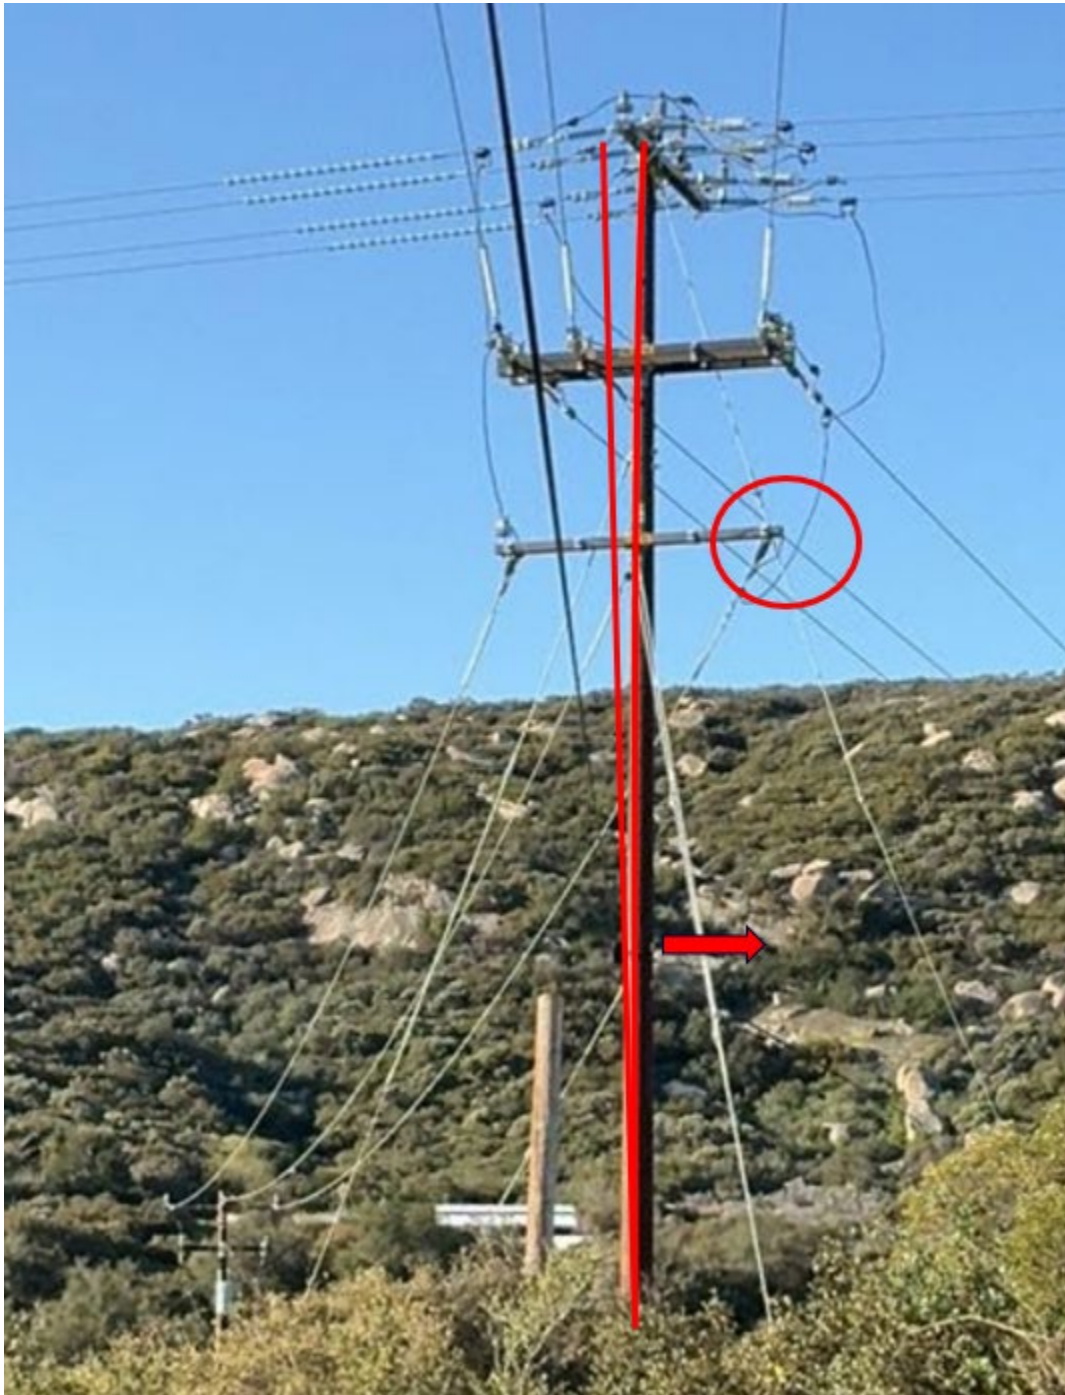
Violation 1. Energy Safety observed that in implementing 2024 WMP initiative 8.1.2.1 - Covered Conductor Installation (WMP.455), SDG&E failed to complete Covered Conductor Installation on pole ID P275777, Grid Hardening ID P275777_0073-R-CC_4102 at coordinates 32.760862481866, 116.688413323077. Energy Safety considers this completeness violation to be in the Moderate risk category.

Furthermore, based on: (1) the postulated directionality of the load (i.e., force) resulting from the CIP's transfer, (2) the induced deflection observed in the structure, and (3) the resulting slack in the down guy producing identified violation, the evidence indicates that the CIP's actions were the cause of the nonconformity identified in the violation. Imagery obtained by OEIS on March 25, 2025 (Figure 4), depicts the CIP's facilities affixed to the new pole, overlaid with the aforementioned phenomena for illustrative purposes.

Figure 4 – Image obtained on 3/25/2025 by OEIS and provided in NOV report showing CIP transferred to new facility, overlay with directionality of force induced by CIP facility, postulated deflection of structure caused by CIP attachment, and subject hardware conflict (for illustration purposes only)

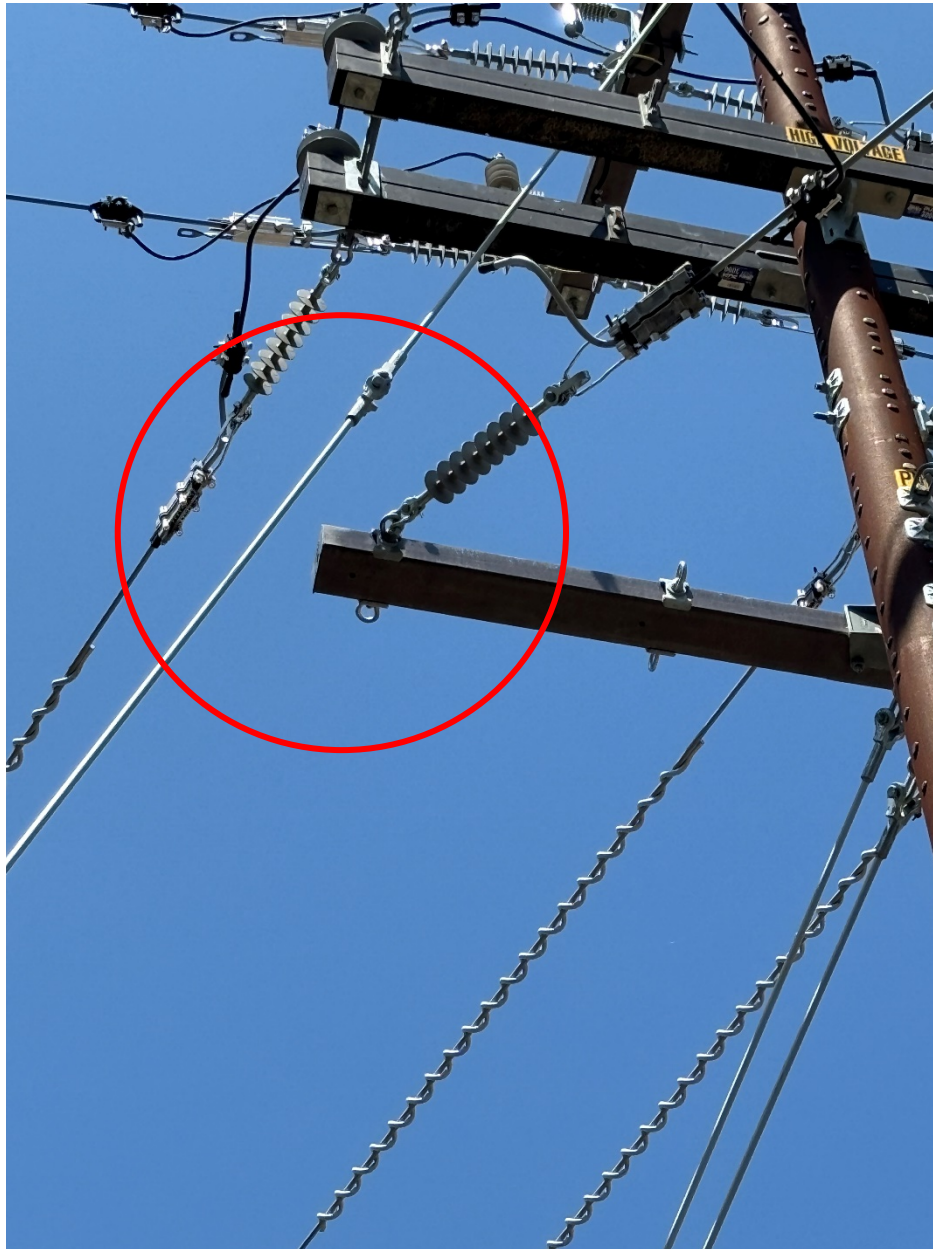
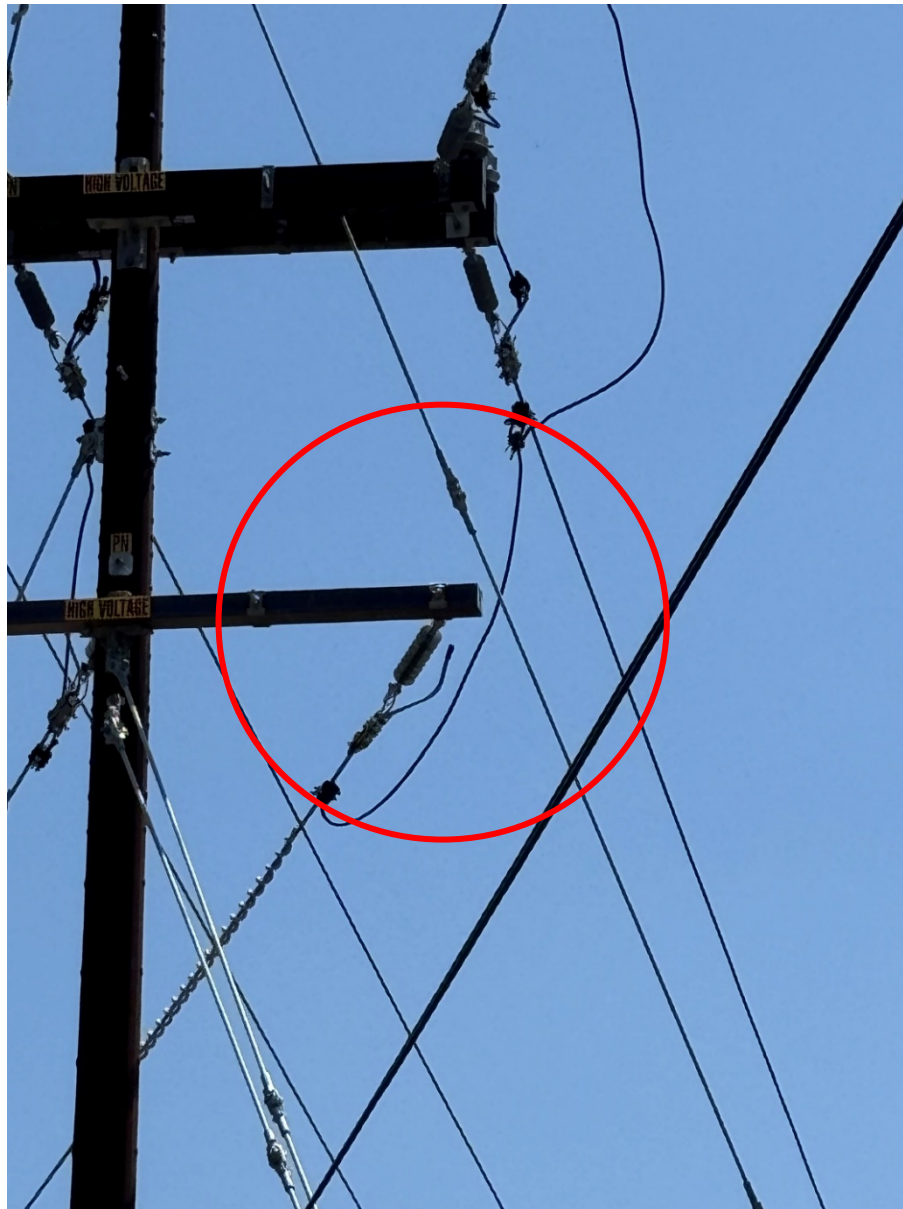
Figure 5 - Image captured on 6/24/2025 by SDG&E construction team after modification of facility

Figure 6 - Image captured on 6/24/2025 by SDG&E construction team after modification of facility

Notwithstanding the above, SDG&E resolved the violation on June 24, 2025, by tightening the guy wire on Pole P275777 (see Figures 5 and 6).
