## NOTICE OF VIOLATION

# INSPECTION REPORT

Electrical Corporation:	Southern California Edison Company
Report Number:	CAD_SCE_SIS_20250708_1316
Inspector:	Samuel Isaiah
WMP Year Inspected:	2024
Quarterly Data Report (QDR) Referenced:	Quarter 4 (Q4)
Inspection Selection:	Energy Safety viewed the contents of the Q4 QDR and performed an analysis that resulted in the selection of the WMP initiatives and locations referenced in this report.
Relevant WMP Initiative(s):	8.1.3.1 - Distribution Detailed Inspections and Remediations (IN-1.1)
Date of inspection:	July 8, 2025
City and/or County of Inspection:	Temecula, Riverside County
Inspection Purpose:	Assess the accuracy of Southern California Edison Company's QDR data, completeness of its work, compliance with WMP requirements, and compliance with its protocols.

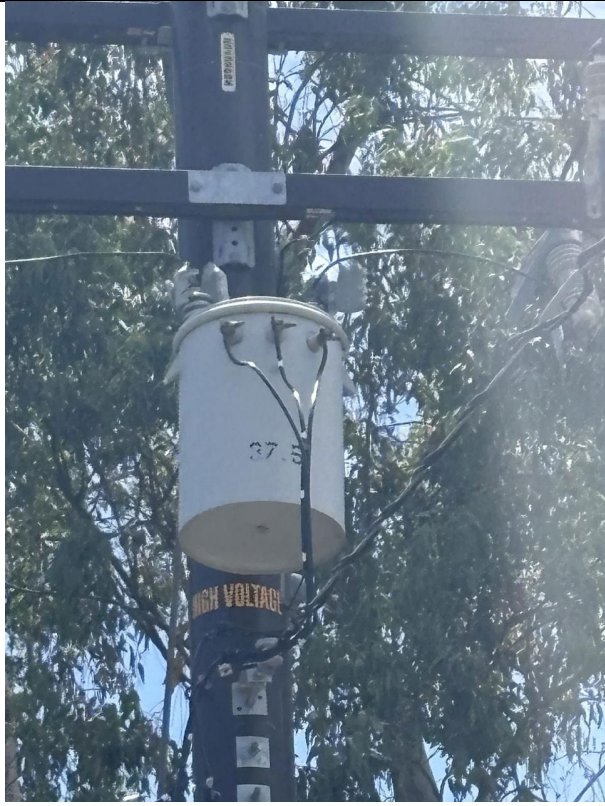
On Pole ID 2343288E, Grid Hardening ID 413885136-2343288E at 45231 Vía Los Ventos, Temecula, CA, 92590, 33.477405, -117.297697, the inspector observed that the avian protection replacement work was not completed. The inspector's observation is documented in Violation 1 photographs, which are attachments to this report. Photo numbers IA1Img1, IA1Img2 and IA1Img3 depict that both transformer's bushings were unhinged, and the external connecting terminals were exposed. Per information provided by SCE to the Compliance Inbox on April 3, 2025, at 12:15 pm, the unsecured transformer bushings were repaired.

1. Southern California Edison Company's 2024 WMP 8.1.3.1 Distribution Detailed Inspections and Remediations work identified that the unsecured transformer's bushings were repaired at this location.
2. The transformer bushings were unhinged, and the external connecting terminals were exposed to wildlife.

**IA1Img1:** Transformer bushings unhinged

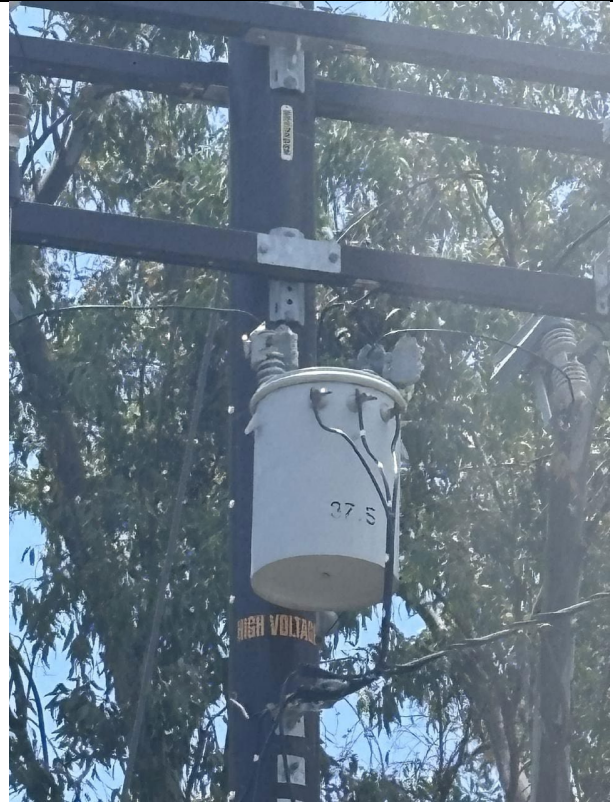
**IA1Img2:** Transformer bushings unhinged

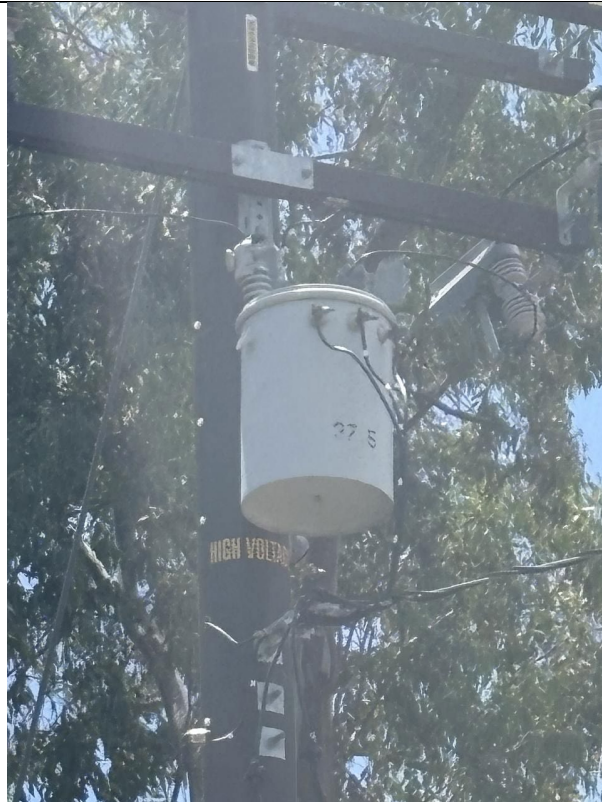
**IA1Img3:** Transformer bushings unhinged
