**SUBJECT:** Southern California Edison Company's Response to Notice of Non-Performance NON\_CAD\_SCE\_AXS\_20250904\_1406

| <b>Notice</b> | <b>#</b> | <b>Structures</b> |
|---|---|---|
| NON_CAD_SCE_AXS_20250904_1406 | 1 | 1232599E |

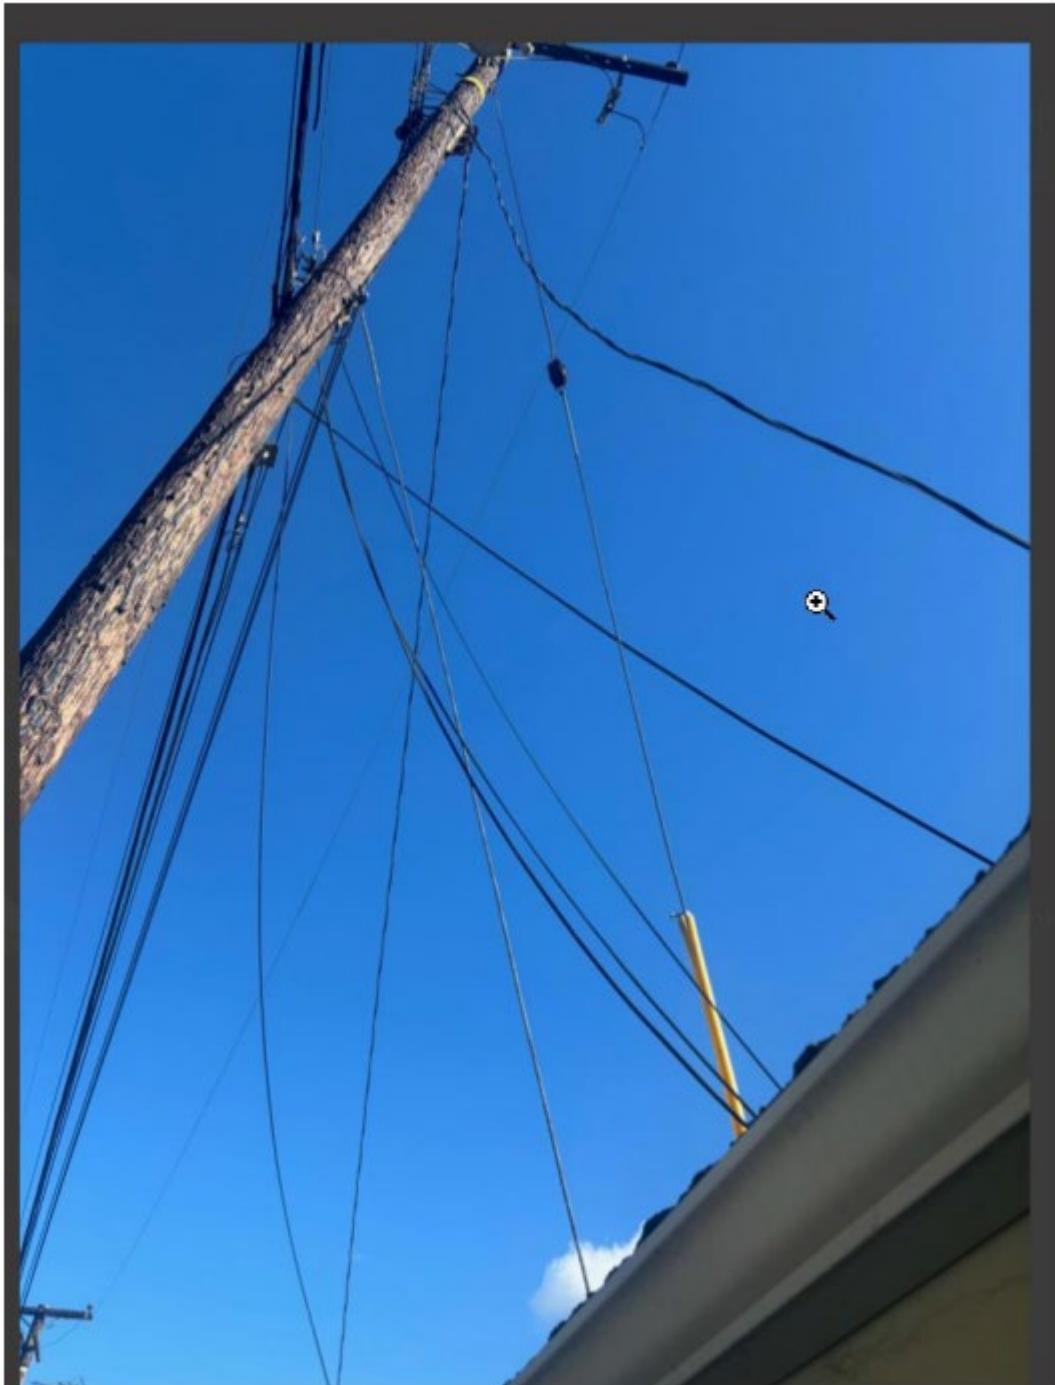
Photo 1

The notification for structure ID 1232599E called for the tightening of the down-guy wire. Upon additional review and field verification conducted on November 19, 2025 in response to this Notice, SCE personnel further tightened the guy wire to the maximum extent feasible while maintaining the structural stability of the pole. Field personnel also noted a slight lean toward the guyed side. Out of an abundance of caution, SCE is assessing whether any additional maintenance of the pole is warranted; however, the pole remains stable and has been assessed by SCE personnel to be safe. Please see
