NOTICE OF NONPERFORMANCE

INSPECTION REPORT

Electrical Corporation:	PG&E
Report Number:	ESD_PGE_GCA_20251106_1429
Inspector:	Gary Candelas
WMP Year Inspected:	2025
Quarterly Data Report (QDR) Referenced:	Quarter 2
Inspection Selection:	Energy Safety inspected the locations based on PG&E's Q2 QDR.
Relevant WMP Initiative(s):	8.2.3.2 Wood and Slash Management
Date of inspection:	November 6, 2025
City and/or County of Inspection:	Meadow Vista, Placer County

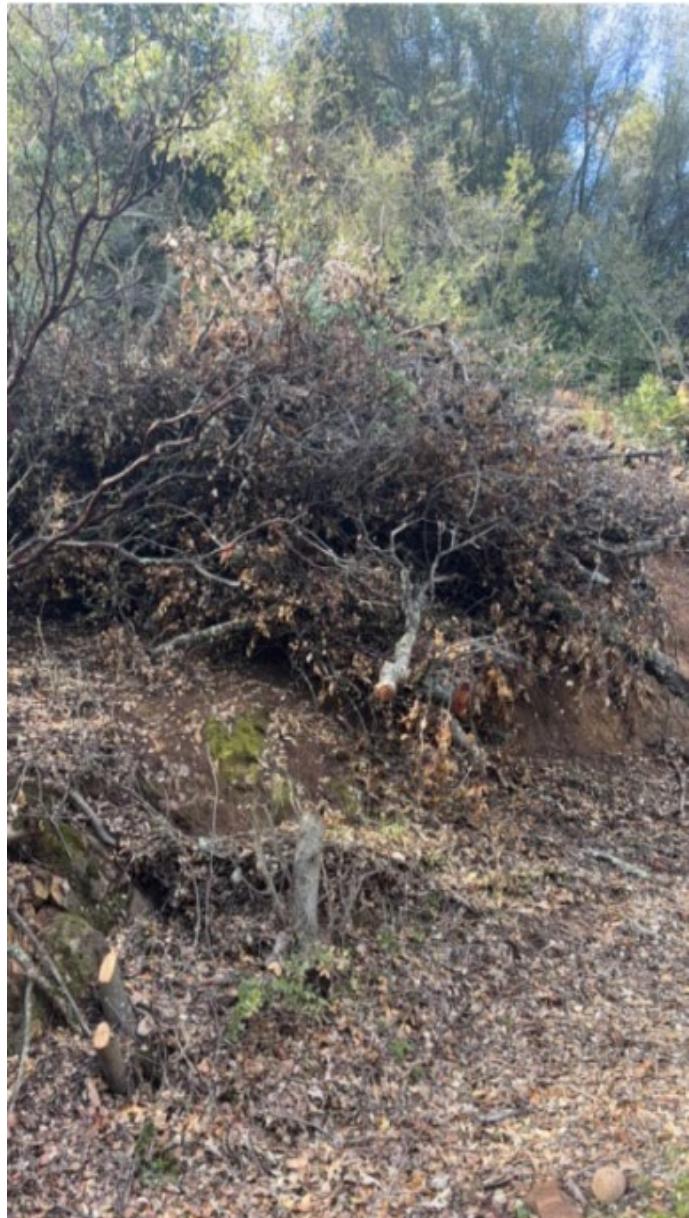
Energy Safety considers this deficiency as a "Moderate" because the slash pile is over 18-inches in height, creating a potential fuel source for wildfire.

At VMP IDs RX-04390156, RX-04390169, and RX-04390160 near pole ID 121477130, PG&E reported it completed work under its VMOM program. PG&E's Q2 data reports that its crew removed three oak trees on May 18, 2025. Energy Safety's inspector observed slash, wood chips, and woody debris from the oak trees. Additionally, the inspector observed a pile of slash debris was higher than 18 inches. The inspector's observation is documented in photos 1 and 2, which are exhibits to this report.

Photo 1: Photo of pile of slash and wood debris

Since Energy Safety's inspection, PG&E conducted a field visit on November 20, 2025, and completed the clean-up and disposal of wood and slash at the location in this report. Therefore, Energy Safety considers NON ESD_PGE_GCA_20251106_1429 closed. No further action from PG&E is required in response to this NON.

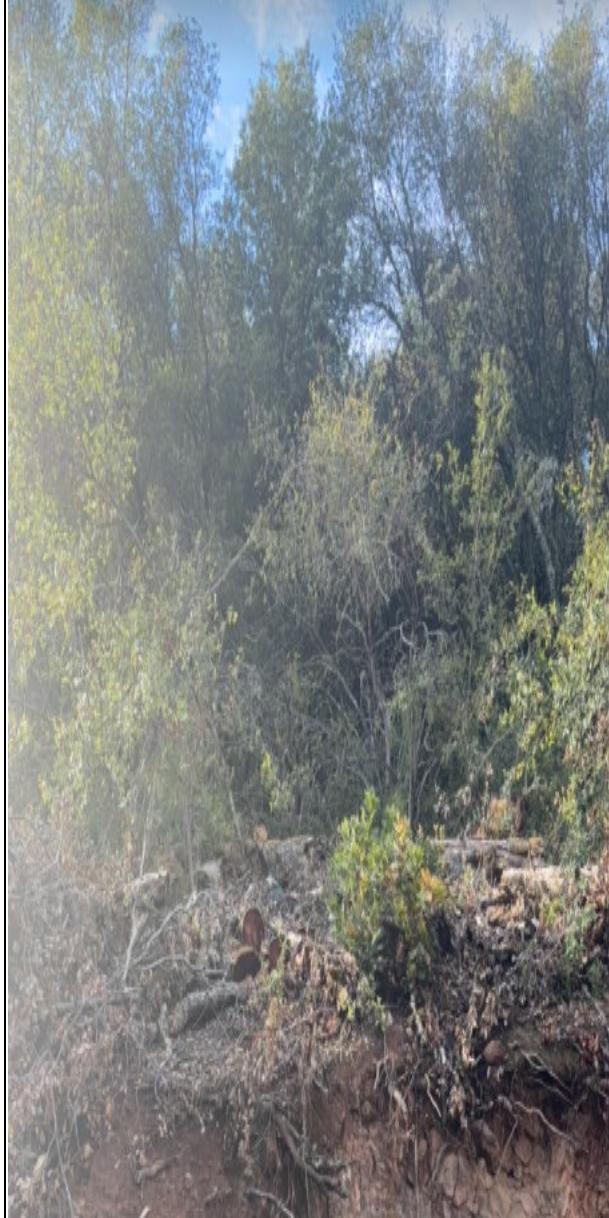
Photo 2: Photo of slash and wood debris
