## **NOTICE OF NON-PERFORMANCE**

# INSPECTION REPORT

Electrical Corporation:	Liberty Utilities
Report Number:	NON_ESD_LU_AKM_20251124_1309
Inspector:	Akiko Masuda
WMP Year Inspected:	2025
Quarterly Data Report (QDR) Referenced:	Quarter Q3
Inspection Selection:	Energy Safety inspected the locations based on Liberty’s Q3 QDR.
Relevant WMP Initiative(s):	2025 WMP initiative number 8.2.3.1 Pole Clearing WMP-VM-VFM-01
Date of inspection:	November 24, 2025
City and/or County of Inspection:	Coleville, California

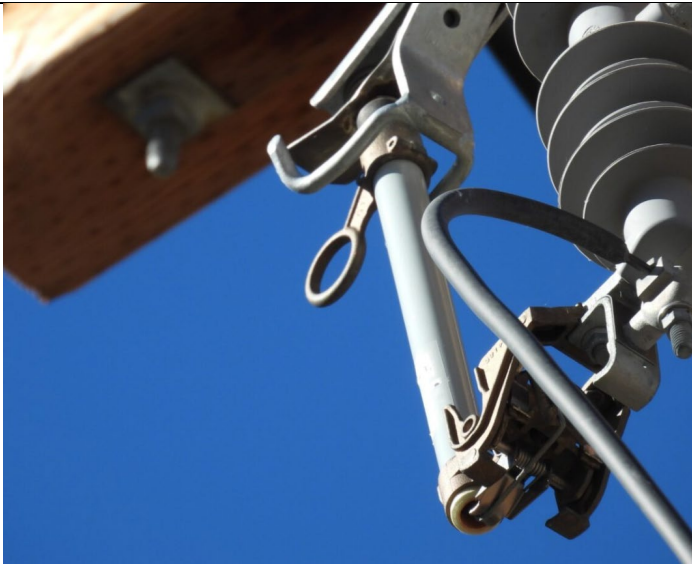
pole ID 293554 and an overall view of the equipment on the pole. Photo 3 shows the non-exempt universal fuse on the pole. Photos 4, 5, and 6 depict vegetation present within 10 feet of the pole. Photos 7 and 8 depict a closer view of the dried vegetation, Russian thistle and yellow rabbitbrush.

<p><b>Photo 1:</b> Pole ID 293554</p>	<p><b>Photo 2:</b> Overview of the equipment on the pole</p>

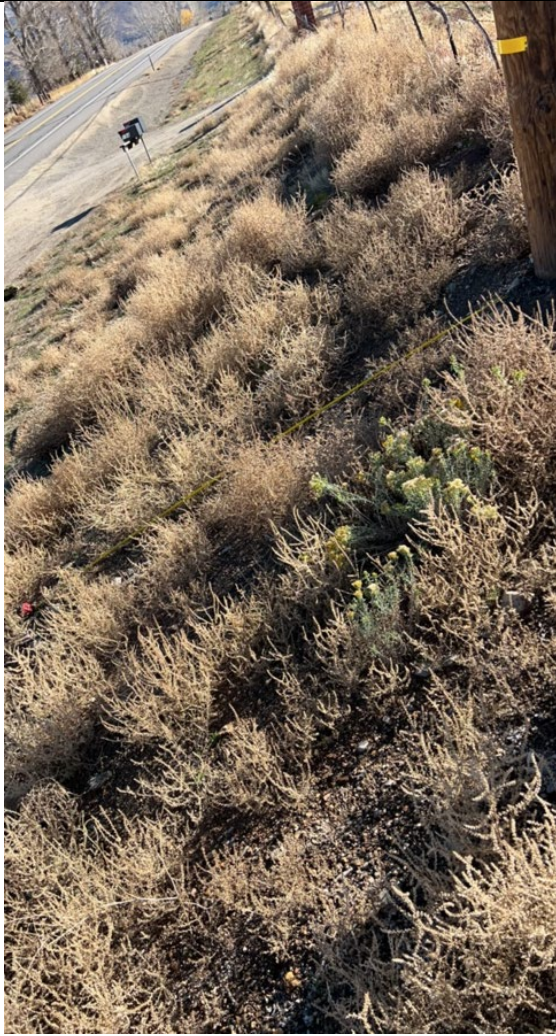
Energy Safety considers this deficiency "Moderate" because of the presence of dry vegetation which provides a fuel bed of flammable vegetation.

**Photo 4:** Dry vegetation within a 10-foot radius of the pole. The photo was taken looking north toward Highway 395 from the pole.

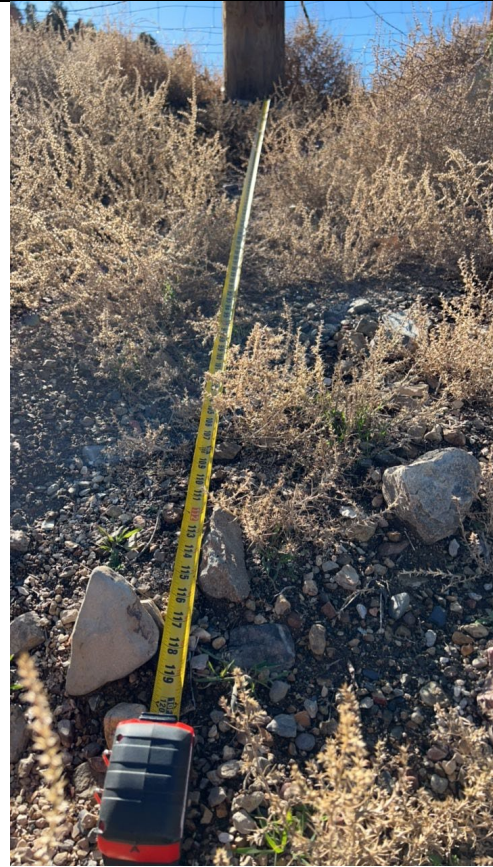
**Photo 5:** Dry vegetation within a 10-foot radius of the pole. The photo was taken looking south toward Highway 395 from the pole.

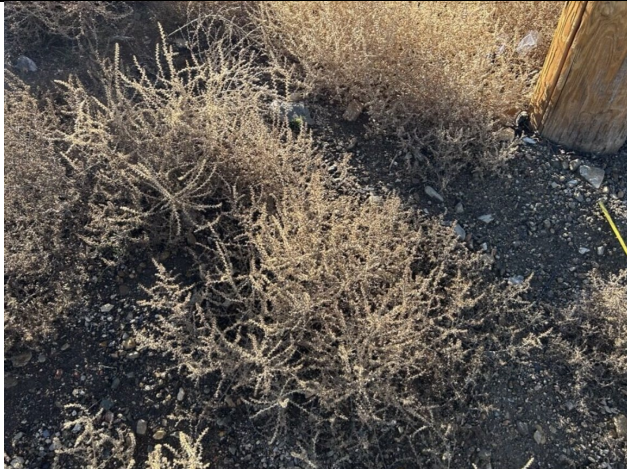
**Photo 6:** Dry vegetation within a 10-foot radius of the pole, shown with a tape measure.

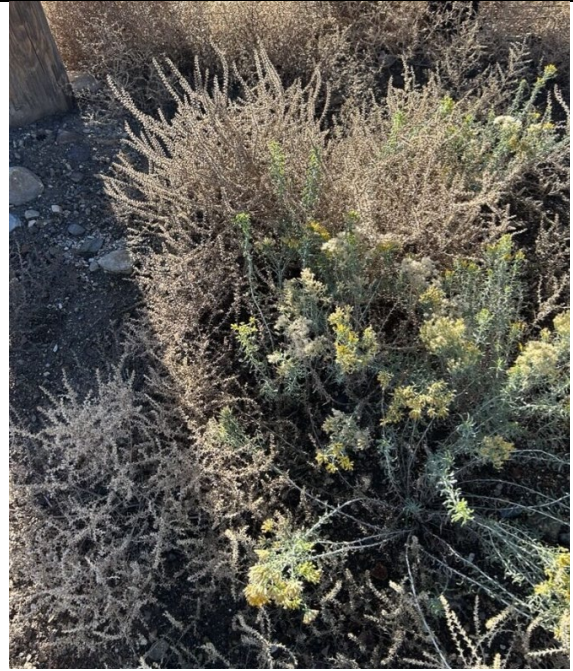
**Photo 7:** Close-up view showing dried vegetation, primarily Russian thistle.
