NOTICE OF NON-PERFORMANCE

INSPECTION REPORT

Electrical Corporation:	Liberty Utilities
Report Number:	CAD_LU_RMA_20250924_1435
Inspector:	Romeo Marroquin Ajcac
WMP Year Inspected:	2025
Quarterly Data Report (QDR) Referenced:	Quarter 2 (Q2)
Inspection Selection:	Energy Safety viewed the contents of the Q2 QDR and performed an analysis that resulted in the selection of the WMP initiatives and locations referenced in this report.
Relevant WMP Initiative(s):	8.1.2.12 Tree attachment removals
Date of inspection:	September 24, 2025
City and/or County of Inspection:	South Lake Tahoe, El Dorado County
Inspection Purpose:	Assess the accuracy of Liberty utilities' QDR data, completeness of its work, and performance of WMP requirements.

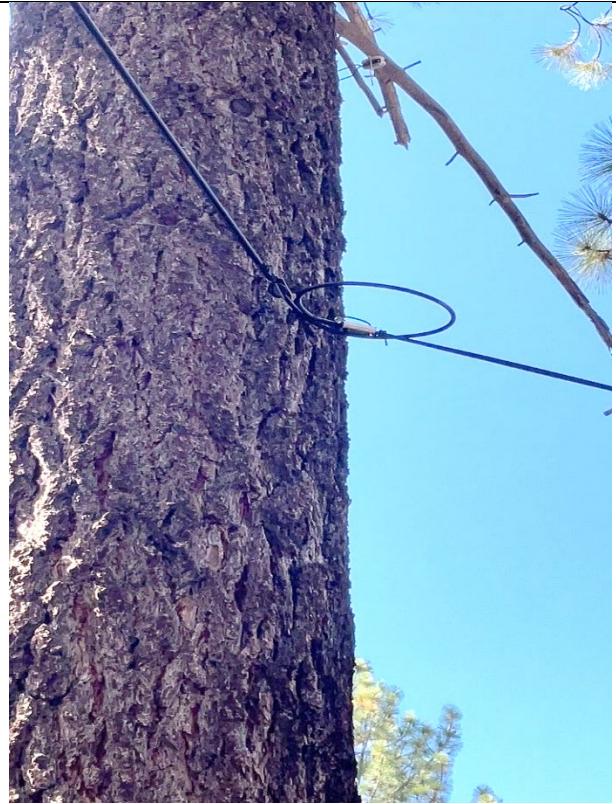
1. Four tree attachment removals were submitted as complete at this location.
2. The inspector observed that two out of four tree attachments were transferred to the new pole.
3. Two tree attachments were not removed from two trees within 15 feet of the new pole.

IA1Img1: One tree attachment was left on tree.

Deficiency 1. Energy Safety observed that in implementing the 2025 WMP initiative 8.1.2.12 - Tree Attachment Removals, LU failed to complete removal of two tree attachments on Pole ID 297905, Grid Hardening IDs c05bae02-301c-44fc-ba3e-093e5480bed7, 9c288076-e205-4406-b60d-de7aee69d097, 6a9d8845-7b27-4f67-a3ea-91e8173fe10e, and 8257935d-f917-44d9-b477-c09203aeee88 at coordinates 38.91285874805942, -119.999759. Energy Safety considers this non-performance to be in the Minor risk category. LU must complete a corrective action for this deficiency by 12 months from the date of this notice.¹

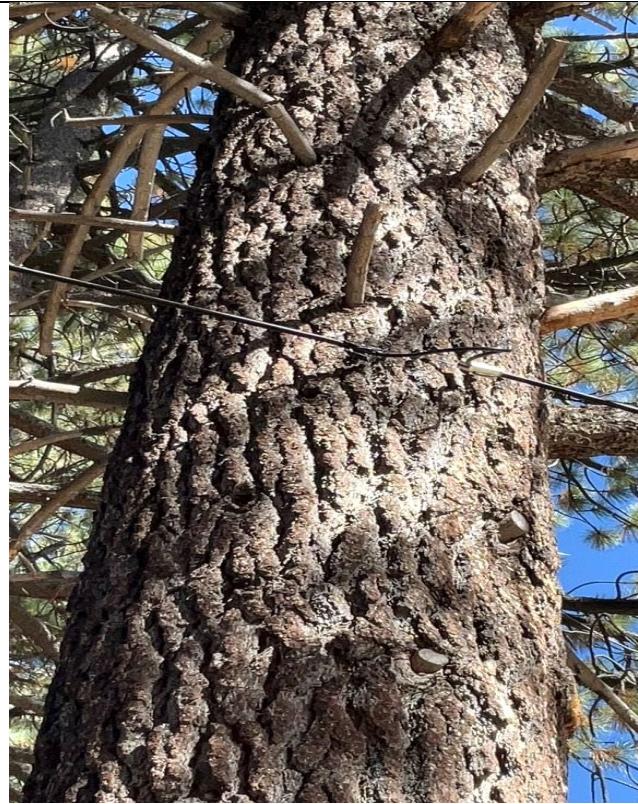
IA1Img2: A second tree attachment was left on a second tree.

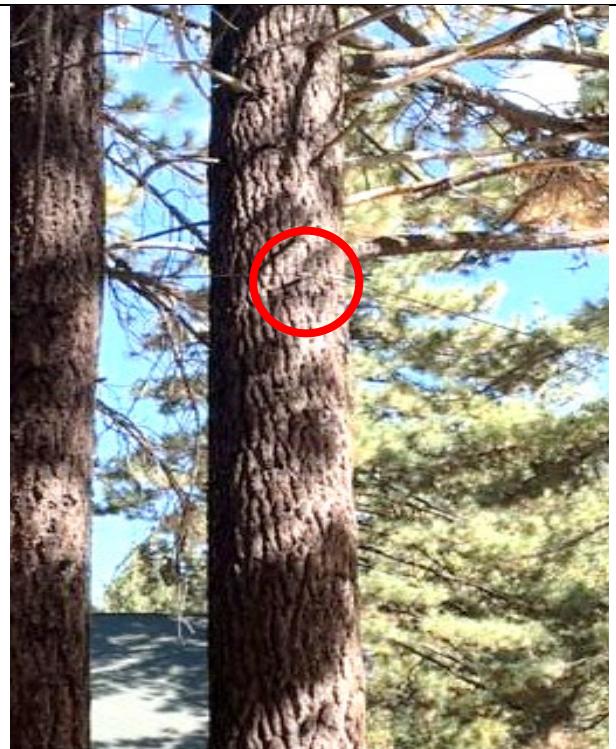
IA1Img3: One tree attachment was left on tree (wide view).

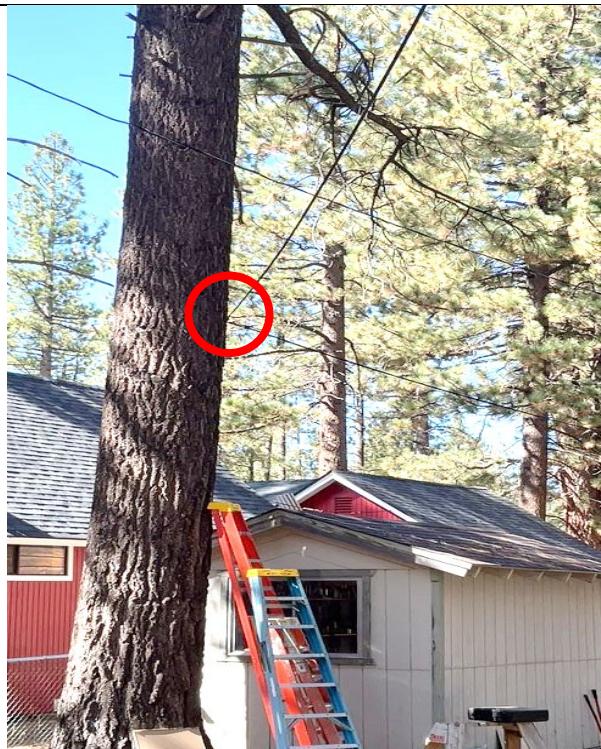
IA1Img4: A second tree attachment was left on a second tree (wide view).
